The Dangers of Failure Masking in Fault-Tolerant Software: Aspects of a Recent In-Flight Upset Event

C. W. Johnson^{*}, C. M. Holloway[†]

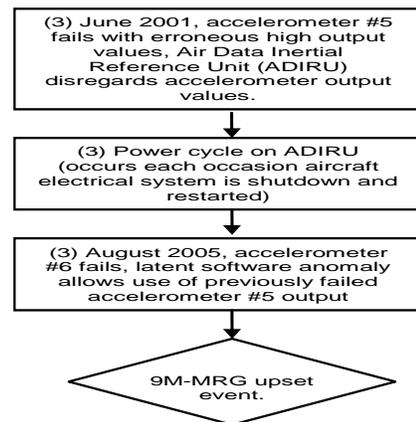
Figure 1: High-Level Overview of the Case Study Incident

Figure 1 illustrates the immediate events that contributed to the case study incident. The focus here is not on identifying a cause

for the accident but simply on establishing a more detailed timeline for the sketch that was presented in the introduction. The number that is used to label each box in the ECF diagram refers to the page on which that event is described in the Australian Transport Safety Bureau's official report [1]. This enables readers to use these diagrams to support the more detailed analyses of the textual documentation. The diamond indicates the eventual outcome of the events that lead to it.

As can be seen, the initial events may be traced back more than four years before the mishap. Accelerometer number 5 failed with erroneous high output values. The Air Data Inertial Reference Unit (ADIRU) software was programmed to disregard such output from the accelerometer and, instead, to rely on values from backup systems. The initial failure was, however, masked following a restart of the ADIRU. This created a vulnerability that was compounded by a latent software error – or bug. Following the failure of another accelerometer the ADIRU could revert to accepting input from the accelerometer that had initially failed and been excluded from its computations. This scenario contributed to the failure that is described in the opening sections of the paper.

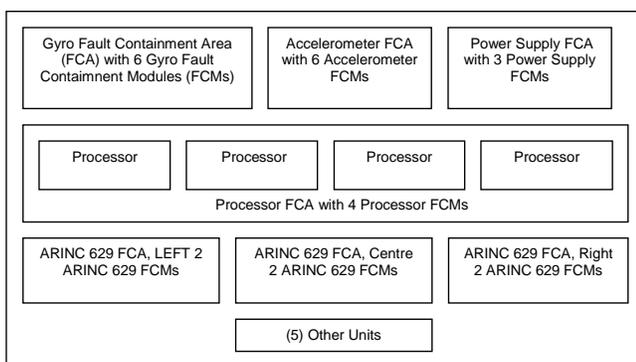
Figure 2: Air Data Inertial Reference Unit (ADIRU) Architecture (ATSB, 2007, p.5)

Figure 2 provides an overview of the architecture that supports the Air Data Inertial Reference Unit (ADIRU) on the B777. A core concept was to exploit redundancy as a means of achieving fault tolerance. The unit was divided into seven fault containment modules or areas. Each of these was physically and electrically isolated from the others. The intention was that the aircraft could have a fault in any of the modules and still remain serviceable. This feature would enable operators to continue flying until the number of fault-free modules fell below a minimum specified by the component manufacturer. This fault tolerance supported lower operating costs, for instance, by reducing the potential disruption to aircraft operations from unscheduled maintenance. In particular, the ADIRU used a fault containment module to analyze data from accelerometers and gyros before passing them through the ARINC 629 units to navigation and flight control systems.

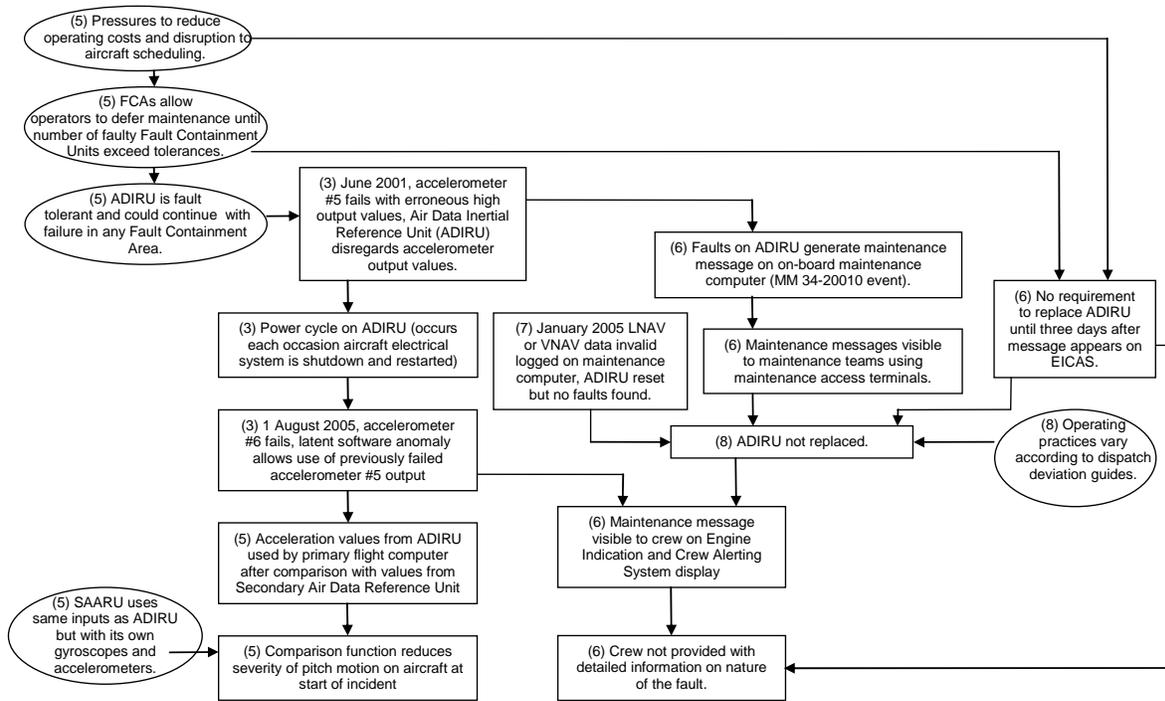
Figure 3: Maintenance Not Required to Replace Fault Tolerant ADIRU

Figure 3 builds on the previous analysis and illustrates how the architecture and design objectives for the ADIRU software contributed to the case study incident. As in Figure 1, the rectangles represent events leading to the mishap and page numbers in the ATSB report are indicated in parentheses. The ovals denote contributory factors. These provide a short-hand representation for many individual events that together create the preconditions for an incident. For example, many aspects of this mishap can be traced back to the initial aim of reducing operating costs and disruption to aircraft scheduling. This created a condition in which designers developed fault containment areas or modules that enabled operators to defer maintenance until the number of faulty Fault Containment Units exceeded specified tolerances.

The left-hand chain of events captures elements of the ECF diagram shown in Figure 1; including the initial failure of accelerometer number 5 in 2001 and the subsequent failure of number 6 in 2005 that triggered the mishap. As can be seen, however, Figure 3 significantly extends the analysis in the previous diagram. For example, it refers to the Secondary Attitude Air Data Reference Unit (SAARU). This extends the concepts of redundancy and of defence in depth by providing an alternate source of attitude, heading and air data to the ADIRU. A comparison was made between the output of the ADIRU and the SAARU during the mishap and this helped to mitigate the impact of the incorrect values from the ADIRU. This illustrates an important point in this paper – the aim is not to undermine the use of fault tolerance and redundancy but instead to demonstrate the particular dangers of software masking component failures both to operational crews and maintenance teams. In this case, it can be argued that the redundant SAARU provided sufficient control for the pilot to avert more serious consequences from the ADIRU faults.

The right side of Figure 3 looks more closely at maintenance issues in the case study incident. The initial failure of accelerometer number 5 in 2001 triggered a maintenance message on the on-board maintenance computer; this was known as an ADIRU MM 34-20010 event. Such messages could be read by maintenance teams using a ground-based terminal but were not directly visible to the crew. Some ADIRU events can, however, be displayed in-flight on the Engine Indication and Crew Alerting System (EICAS). If such an in-flight warning occurs, then the ADIRU must be replaced with a serviceable unit within three days. As can be seen in Figure 3, the crew did not receive such a warning following the 2001 accelerometer failure and so the ADIRU was not replaced. However, the ECF diagram also denotes that different operators implemented different practices and risk mitigation strategies following such MM events. The aircraft manufacturer noted that: “the ADIRU can be dispatched with MM 34-20010 present until such time that the operator deems it prudent to remove the ADIRU to avoid a schedule interruption due to occurrence of the ADIRU Status message. The decision to remove the ADIRU based on the presence of MM 34-20010 only is made by the operators on an economic basis, not a safety basis” [1, p.8].

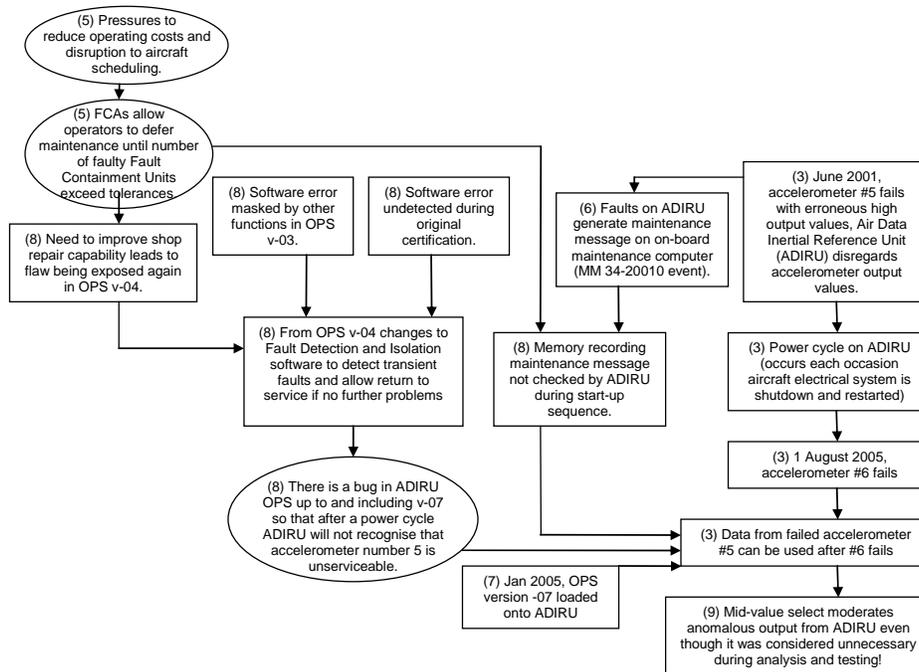
Figure 4: Software Propagates Failure and Mitigates Adverse Effects

Figure 4 focuses on the software issues that contributed to the in-flight mishap. As before, many of the particular events can be traced back to pressures to reduce operating costs and avoid disruption to aircraft scheduling. This created the Fault

Containment Area architecture that enabled maintenance to be deferred. It also led to software requirements for the ADIRU so that the system would check the status of critical components but allow the unit to continue operation if minimum criteria for the availability of FCAs were met. The implementation of this software requirement was flawed in early versions of the OPS –

software. However, up to version v-03 this problem was mitigated by additional checks in other areas of the application. A renewed requirement to improve shop repair capability led to the flaw being exposed again in OPS v-04. The OPS software up to and including v-07, therefore, contained a bug such that after a power cycle the ADIRU would not recognise that accelerometer number 5 was unserviceable.

Figure 4 also denotes how a maintenance message was generated following the 2001 fault on accelerometer number 5. However, the fault status was not checked by the ADIRU following a power up for the reasons presented previously. This

combination of events led to use of data from the failed accelerometer when a further fault was detected in 2005 with accelerometer number 6. Again, however, this incident reveals how the ‘defence in depth’ techniques of modern avionics helped to mitigate the potential consequences of this bug. The ADIRU software had been designed to pass on mid-range values if components provided data that varied between two implausible extremes. It is important to stress that designers may underestimate the value of the defences they create. The bottom event in Figure 4 records that this additional safety feature was considered to be superfluous during testing and analysis of the ADIRU.

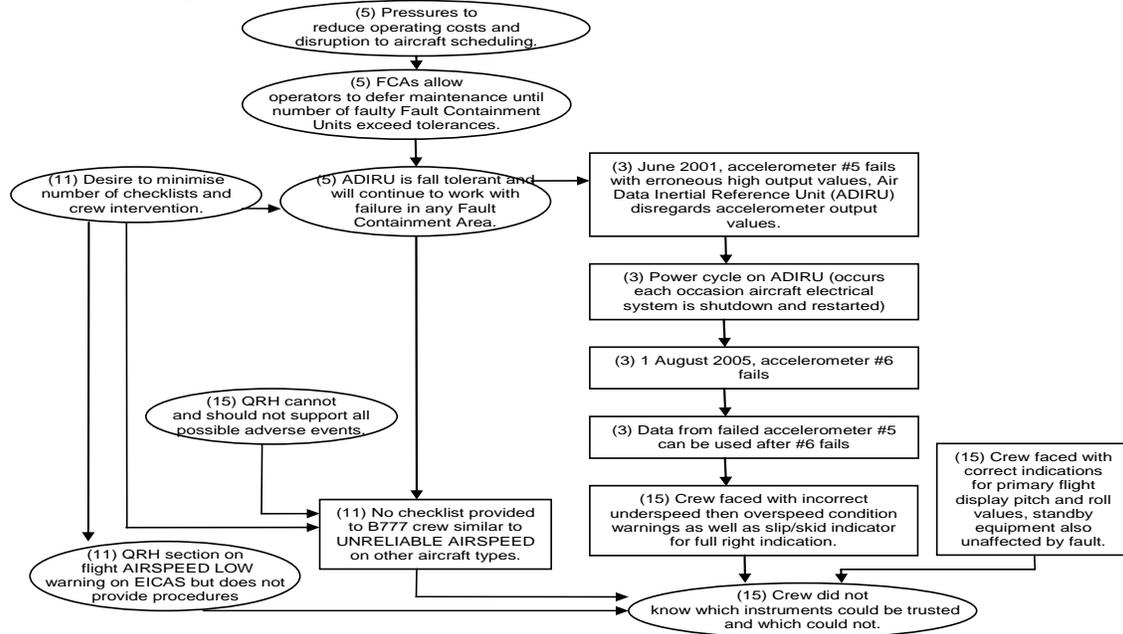
Figure 5: Fault-Masking Undermines Crew Interaction

Figure 5 illustrates how the impact of software bugs propagates beyond the embedded systems of modern avionics to affect crew interaction. The ECF diagram illustrates how the silent masking of redundant failures undermined the ability of human operators to diagnose and respond to the problems that confronted them. Page 15 of the ATSB report describes how the crew was faced with incorrect underspeed warnings, followed by overspeed warnings, as well as a full right slip/skid indication following the failure of accelerometer number 6. At the same time, correct indications were presented for the pitch and roll values on the primary flight display. Standby equipment was also unaffected by the fault. The crew were, therefore, unsure which of the instruments to trust. Their uncertainty was exacerbated by design decisions that stemmed from the underlying philosophy of masking redundant failures during continued operations, mentioned in previous sections. Figure 5 records that previous aircraft types had provided checklists for UNRELIABLE AIRSPEED in the crews’ Quick Reference Handbooks (QRH). However, the redundancy implemented by the B777 software systems implied that the crew should never be faced with such an indication. The system was designed to ensure that unreliable input from key components should automatically

trigger a transition to redundant systems without any intervention from the crew. It was reasonable, therefore, to argue that this section should be dropped from the QRH. Crews often complain when documentation is unnecessarily verbose or difficult to navigate. It was possible for multiple failures to trigger a NAV AIR DATA SYS message on the EICAS. The QRH then referred the crew to an unreliable airspeed table. However, this particular warning was not triggered during the case study incident. The key point here is that the problems facing the crew were exacerbated by the decision to mask information that designers did not consider would be needed by the crew. However, the circumstances of this mishap reiterate the importance of providing some degree of visibility to the crew when it is difficult or impossible to guarantee the resilience of fault tolerant systems [6].

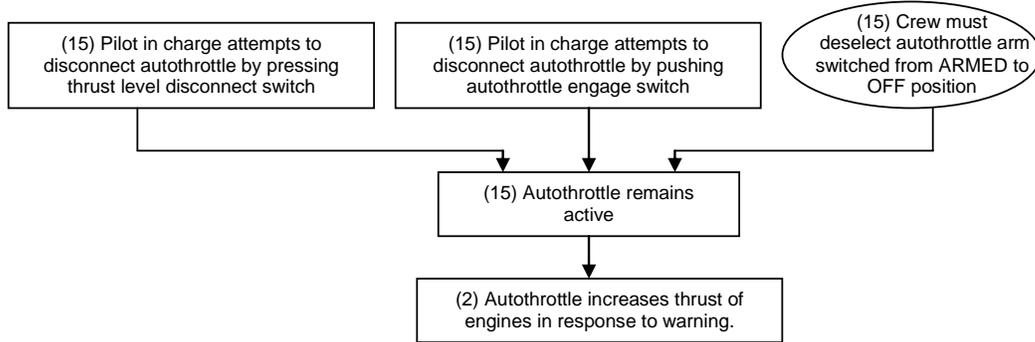
Figure 6: Auto Throttle Uncertainty Further Undermines Situation Awareness

Figure 6 continues the analysis of crew interaction in the aftermath of the 2005 auto throttle failure. As mentioned, the pilot was faced with a situation that designers had not considered to be possible. The auto throttle system remained active and the underspeed/overspeed warnings suggested that the malfunction may have been related to these functions. In consequence, the pilot attempted to disconnect the autothrottle by pressing the thrust lever disconnect switch and pushing the autothrottle

engage switch to toggle it off. However, these attempts were ineffective because the crew failed to switch the autothrottle arm switch from ARMED to OFF. In consequence, the autothrottle continued to increase thrust in response to the low-speed data that was erroneously being supplied from the ADIRU and the fault accelerometer. The interaction difficulties faced by the aircrew when attempting to disarm the autothrottle are typical of the ways in which the stress imposed on a human operator by an initial failure can trigger further mistakes. These errors serve to

compound the problems created by an initial mishap. Figure 6 illustrates how the crew now not only had to understand the reasons for the erroneous and inconsistent readings from their instrumentation, they now had to find an explanation for their failure to disarm the auto throttle. Without additional support from documentation, such as the QRH, it can be difficult for any crew to avoid a gradual loss of situational awareness through apparent interactions between such compound failures.

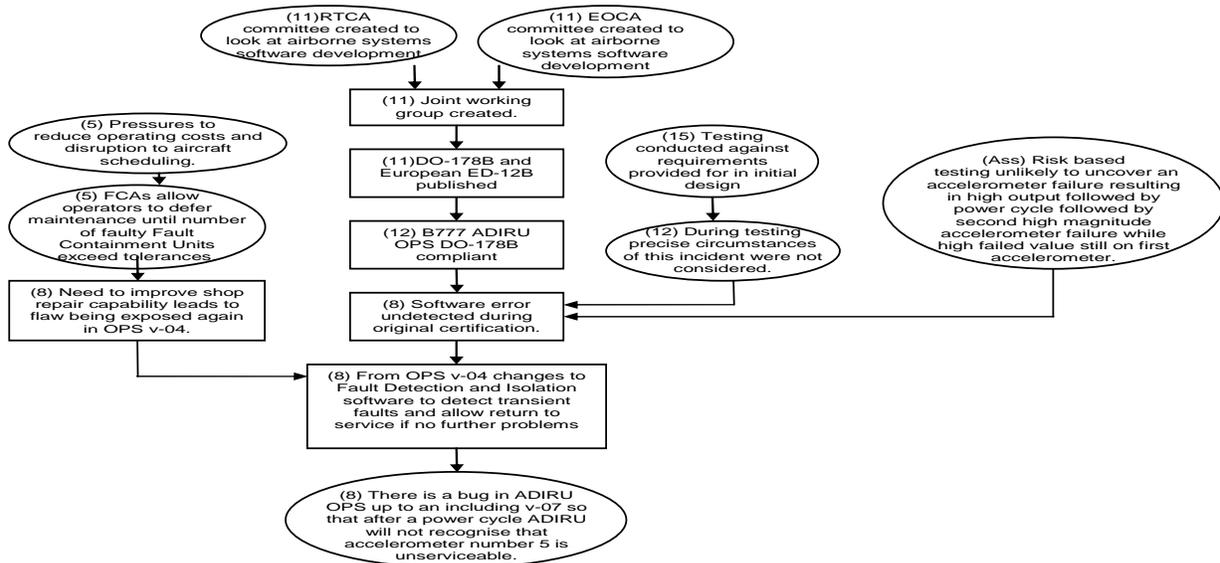
Figure 7: Process-Based Certification and the Selection of Test Cases

Figure 7 illustrates some of the certification-related issues that were raised by the case study incident. It notes that DO-178B [7] and the European ED-12B equivalent were derived from joint working groups within the RTCA and the predecessor of the European Organisation for Civil Aviation Equipment. It also shows that the ADIRU OPS software was DO-178B compliant. Even so, testing failed to consider the precise circumstances of the failure that was revealed in this incident. The diagram also records an assumption that risk-based testing was unlikely to uncover an accelerometer failure resulting in high output, followed by power cycle, followed by a second high magnitude

accelerometer failure while the high failed value was still on first accelerometer. Although the consequences of such a scenario were potentially severe, such a contingency might arguably have been considered too unlikely to be considered in detail during system testing. It is, however, difficult for the ATSB and other investigatory organisations to confirm such analyses without access to detailed design process information that is likely to be commercially sensitive.

This incident reiterates the importance of considering the impact of multiple component faults in the requirements that are used to guide the development of fault tolerant software, especially where fault-masking techniques shield operational personnel

This incident illustrates the strengths and the weaknesses of current certification standards for commercial systems containing aviation software. The ADIRU software had been tested and developed to the standard required at the time of certification. DO-178B, in common with most recent software standards across the safety-critical industries, focuses on development processes rather than the certification of particular lines of code. In particular, it contains requirements to ensure the testing of delivered code against the original safety requirements identified for that software. The level of testing is partly determined by the risks that are to be mitigated by the functionality of the code. However, the ADIRU testing “was limited to the original specification and requirements of the component” [1, p. 16]. These did not consider the particular scenario that arose during the incident. This has important implications for process based standards such as DO-178B. In previous generations of product based specifications, the failure of a particular system was symptomatic of potential flaws in that particular component. However, in process based certification the failure of a system implies that there may be wider flaws in the systems developed under that process. It is for this reason that the manufacturer responded to the incident not simply by correcting for the particular combination of accelerometer failures that characterized this mishap, but by also reviewing the handling of a wide range of potential multiple hardware failures.
