Final Report:
Review of the BFU Überlingen Accident Report

(Version 1: 17/12/2004)

Contract C/1.369/HQ/SS/04

Technical Report A: Incorporating Deliverables 1 and 2

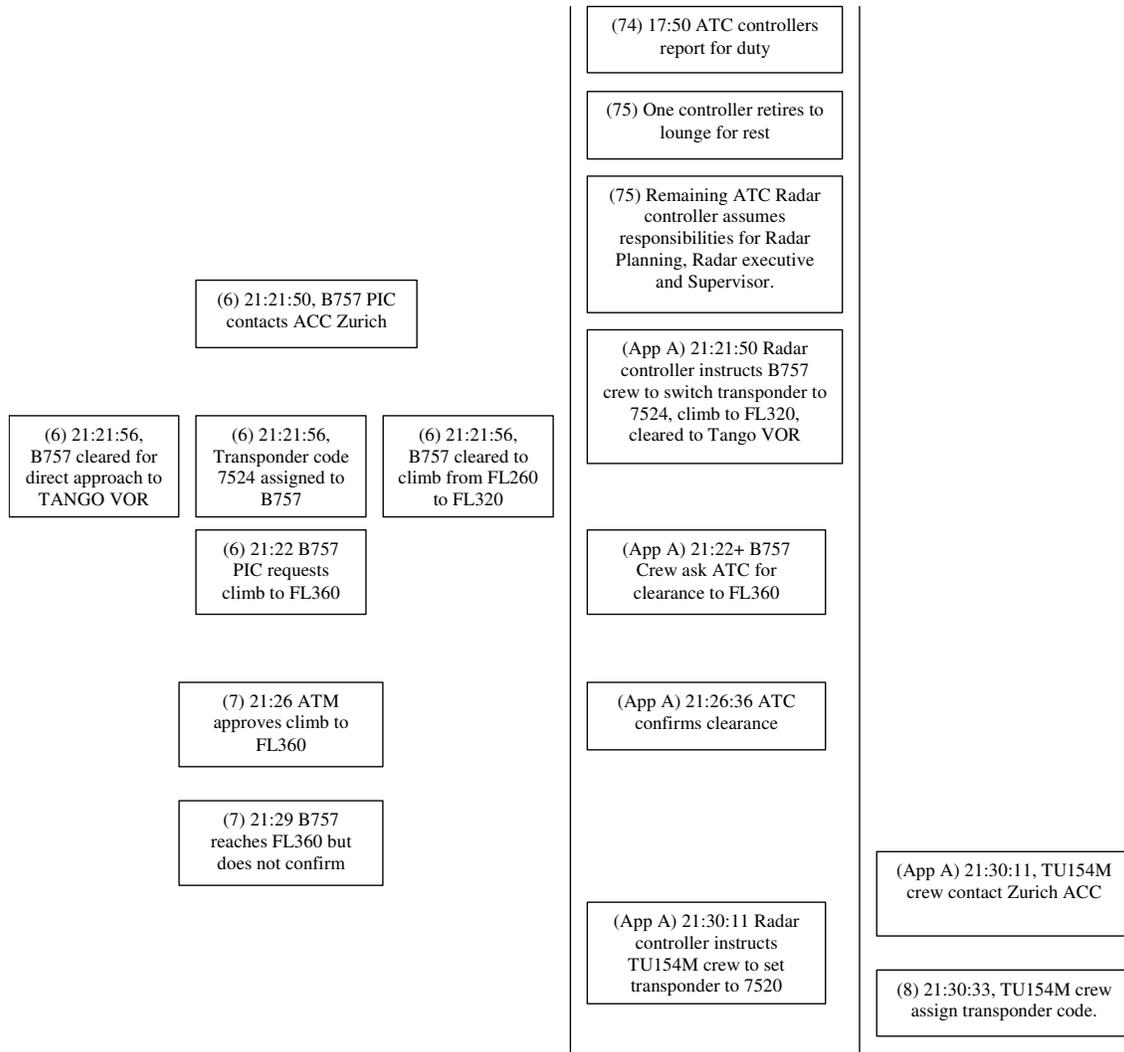
Figure 1: Except from the Revised Timeline of Events

In Figure 1, events are denoted by each rectangle. Time flows from the top to the bottom of the diagram. The left column is used to group events that relate to the B757. The middle column shows events associated with the Air Traffic Managers. The right column denotes events associated with the crew of the TU154M. The figures in brackets refer to pages in the BFU report that provide evidence for these events. For instance, “(8) 21:30:33 TU154M crew assigns transponder code” denotes that the BFU discusses the assignment of the transponder on page 8. A reference to “(App A)” relates to Appendix A of the BFU report.

Figure 1 illustrates some of the limitations of using timelines. For instance, this diagram denotes the B757 Pilot in Charge’s request to climb to FL360. There is nothing here to indicate the implications or consequences of this request. The TU154M was already at FL360 and approaching the Zurich ACC centre. Nor does the timeline illustrate the factors that might have persuaded the controller to grant the request. As we shall see, paper based flight strips were used to replace some aspects of the SYCO flight plan processing system that was being upgraded and these paper strips did not show any potential conflict in the flight plans. The key point is that these timelines provide an entry point for any analysis and must be supplemented by additional techniques if they are to yield more detailed insights, for example about the partially supported recommendations that were identified in previous sections.

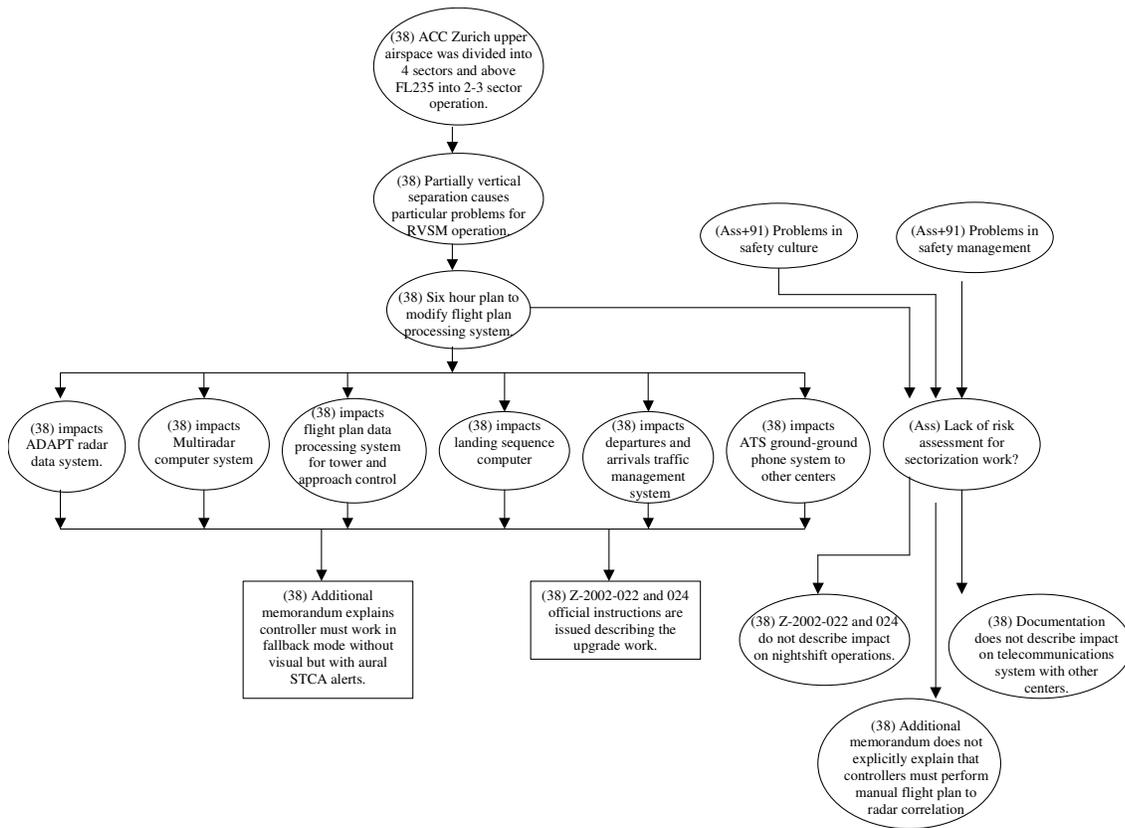
Figure 2: Contextual Factors Influencing the Technical Systems Environment in the Zurich ACC

Figure 2 presents the next stage in our analysis. It represents a simplified form of Events and Causal Factors analysis, initially pioneered by the US Department of Energy. Previous EUROCONTROL projects have used similar diagrams to model human error and systems failure in ATM incidents, for example in HUM.ET1.ST13.3000-REP-02 Human Factors in the Investigation of Accidents and Incidents. Ellipses are used to denote contributory factors that combine to make events more likely. Events, as before, are denoted by rectangles. The figures in parentheses refer to the page numbers in the BFU report that contain information about these contributory factors. This diagram sets the background for the more detailed causal modeling of the accident. As can be seen, Figure 1 starts with the observation that ACC Zurich upper airspace was divided both vertically and horizontally. The particular vertical division about FL235 into 2 or 3 sector operation created particular problems for the operation of RVSM and so page 38 of the BFU report outlines a six hour plan to modify the flight plan processing system to simplify the upper airspace and support the implementation of RVSM. This plan effected a number of different systems: the ADAPT radar data application; the multi-radar computer system; the flight plan data processing system for tower and approach control; the landing sequence computer; the departures and arrivals traffic management system and the ATS ground to ground phone system with neighboring centers. A further

Recommendation 2:

Additional emphasis should be paid to a risk-based approach to the identification and dissemination of information about the impact of necessary upgrades on the ATM infrastructure.

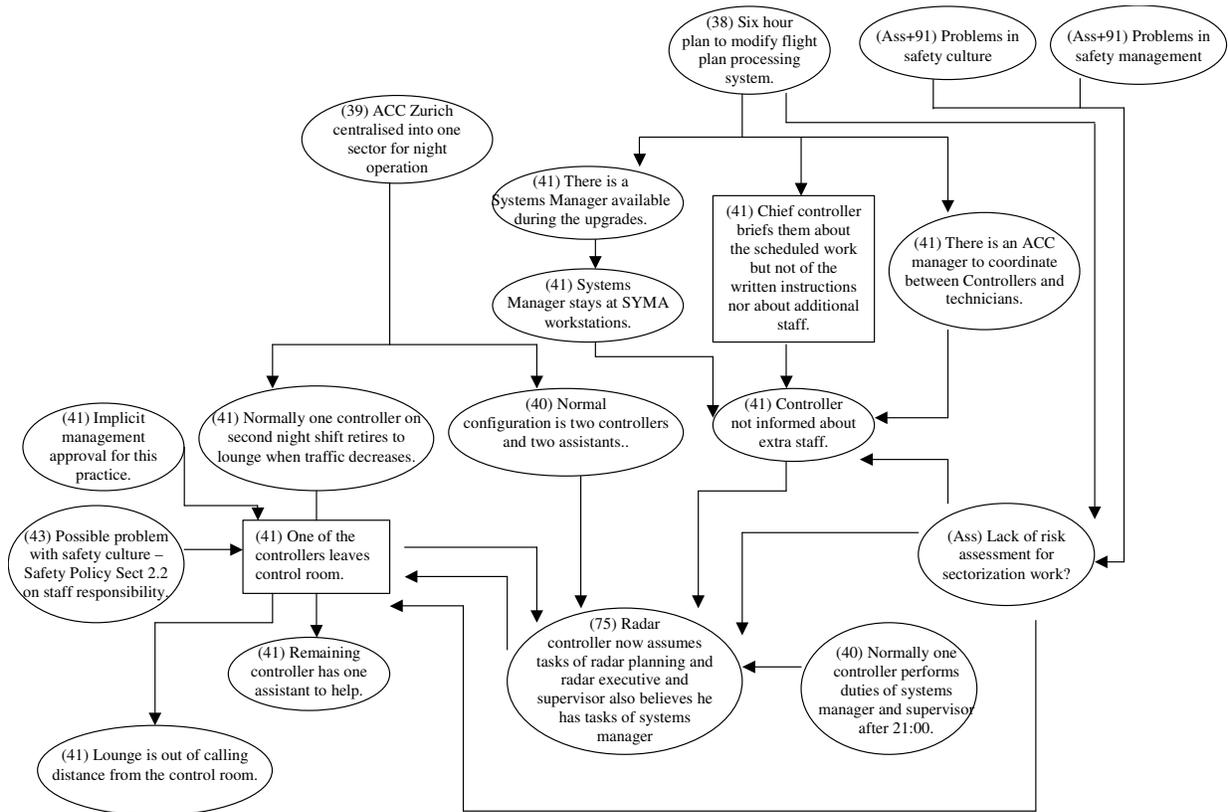
Figure 3: Contextual Factors Influencing the Human Systems Environment in the Zurich ACC

Figure 2 used a simplified ECF diagram to analyse the technical background to the Überlingen accident. In contrast, Figure 3 focuses more on personnel and staffing issues. As can be seen, ACC Zurich used a form of centralised operation during night operations. The normal configuration was for two controllers to be supported by two assistants. It was also usual for one of the controllers to leave the control room as soon as the traffic died down so that he or she could rest in the lounge. During the accident, one of the controllers left the control room. This practice was known to management and there was no apparent

Recommendation 3:

Additional emphasis should be paid not simply to minimum staffing levels as recommended in the BFU report but also to a risk-based approach to the identification of situations that require additional staffing and to the need to inform staff when those additional resources are available.

Recommendation 4:

Additional emphasis should be placed not simply on minimum staffing levels (Recommendation 18/2004) but to *appropriate* staffing levels that match the maximum plausible task loading on controllers that might be anticipated from their operational and technical environment, considering the dangers of complacency and fatigue from idle operators during quiescence.

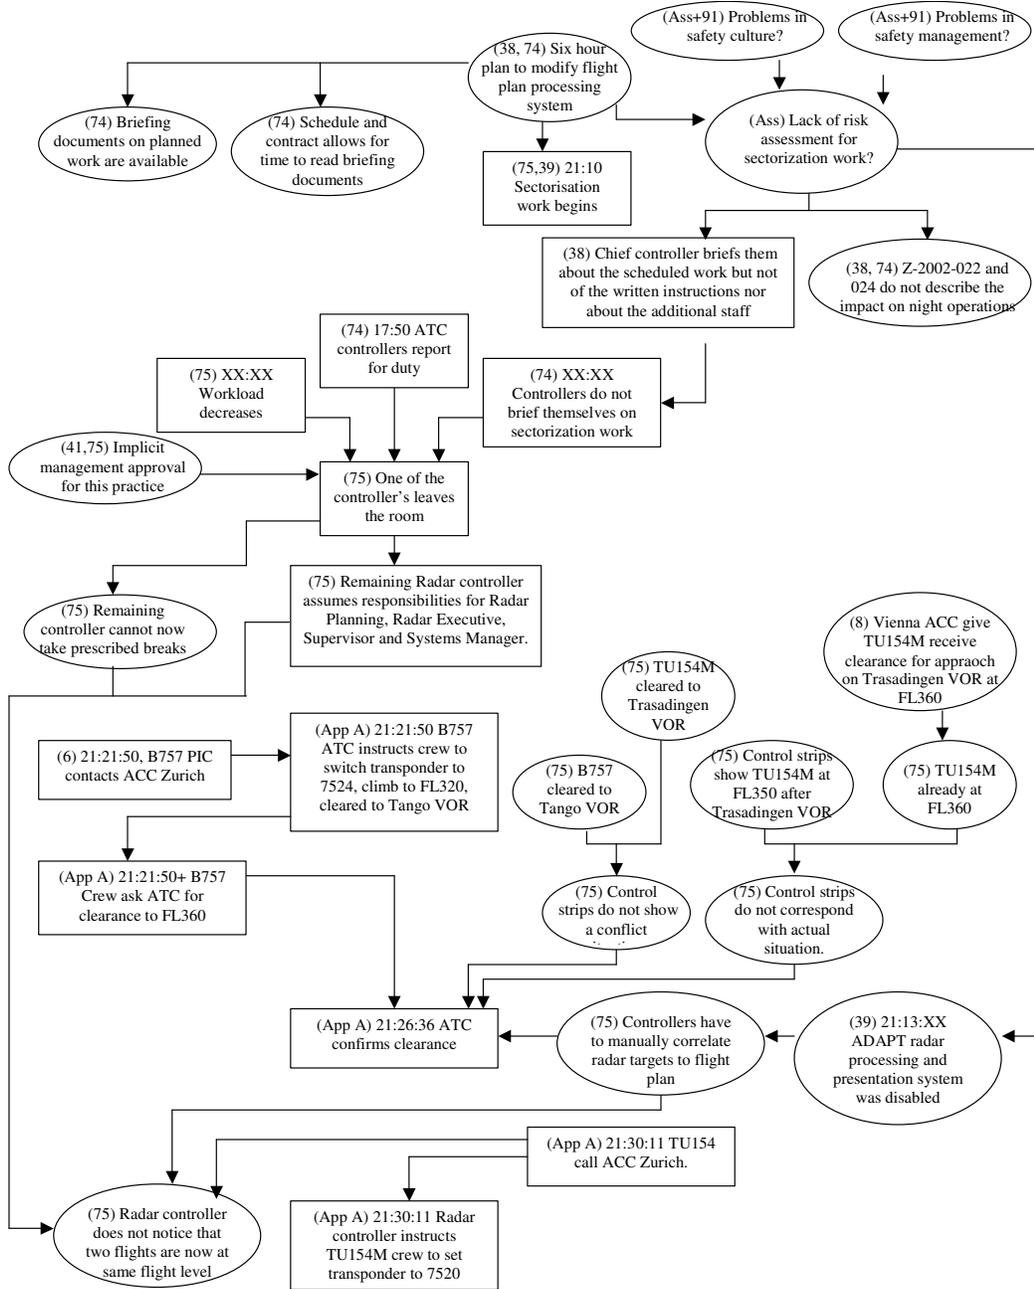
Figure 4: ECF Analysis of the Überlingen Accident - Clearance for B757 to Join TU154M at FL360

As can be seen, Figure 4 takes the analysis from the time at which the controllers report for duty (17:50). However, it also carries forward elements of the earlier analysis of the technical and personnel infrastructure. For instance, it refers to the lack of documentation on the impact of the upgrades. It also links back to the lack of any adequate risk assessment and the impact that this may have had on, for instance, the Chief Controller's briefing about the upgrade work. Similarly, this diagram includes elements of Figure 3 that refer to the remaining controller assuming a considerable number of additional responsibilities at a time when they were left exposed by a lack of systems support. Figure 4 goes well

beyond the previous ECF diagrams because it begins to map out the more immediate chain of events that led to the accident. As can be seen, the B757 contacts Zurich ACC at 21:21:50. The request is made for clearance to FL360 immediately after the initial contact and this is granted at 21:26:36. The conditions that make this event more likely include the fact that the paper control strips for the B757 and TU154M do not show any apparent conflict. They are cleared to different waypoints. The controller's difficulty in anticipating the potential conflict is compounded by the observation on page 75 of the BFU report that the strips no longer began to reflect the true situation as the TU154M was shown at FL350 after Trasadingen VOR. However, the controller would have had to detect this inconsistency manually given that the automatic flight plan and radar correlation (ADAPT) support had been disabled as part of the SYCO flight plan processing system upgrade. The ECF diagram ends with the call from the TU154M to Zurich ACC as it approaches their airspace.

The key insight from Figure 4 is the role that inadequate risk assessment may have played in exposing the Controller to an error inducing context. This builds on the previous contextual analysis that has already made a similar point because it shows the more detailed causal mechanisms that lead from managerial and cultural problems to specific events in the accident itself. In this case, the lack of risk assessment led to the controllers being poorly informed about the sectorisation work. It is possible to conjecture that if additional information had been available, for instance about the interruption to the SWI-02 communications system with neighbouring centres then the second controller might not have departed for the lounge. Similarly, if an adequate risk assessment had been conducted then additional consideration might have been paid to the possible consequences of disabling the ADAPT radar system.

Recommendation 5:

Additional emphasis should be placed on the concrete safety management techniques that might have identified the specific hazards in this accident well before the incident took place. These techniques include maintenance risk assessment according to the principles laid down in the ESSAR publications.

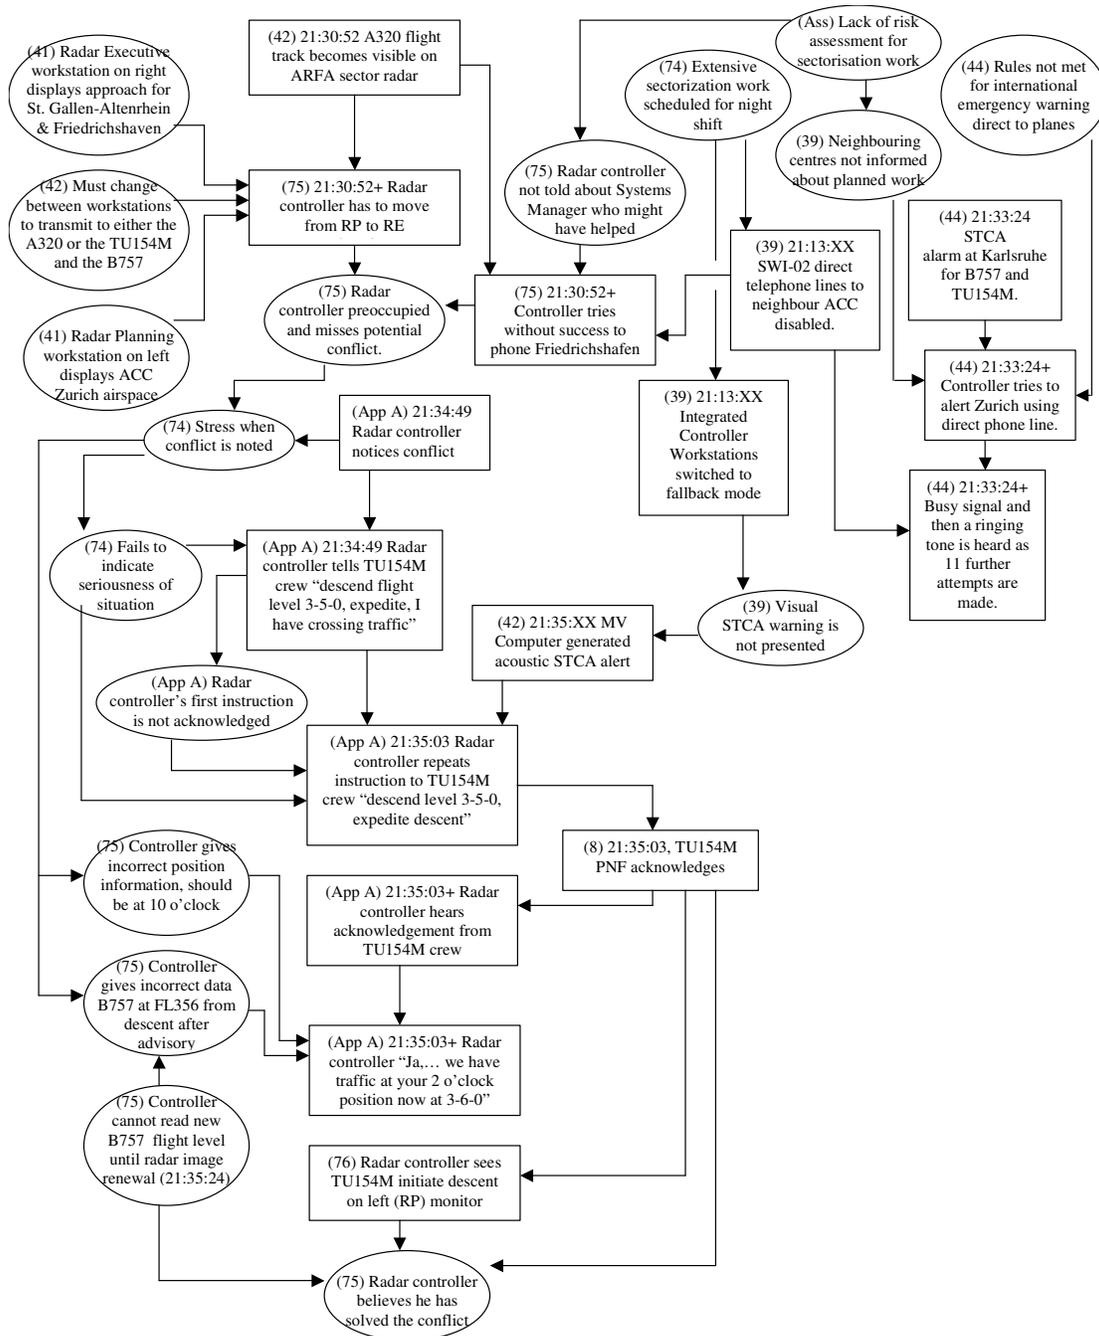
Figure 5: ECF Analysis of the Überlingen Accident – Radar Controller Notices and Attempts to Resolve Conflict

Figure 5 continues the ECF analysis of the BFU report from the moment when the TU154M approaches ACC Zurich to the point at which the BFU argue the Controller believed he had resolved the conflict. Key observations in this stage of the analysis are that at 21:33:24 there is an STCA alarm at Karlsruhe. This is one minute and eighteen seconds before the TCAS warning on the aircraft and approximately two minutes between the missed audible STCA warning at ACC Zurich. During these intervals it might have been possible for the Karlsruhe staff to alert the controller to the potential problem, however the SWI-02 direct communications facility had been interrupted as part of the upgrade work. Similarly, the visual STCA warning at ACC Zurich was also disabled and this might have bought an additional two minutes warning compared to the time at which the controller began responding to the conflict. Figure 5 also illustrates another possible reason for the controller's failure to detect the potential conflict. An A320 flight enters the controllers area and he attempts to coordinate with Friedrichshafen. As we have seen, however, neither the controller nor the neighbouring areas were informed of the potential interruption to

Figure 5 also shows that the controller notices the conflict between the B757 and TU154M at 21:34:49. As mentioned previously, it is difficult to determine the precise cognitive and perceptual factors that prompted his subsequent intervention. The diagram does, however, introduce an assumption that the stress of detecting a potential conflict under such adverse working conditions may explain his apparent failure to inform the aircrews of the seriousness of the incident, noted on page 74 of the BFU report. The ECF diagram denotes that the initial descend command was not explicitly acknowledged by the TU154M crew and so the instruction is reiterated. The Pilot-Non-Flying acknowledges the second request and the controller responds by, arguably, explaining the request; 'Ja,... we have traffic at your 2 o'clock position now at 3-6-0'. Again the stress of the situation may explain the apparent anomaly in this comment when the B757 should have been in the 10 o'clock position relative to the TU154M. At this point the controller observes the descent of the TU154M as requested but cannot observe the descent of the B757 in response to their TCAS advisory because the controller's radar image is not renewed until 21:35:24. Hence, the BFU argue that he believed he had resolved the conflict.

Recommendation 6:

Any risk based assessment of the impact of large scale maintenance and upgrade activities should consider a range of plausible worst case scenarios especially where there may be common causes of 'failure'. In this case it was important to consider the combined effects of the loss of telecommunications as well as radar and flight plan correlation facilities rather than considering the consequences of each system loss in isolation.

Recommendation 7:

A subsequent analysis of the accident should be conducted to identify the cognitive and perceptual cues that helped the controller to identify the potential conflict. It may have been through the Controller's direct observations of their radar displays, alternatively they may have been alerted to the conflict by indirect observations of the TCAS advisories that were issued in both cockpits at almost the same time the controller began to issue the initial descent instructions to the TU154M. Similarly, further attention to be paid to the protocols and procedures governing the transmission of location information such as the '2 o'clock' warning at 21:35:03. The BFU claim that this may have seriously disoriented the crew of the TU154M as they sought to resolve the TCAS alarm and yet nothing is stated about this in the existing recommendations.

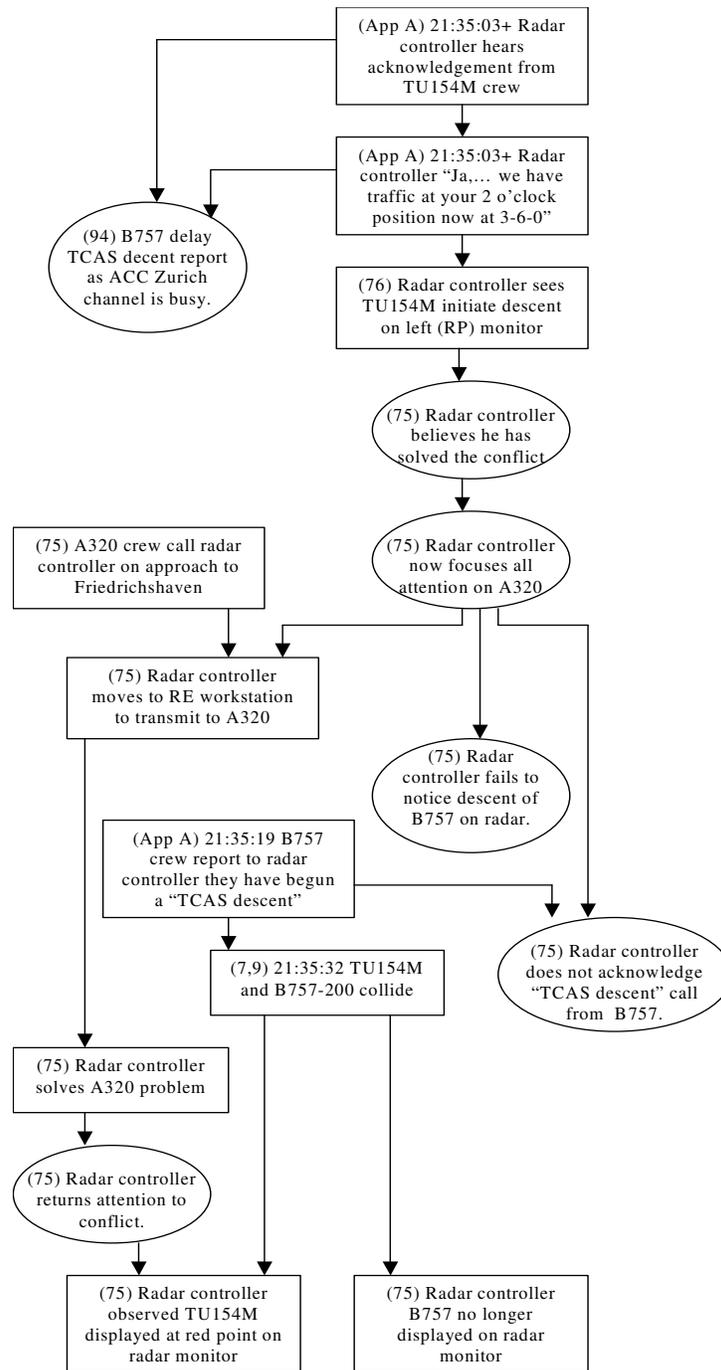
Figure 6: ECF Analysis of the Überlingen Accident – B757 Report TCAS Descent

Figure 6 illustrates the immediate events before the collision. Again, the controller begins to focus his attention on the A320 on its delayed approach to Friedrichshafen. This allocation of attention is explained in the BFU report by the observation that the Controller now believed they had resolved the conflict once the crew of the TU154M had expedited their descent to FL350. The decision to focus on the A320 had important consequences as the controller again had to move to the Radar Executive workstation to transmit to this aircraft. Any subsequent transmissions to the B757 or the TU154M would then involve a further move back to the Radar Planning workstation, although all flights were visible on both displays. The outcome of this 'distraction' or division of attention was that the controller failed to observe the radar trace of the B757's descent in response to the previous TCAS advisory.

The controller's preoccupation with the A320 and the split working positions can also be argued to explain his failure to notice the B757 crews' radio signal that they had begun a 'TCAS descent'. The BFU report suggests that the timing of this call was particularly unfortunate. The crew of the B757 had been trained to alert ATC as soon as possible after a TCAS advisory. Both the Pilot Flying and the Pilot Not Flying initially tried to contact ACC Zurich:

Recommendation 8:

Further thought should be given to the verbal protocols governing the exchange of information between controllers and the crews of all aircraft involved in a TCAS incident. Whenever possible channels of communication should be kept clear until all the parties involved have confirmed their immediate response to the warnings. The BFU recommendation 08/2004 that RA's be downlinked to ATC does not remove the need for such a verbal protocol given that even the revised ICAO guidelines offer crews discretion in the response to an advisory if they feel that to follow the TCAS alert would endanger safety.
