Modeling the Linate Runway Incursion: Questioning Managerial and Operator Tolerance for Degraded Technical Infrastructures

Chris W. Johnson,
Department of Computing Science,
University of Glasgow,
Glasgow, G12 8RZ, Scotland.
+44 141 330 6053
johnson@dcs.gla.ac.uk
<http://www.dcs.gla.ac.uk/~johnson>

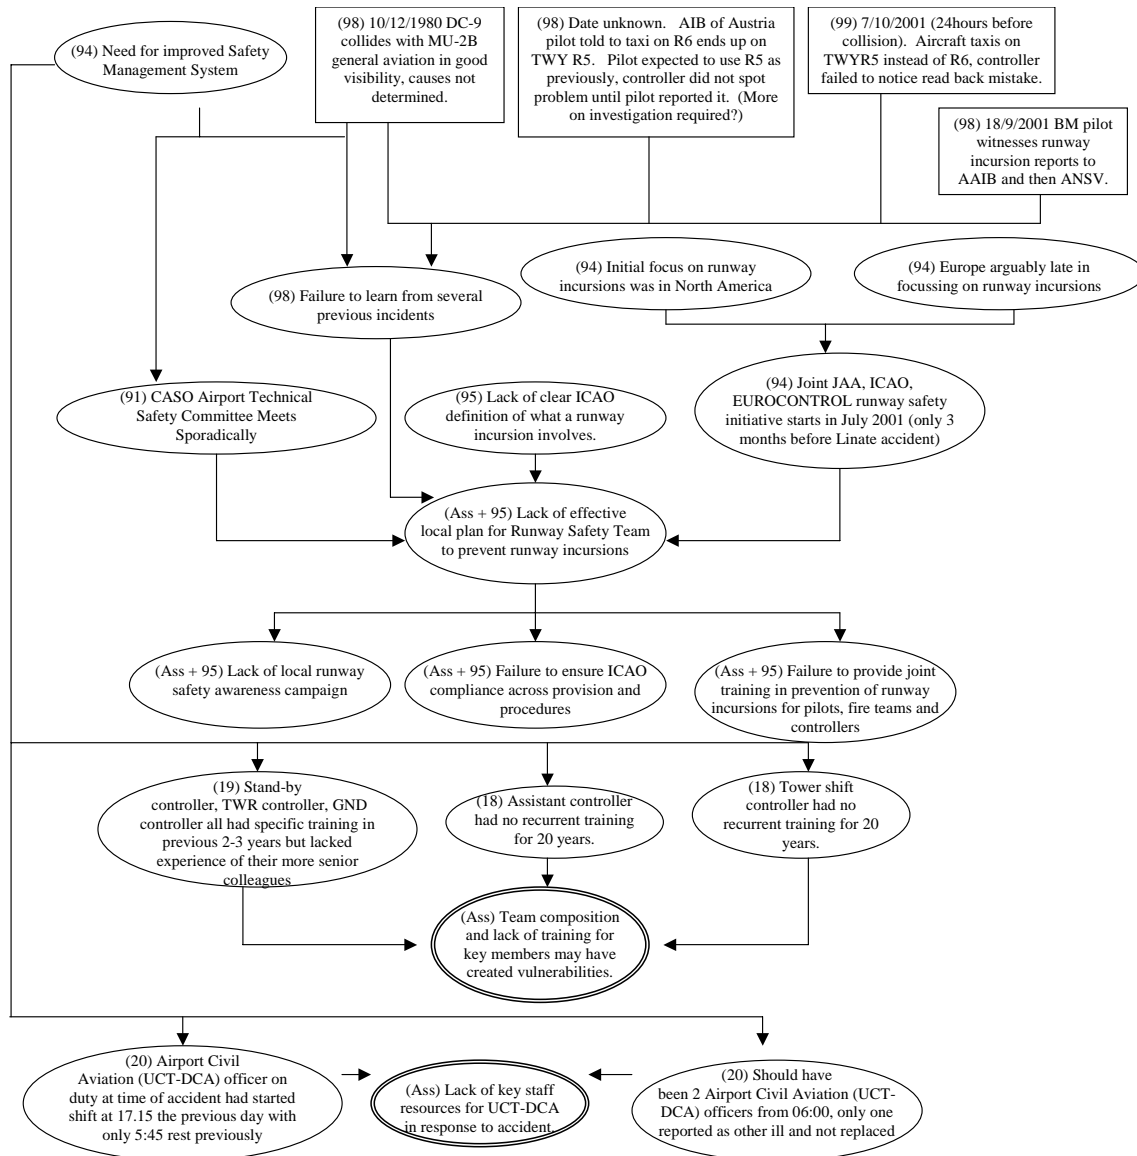
Figure 1: Contextual Factors Stemming from Organizational Issues Prior to the Linate Accident

Figure 1 also records the ANSV's observation that most of the early concern about runway incursions came from North America rather than Europe. This may partly explain why transatlantic initiatives to address the problem began to make significant progress some three months before the collision leaving insufficient opportunity for many of the subsequent recommendations to be adopted at Linate. These factors combined with the issues that stemmed from the lack of effective Safety Management. Together they contributed to a situation in which there was no effective runway safety plan. The lack of a fully developed runway safety team may also help to explain the absence of runway safety awareness campaigns, of a failure to ensure compliance with ICAO runway requirements and for well integrated plans to deal with runway emergencies.

Figure 1 also includes a link between the need to improve Safety Management Systems and the lack of staff in the DCA (Airdrome Judicial Authority) and the UCT (Traffic documentation section). There would usually have been two UCT officers on duty but only one had turned up for duty. Fortunately, their colleague on the previous shift was still

present even though they had worked a continuous total of 13 hours on duty. Such “failures to adhere to prescribed obligations” provide specific examples of the ways in which problems in safety management create the vulnerabilities that were exposed during the accident.

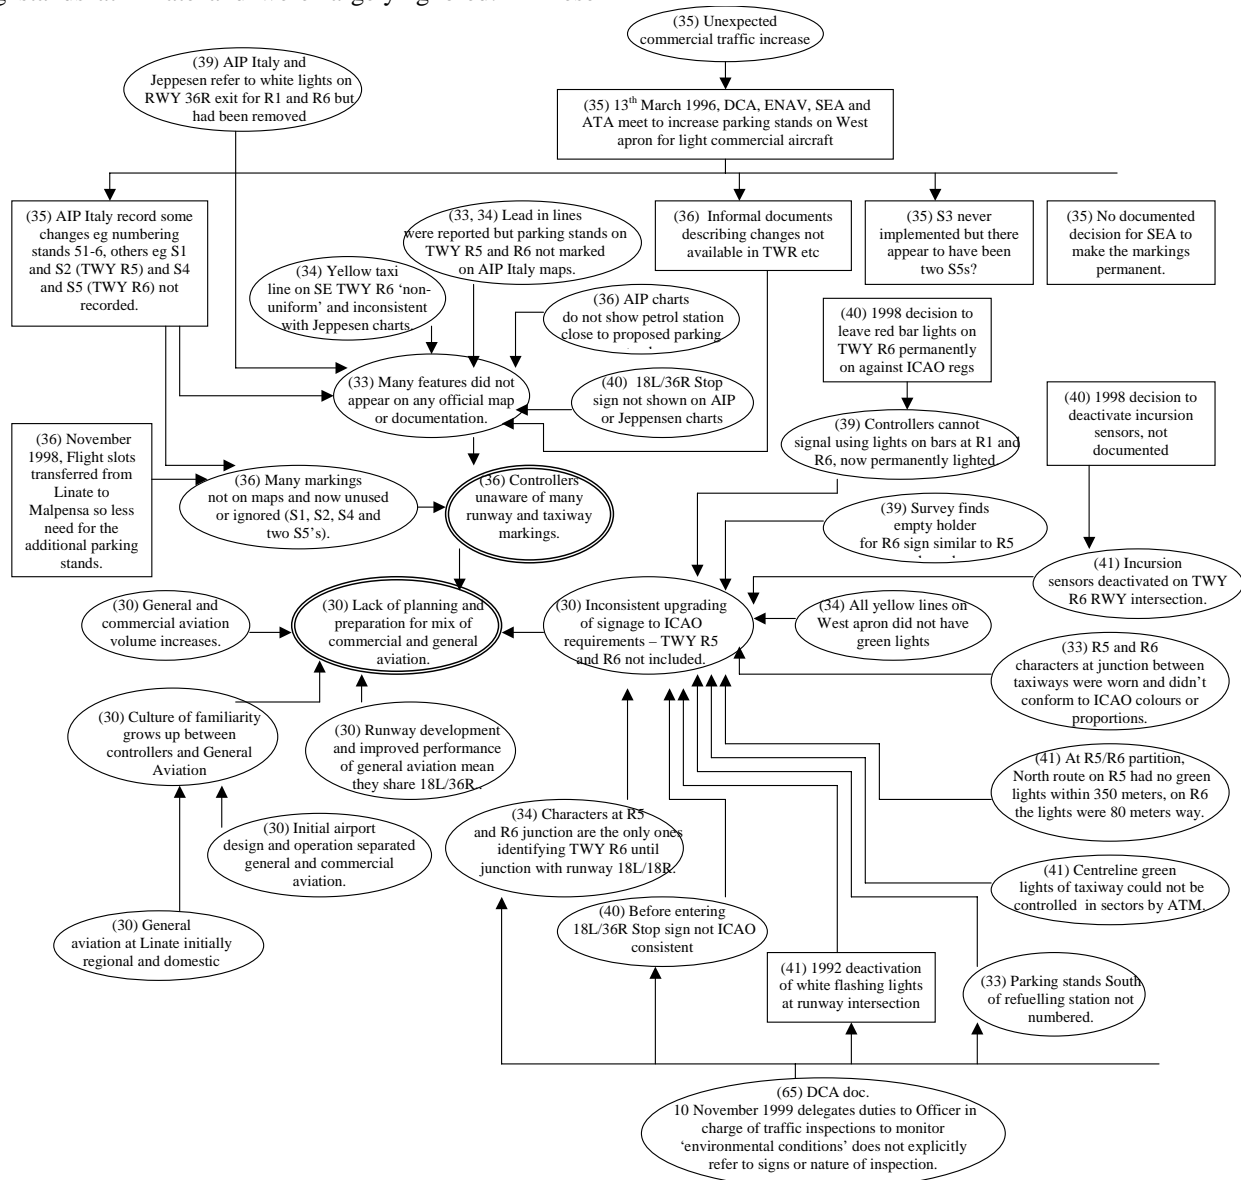
Figure 2: ECF Analysis of the Runway Infrastructure at the Linate Accident

Figure 2 traces the ways in which the organizational issues in Figure 1 were influenced by and influenced the operating conditions at Linate. For example, the following ECF diagram shows that there was an unexpected increase in commercial traffic at the airport. One consequence of this was that many of the operational groups, identified in Figure 1, met to consider increasing the parking stands on the West Apron to accommodate the increase. The ANSV report criticised the lack of aviation (documentation) to support the changes

that were proposed by this meeting. There were also inconsistencies in the parking stands that were finally developed. For example, the stand S3 never seems to have been implemented and yet there were two S5s. This created the potential for confusion when crews reported their positions to controllers using these markings. These omissions were symptomatic of wider problems in the aerodrome documentation available to aircrews and controllers. For example, the Jeppesen charts did not reflect the yellow taxi lines on TWY R6. The right hand side of Figure 2 also illustrates the consequences of a further change in the

operating environment facing ATM personnel before the accident. As can be seen, many of the flight slots at Linate were transferred to Malpensa in November 1998. This transfer meant that there was less need for the additional parking stands at Linate and were largely ignored. These

changes combined with the lack of accurate and authoritative documentation left ATM personnel unaware of many of the markings that aircrew could see as they moved along the taxiways and onto the runways.

Figure 2 also identifies inadequate planning for the mix of commercial and general aviation at Linate. Initially, the design and operation of the airport had separated these different forms of traffic. The general aviation had been largely domestic or regional and the ANSV refer to a 'culture of familiarity' between ATM personnel and the aircrews. However, as we have seen, there had been a gradual increase in traffic at Linate. Runway developments and the increasing power of aircraft used by general aviation pilots created a situation in which runway 18L/36R was shared by an increasingly mixed range of traffic. A further consequence of this was that ATM personnel gradually absorbed the additional overheads associated with synchronizing this mixed-use traffic as they moved from the parking areas, to the

The previous ECF diagram also shows how a DCA document delegated responsibility to the officer in charge of traffic inspections to also monitor the 'environmental conditions' associated with the runways and taxiways. However, there is no explicit mention of the signage or of the types of inspections that might be appropriate to meet this objective. Partly in consequence, there was a range of modifications to the runway and taxiway infrastructure at Linate that did not meet ICAO requirements. These included the stop sign before 18L/36R, the 1992 deactivation of white flashing lights at the runway intersection, the 1998 decision to deactivate incursion detectors etc. It should be noted that this last

modification was not properly documented and this reinforced the comments made in additional recommendation 8. The inconsistent signage created problems for the aircrews that had to navigate onto appropriate runways. It may explain the previous runway incursion incidents mentioned in previous paragraphs. Further problems were created by the lack of control over critical sections of runway and taxiway lighting. ATM personnel could no longer alter the configuration of these light sources to provide positional cues to aircrew.

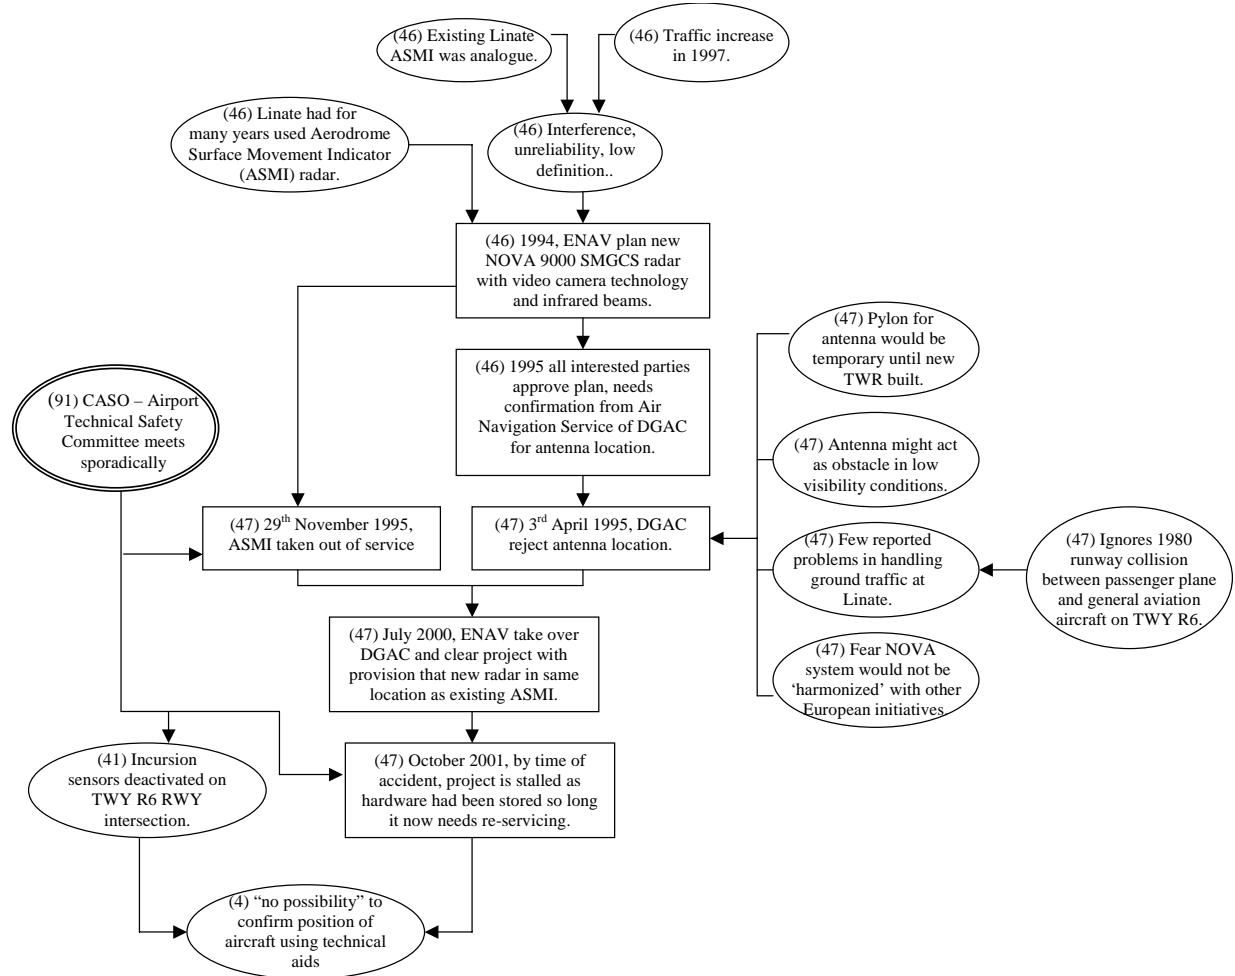
Figure 3: ECF Analysis of Technological Infrastructure at the Linate Accident

Figure 3 examines the technological environment at Linate. As can be seen from events on the right of the extended ECF diagram, some of the decisions involving ground movement radar and incursion detection systems can be partly ascribed to the sporadic role of the airport technical safety committee, as described on page 91 of the ANSV report. As can be seen, the existing Aerodrome Surface Movement Indicator (ASMI) radar at Linate was analogue. The traffic increase mentioned in previous paragraphs exposed the reliability and low definition of this system to a point at which ATM personnel began to look for an alternative. There was a plan to introduce a NOVA 9000 Surface Movement Guidance and Control System (SMGCS) using video camera technology. The old AMSI system was taken out of service some 3 years before the accident. The plans to install the new system were jeopardized when the predecessor of

ENAC objected to the antenna location. They argued that this would involve additional expense by constructing a temporary structure that would then be moved once a new Tower was built. It was also argued that the proposed structure might hinder visibility and that there were few reported problems in handling ground traffic at Linate. The ANSV do not explicitly consider the relevance or strength of this argument given the previous incidents noted in this report. Equally, the DGAC precursor of ENAC might not have been told about such previous incidents and hence would, from their point of view, have been justified in reaching this conclusion. The ECF diagram in Figure 3 notes this possible objection by showing the 1980 collision between a passenger aircraft and a commercial plane as a counter example. The previous diagram also illustrates the DGAC's concern that the new system would not harmonize with other European initiatives. This last point is

particularly interesting as a reason to delay expenditure on a significant component of a ground-based safety net. It seems to be counter-intuitive that ATM personnel would be deprived of an important tool so that the eventual system would be consistent with a European initiative that was intended to harmonize safety provision.

The lower portion of Figure 3 uses the ECF formalism to continue the analysis. In July 2000, ENAV assumed many of the previous responsibilities held by DGAC. One side effect of this hand-over was that approval was finally granted for the development of the new Surface Movement Guidance and Control System. The antenna was to be located in the same position as the previous Aerodrome Surface Movement Indicator (ASMI) radar. The ECF diagram also shows that at the time of the collision this upgrade project was further stalled as mothballed hardware had to be re-serviced before the new system could be delivered. As we have seen from Figure 2, the runway incursion sensors had already been deactivated on TWY R6. In consequence, there was “no possibility” to confirm the positions of the various aircraft on the morning of the collision using technical aids.

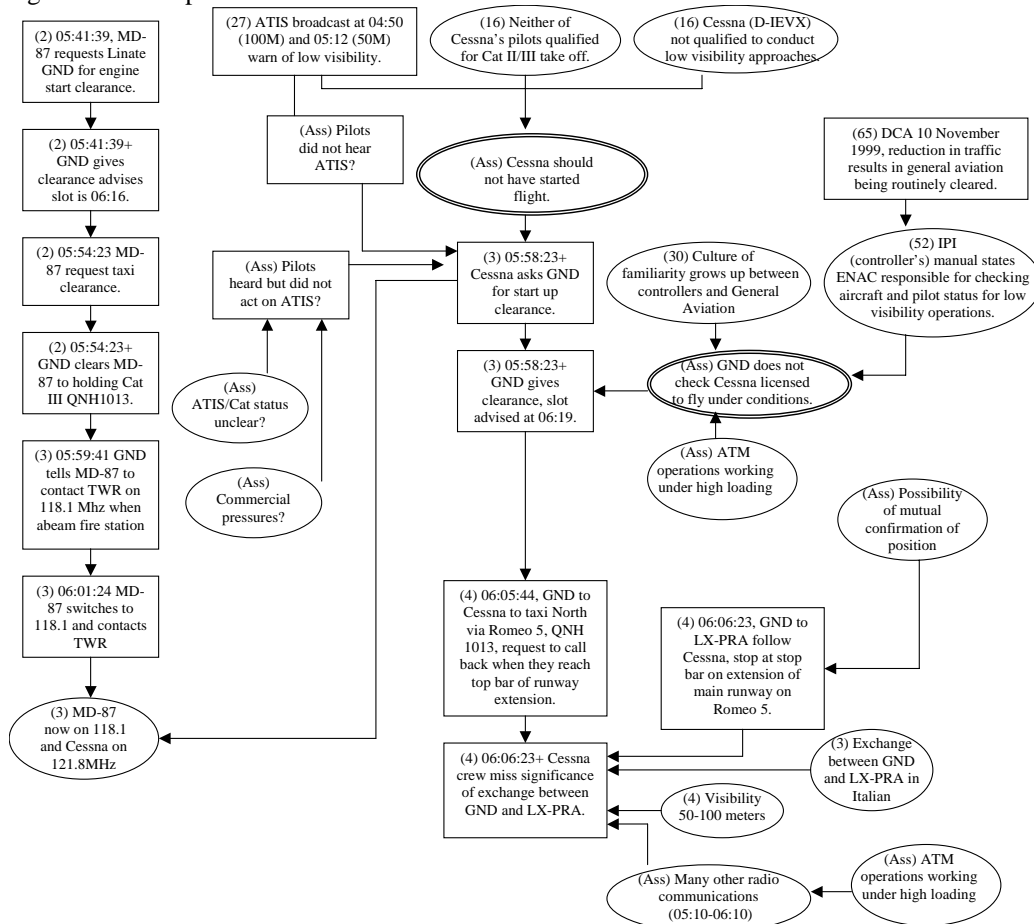
Figure 4: ECF Analysis of the Linate Accident – Initial Events on the Morning of the Accident

Figure 4 illustrates the way in which ECF diagrams form a bridge between organizational, contextual issues and the events that led to the accident. It begins with the observation that there was an Automatic Terminal Information System (ATIS) broadcast at 04:50 advising of low visibility. Figure 4 also captures the observation that

neither the aircraft nor the pilots were qualified to take-off under the Cat II/III conditions that held on the morning of the accident. It follows that the Cessna should not have started the flight. We consider two possible explanations, although there are others. Firstly, the crew may not have checked the ATIS announcements. This is marked as an assumption in the diagram and can only provide a partial explanation. The crews’ own assessment of the prevailing meteorological conditions should also have alerted them to the possible dangers. Figure 4 also considers the possibility that they heard the ATIS announcement but failed to act on it, either because of the commercial and personal pressures mentioned above or because the ATIS announcement did not spell out the Cat status of the aerodrome under the prevailing meteorological conditions. It can be argued that ATM personnel should have checked the license conditions of the aircraft to ensure that they were permitted to operate in the low visibility conditions that currently held at Linate. As we have seen, however, ATM staff were working under a relatively heavy loading. In addition, Figure 1 has described how the initial dominance of local and regional general aviation at Linate may have led to the development of a culture of familiarity between ATM personnel and these crews. The reduction in traffic following the movement of slots to Malpensa may also have contributed to working practices that routinely cleared general aviation operations even though the controller’s manual stated that ENAC was responsible for checking aircraft and pilots for low visibility operations.

The left-hand sequence of events in Figure 4 describes how the MD-87 commenced its departure. This included the comment that the aircraft was to taxi to the ‘holding position Cat III, QNH 1013’. This analysis continues to the point at which the MD-87 transferred their radio frequency to the TWR on 118.1 while the Cessna continued to communicate with GND control on 121.1MHz. It is important to remember that some nine minutes elapsed between this handover to the TWR and the time of the collision. It might be argued that the protocols used for such handovers should be re-examined given that the opportunity for GND, TWR and the two crews to coordinate their actions was now significantly reduced. The common channel of communication between the GND controllers, the MD-87 and the Cessna diverged into two separate and distinct communications channels between GND and the Cessna and between the TWR and the MD-87 from 06:01:24 onwards. The previous ECF diagram also describes how GND personnel cleared another aircraft LX-PRA to follow the Cessna until the stop bar on the extension of the main runway on taxiway R5. As we have seen, this exchange was in Italian. This may partly explain why neither crew was able to use this clearance to provide information on their

relative positions [5]. Equally, however, the crew of LX-PRA may not have been able to see that the Cessna was no longer in front of them given the reduced visibility on the taxiways.

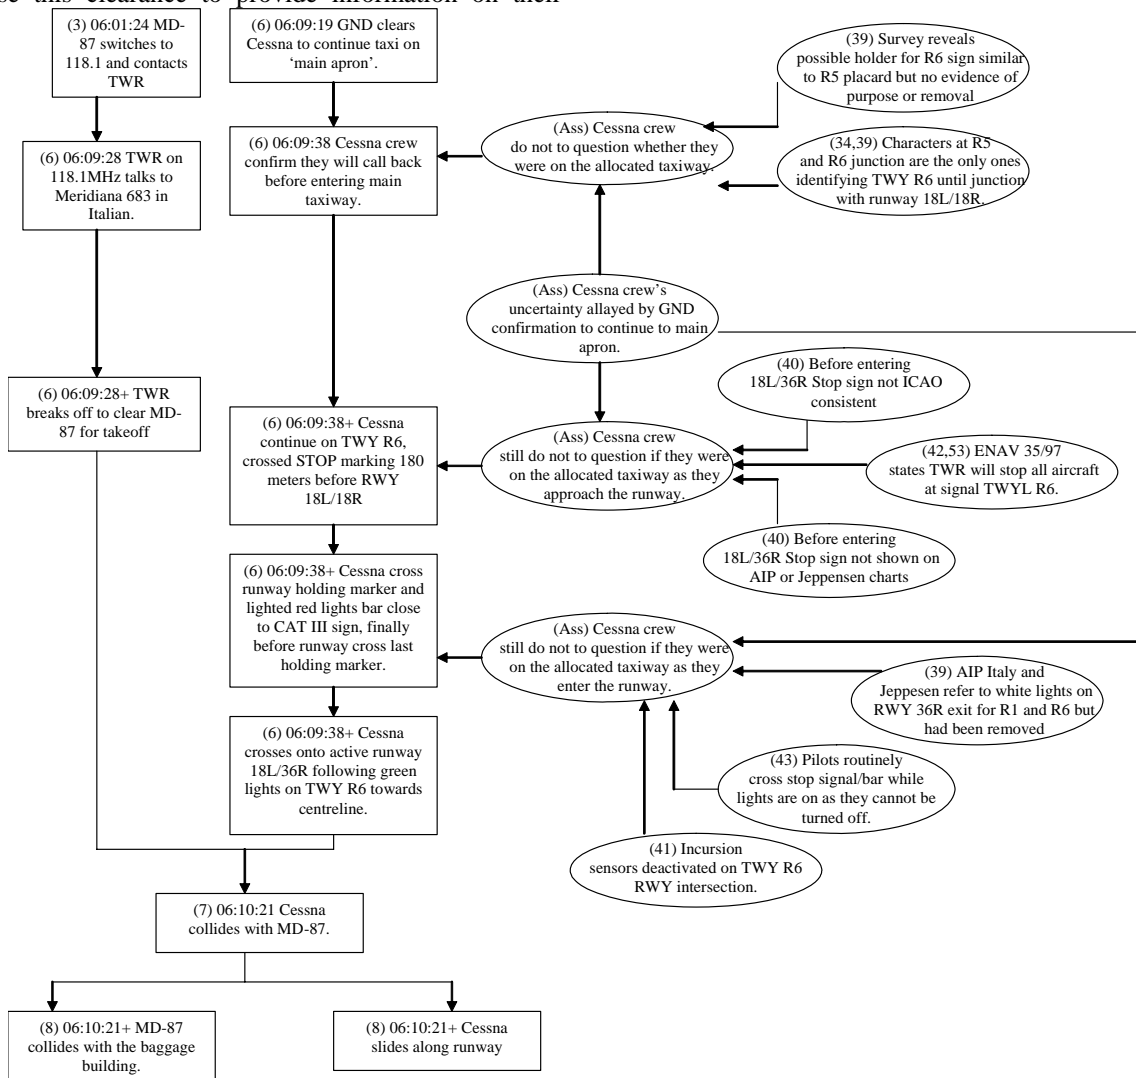
Figure 5: ECF Analysis of the Linate Accident – Events Immediately Prior to the Collision

Figure 5 builds on this analysis and includes the assumption that the Cessna’s pilot and co-pilot did not question whether they were on the correct taxiway at this stage because the GND control had given them permission to continue taxiing. The ECF diagram again includes insights from the previous analysis of the environment at Linate. In this case, the crew did not question their position because there were no external prompts to indicate that they might have been on R6 rather than R5. There may have been a missing placard similar to one that was found for R5 and there were no other markings to indicate the identity of their taxiway other than the characters at the junction, mentioned previously. Figure 5 also shows that the Cessna’s crew crossed the STOP markings 180 meters before RWY 18L/18R onto TWY R6. The ECF diagram reiterates points from Figure 2 that the STOP sign was not ICAO compliant. The sign was not shown on AIP or Jeppesen charts even though ENAV regulations required that the TWR should stop all aircraft at the signal on TWY R6.

At some time shortly after 06:09:38, the Cessna crossed the runway holding marker. They passed an illuminated red light bar close to a Cat III sign. Again it must be assumed that they were disoriented and did not at this stage question their assumed location on the appropriate taxiway short of the runway. The ANSV provide some information about the reasons why this final set of defences might have been breached when they argue that pilots routinely had to pass illuminated stop signals because ATM personnel could not routinely turn them off. This diagram also includes further observations on inconsistencies between the signage and official documentation. As before, however, it is uncertain whether these inconsistencies were immediate causes of the accident. There is no evidence that the Cessna crew attempted to use this documentation to trace their position on the taxiway at this relatively late stage in the accident. Their

decision to cross onto the active runway may also have been influenced by the path of the green lights on TWY R6 that led onto the centreline of 18L/36R.

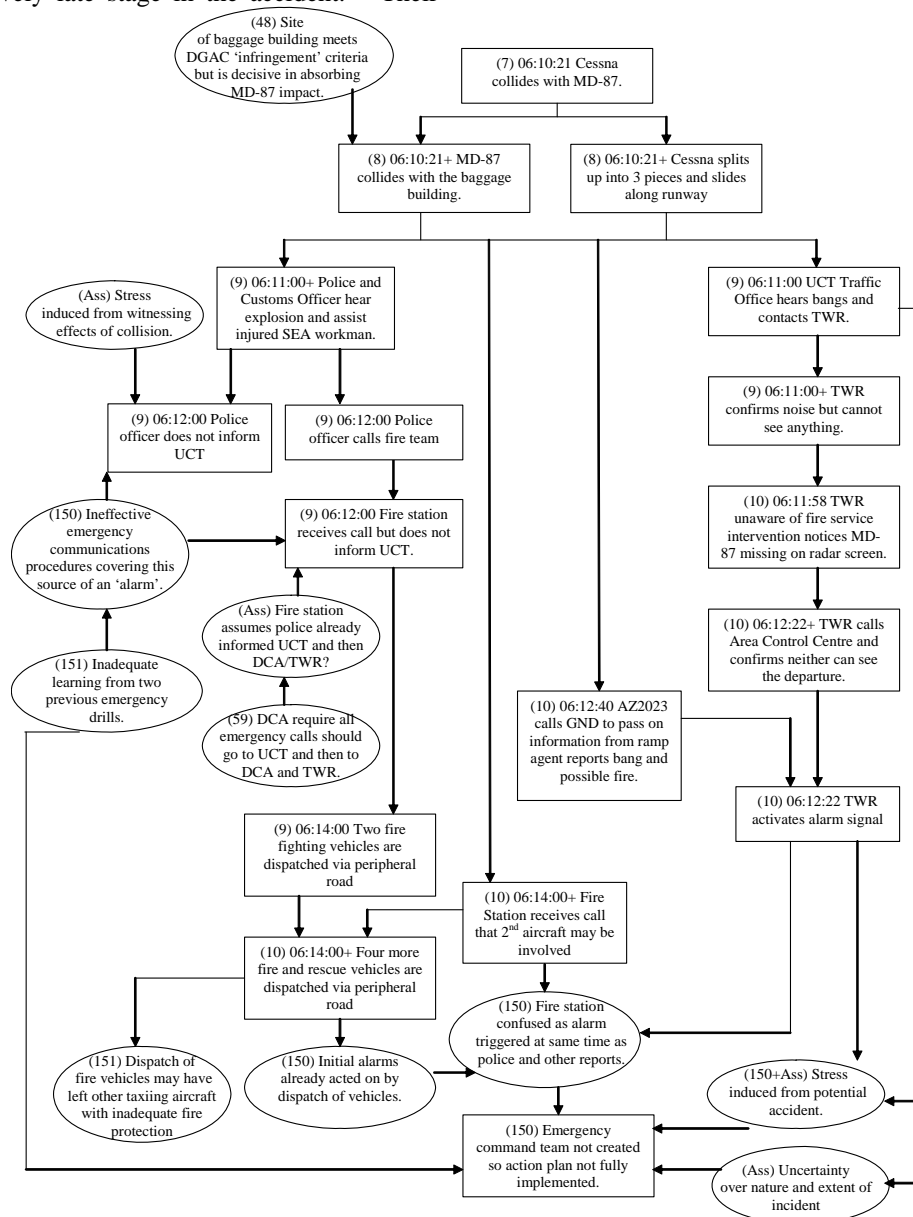
Figure 6: ECF Analysis of the Linate Accident – Events Immediately After the Collision

The Linate accident has many unusual and worrying features. One of these is the lack of coordination that characterized the immediate response to the collision. The adverse meteorological conditions that were an important cause of the incursion also served to exacerbate the problems of responding to the accident. Other organizational factors may not have helped. For instance, the response was hindered by a failure to learn from previous drills that had been organized to prepare for future incidents. Figure 6 provides an overview of the immediate response to the Linate collision.

As can be seen, the MD-87 collided with a baggage building that was situated close to the runway. The location of this structure conformed to the relevant DGAC infringement criteria. A previous ENAV survey had shown that it encroached the permitted area by around 1 meter. Additional warning lights had subsequently been added to the structure. The ANSV concluded that the position of the building was 'decisive' in absorbing the violent impact of the aircraft (page 48) and was 'instrumental in the catastrophic sudden and violent stoppage of the aircraft' (page 160). The official report does not speculate whether the consequences of the incident would have been less severe if the baggage handling facility had not been placed so close to the runway. The ANSV report does not list the location of the baggage facility as one of the factors that caused the adverse outcome to this incident once the collision had occurred. None of the existing recommendations mention the location of buildings adjacent to runways.

Figure 6 extends the analysis of post accident events to consider communications problems that frustrated attempts to coordinate the response to the collision. A Police Officer who was close to the baggage facility heard the collision and rushed to assist the injured. They then contacted the fire station. However, he did not contact the UCT who should have coordinated the response according to the prearranged emergency plan. One consequence of this was that ATM personnel were not immediately alerted about this initial report. The officer's decision to call the Fire Service is entirely understandable given the stress that can be induced from witnessing the after effects of such incidents. The ANSV report also argues that a lack of organisational learning from previous drills had led to problems in the procedures and mechanisms that governed the reporting of incidents from such sources. The fire station received the officer's call and dispatched two vehicles via a peripheral road. It can be argued that even if the police officer, acting under the stress of the moment, had failed to contact the UCT to coordinate the response then Fire personnel should have reported to them. However, Figure 6 shows that the Fire Officers may have assumed that the Police had followed the DCA's recommended procedures and had already made this call. This assumption like the others that have been explicitly represented in previous ECF diagrams can be tested against witness statements and evidence not presented in the official report.

The failure of communications between the emergency service and the UTC coordinators may have hindered the establishment of an emergency team. However, UTC personnel were alerted to the incident even without calls from the Police and Fire Officers. The Traffic Office heard the collision and contacted the TWR. They then attempted to confirm which aircraft was involved. After subsequent calls with the Area Control Centre they realise that the MD-87 is missing and the TWR activates the alarm signal as required by the emergency plan. However, the stress and uncertainty of a potential incident can again be used to explain why neither the ATC nor the UTC staff took the steps necessary to create an Emergency Command Team [6]. This emergency team was supposed to coordinate the response to such incidents. It was

also intended to ensure that the pre-arranged emergency plan was fully implemented. A key issue here is that the same lack of coordination that led to the failure to convene the emergency team, also prevented the coordinated response that the emergency team was intended to address. This form of vicious circle had not been adequately addressed in the previous drills.

The fire station received a second call indicating that two aircraft may have been involved in the incident and, therefore, dispatched four more vehicles. The lack of coordination may have affected this decision as the ANSV argue the dispatch of so many appliances may have left other taxiing aircraft with inadequate fire protection (page 151). This is a significant concern given the uncertainty in the aftermath of the collision and the possibility of wreckage being dispersed across runways and taxiways. In the meantime, the alarm signal from the TWR may have added to the Fire Service confusion. They had already acted on two previous warnings. Hence, it is likely that they concluded they had taken sufficient actions without inquiring about the formation of the command team or explicitly communicating information about their actions back to the TWR. In particular, it seems likely that they assumed that TWR already knew the location and other information that they had received in the previous two calls that triggered the dispatch of their fire vehicles. These assumptions proved to be unwarranted.

Eventually, TWR received a report from I-LUBI that they have seen flames on runway R6. GND tries to confirm whether LX-PRA ever saw the Cessna that they had been requested to follow. They confirmed that they had not seen the Cessna and at about this time the ATA confirm that the Cessna had not returned. While all of this was going on, TWR asked the fire service if they could see two aircraft. There was no answer to this initial call at 06:29:27 and so after the confirmation from ATA, TWR asked the Fire Station to conduct an examination of the runway. The ANSV does not explicitly state whether such an examination should have been scheduled according to the airport emergency plan. However, in retrospect it seems likely that a more considered response to the emergency might have looked beyond the initial site of the MD-87 wreckage in order to ensure that they did not miss any injured survivors either from the aircraft or airport ground staff. Another issue here that was not considered by the ANSV was whether additional technological support could have been provided during this search. For example, the military now routinely make use of low cost night vision equipment, either based on thermal imaging or image intensification technology. This equipment is sufficiently robust now to be considered for deployment to fire service personnel. Thermal imaging devices would provide a useful means of locating burning wreckage on a runway in a relatively short period of time. It should be noted that certain meteorological conditions, such as fog and mist, can reduce the temperature gradients that are recognized by this equipment. However, in most cases this would not be sufficient to mask the heat generated by burning aviation fuel.
