# Understanding the Interaction between Safety Management and the 'Can Do' Attitude in Air Traffic Management: Modeling the Causes of the Überlingen Mid-Air Collision

Chris W. Johnson,  
Department of Computing Science,  
University of Glasgow,  
Glasgow, G12 8RZ, Scotland.  
+44 141 330 6053  
johnson@dcs.gla.ac.uk  
<http://www.dcs.gla.ac.uk/~johnson>

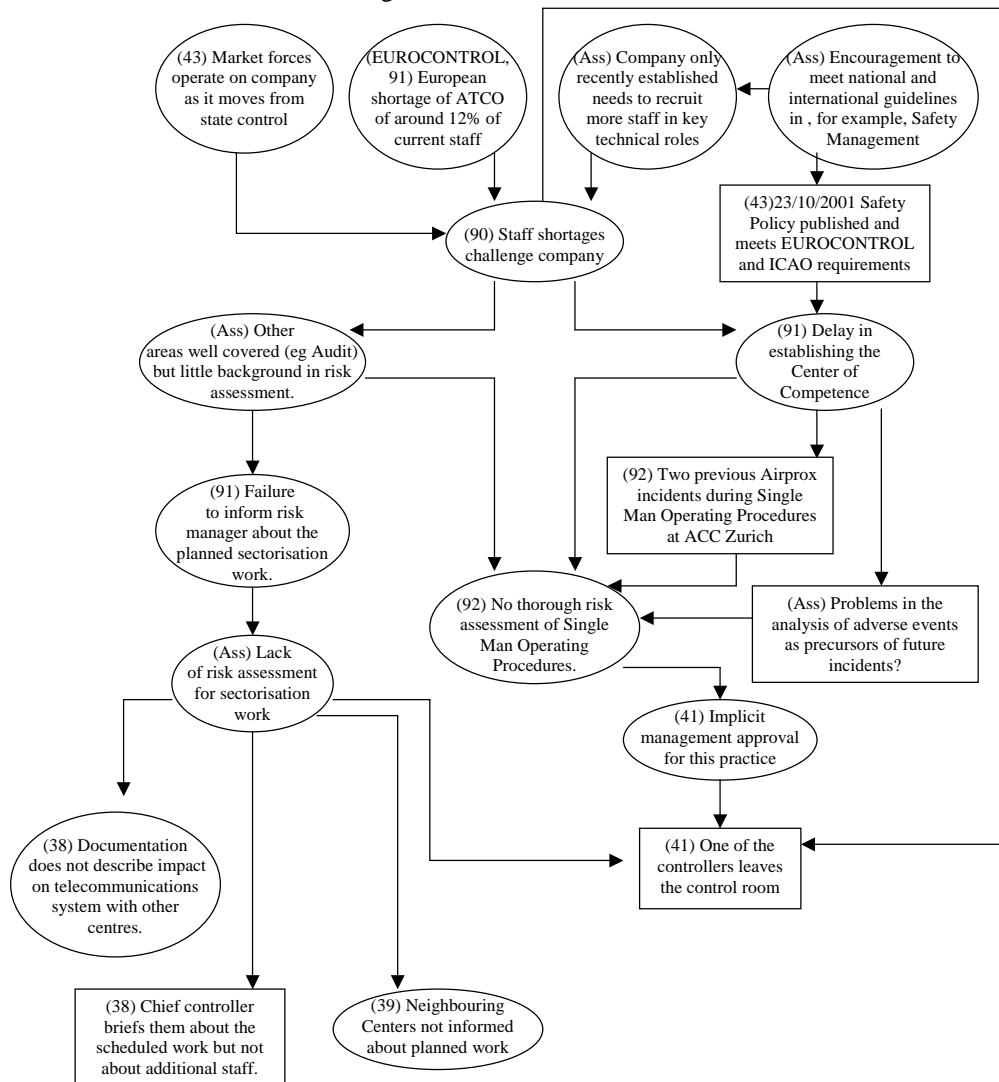
Figure 1: Interaction between Safety Management System and Lead-Up to the Accident

Skyguide had only recently been formed (in 2001) as the successor of the former state controlled ATC "Swisscontrol". Hence, although the organization was relatively mature it had to face a new commercial ethos. The staffing difficulties were compounded by a European shortage of qualified Air Traffic Control officers. The company also had to respond to national and international encouragement to create a Safety Management function within the organization. This encouragement led to the publication of the Company's Safety Policy in 2001 that, in turn, required the development of a Centre of Competence. However, as can be seen from Figure 1 staff shortages delayed the development of this Center. Although existing strengths in areas such as internal audit could still be relied upon there was little background in risk assessment. One consequence of this was that in the lead-up to the Überlingen accident the risk manager was not informed about the planned sectorisation work. Hence, the ECF diagram draws a direct link between high-level judgments and often very ambiguous statements about the importance of 'safety culture' and the detailed events that led to this collision. In this case, we can trace a path directly from the need to meet national and international guidelines of Safety Management Systems through difficulties in staffing to meet the Company's Safety Policy to a failure to inform the Risk Manager that ultimately explains why there was no adequate risk assessment of the sectorisation work.

The importance of the analysis in the previous paragraphs should not be underestimated. As we shall see, the lack of risk assessment illustrated in Figure 1 had profound consequences. It may have prevented staff from understanding the potential consequences of the sectorisation work that took place on the night of the accident. This work deprived controllers of key elements in their technical infrastructure [4]. The organizational factors illustrated in this first ECF diagram can also be used to explain why a single controller was left at the workstations on the night of the accident. There is the obvious connection that staff shortages had led to two members of staff being rostered

rather than three. The delays in establishing the Center of Competence and the lack of background in risk assessment, arguably, explain why there had not been any thorough risk assessment of Single Man Operating procedures even after there had been two previous AIRPROX incidents in ACC Zurich. The delay in establishing the Center of Competence may also explain problems in establishing the types of incident analysis capability that would ensure a more complete risk assessment in the aftermath of previous adverse events.

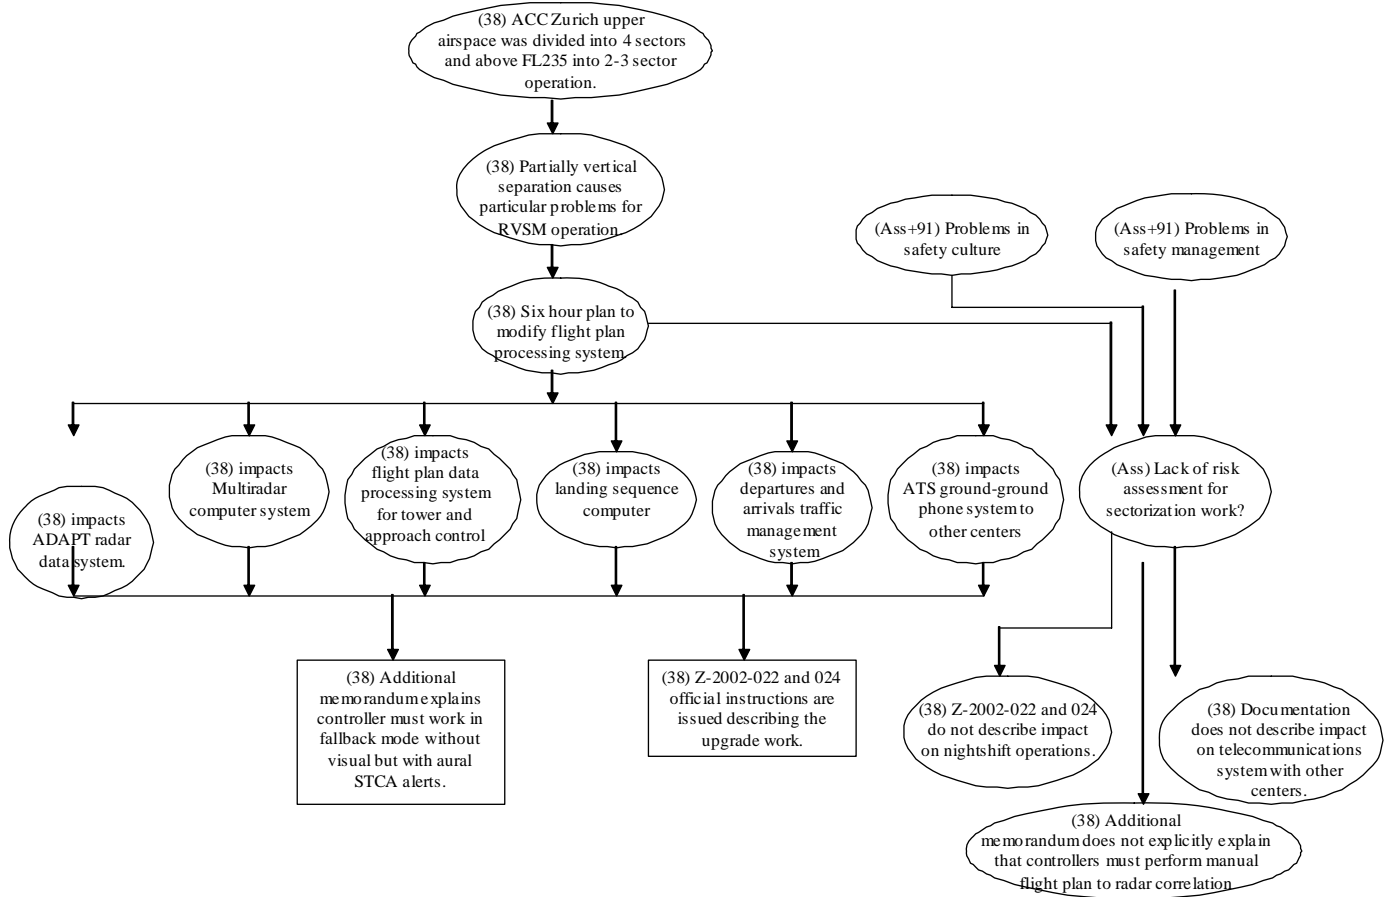
Figure 2: Contextual Factors Influencing the Technical Systems Environment in the Zurich ACC

Figure 2 starts with the observation that ACC Zurich upper airspace was divided both vertically and horizontally. The particular vertical division about FL235 into 2 or 3 sector operations created particular problems for the introduction of Revised Vertical Separation Minimum (RVSM). Switzerland was one of forty one European and North African countries that introduced a revised minimum separation of 300m (1000ft) between aircraft on 24 January 2002. This provided

The right-half of Figure 2 builds on the previous organizational analysis of Skyguide. In particular, it links problems in safety management to the lack of effective risk assessment for the particular work that was proposed within the Zurich ACC. The evidence for problems in safety culture

is provided on page 91 of the BFU report. However, the official investigation does not explicitly consider whether or not a more sustained risk assessment would have identified the potential hazards. In consequence, the associated contributory factors in Figure 2 are annotated shown as assumptions. The key point is that the ECF analysis helps to identify an apparent explanation, such as the lack of any adequate risk assessment, for the failure to document the impact of the upgrade on the telecommunications facilities with neighboring centers. Similarly, this failure can be used to explain the lack of documentation about the impact on night shift operations and the need to manually correlate radar targets against flight plan information.

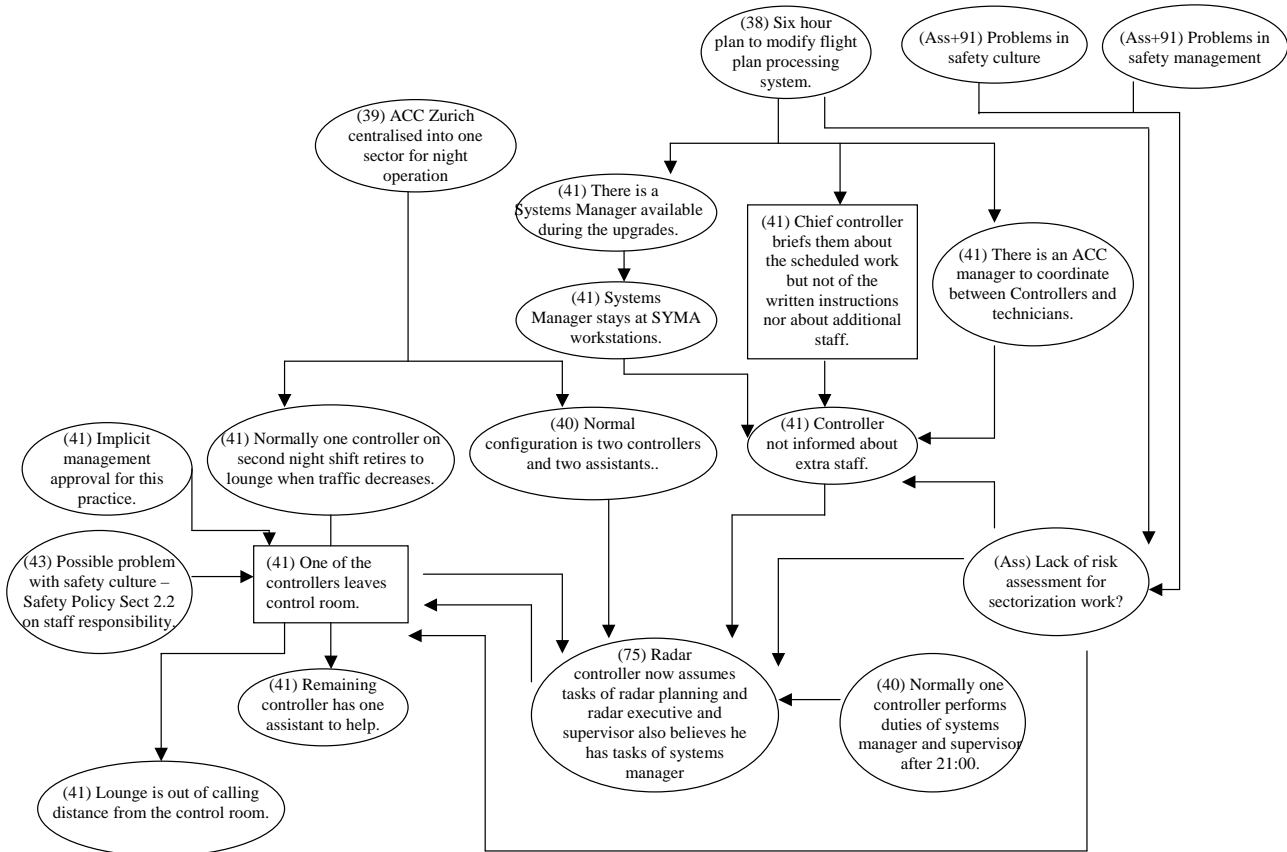
Figure 3: The Human Systems Environment in the Zurich ACC

Figure 3 focuses on human resource issues within ACC Zurich prior to the accident. The normal configuration was for two controllers to be supported by two assistants. It was also usual for one of the controllers to leave the control room as soon as traffic died down so that he or she could rest in the lounge. During the accident, one of the controllers left the control room. Management knew about this practice and there was no apparent pressure to stop it hence there was at least implicit acceptance, documented on page 41 of the BFU report. This may itself also be due to problems in safety-culture mentioned in the previous paragraphs [5]. The additional controller

have ensured minimum manning levels. However, it can be argued that overstaffing of control room environments can lead to complacency, boredom and fatigue that are themselves error inducing factors during quiet intervals in safety-critical tasks. Hence, the ECF analysis in Figure 3 again reinforces the observation that it is not the undermanning itself that is the root cause of the problem. The accident was caused by a combination of the undermanning and a failure to recognize the risks associated with the profound system changes and lack of normal system support as a consequence of the SYCO flight plan processing system upgrade.

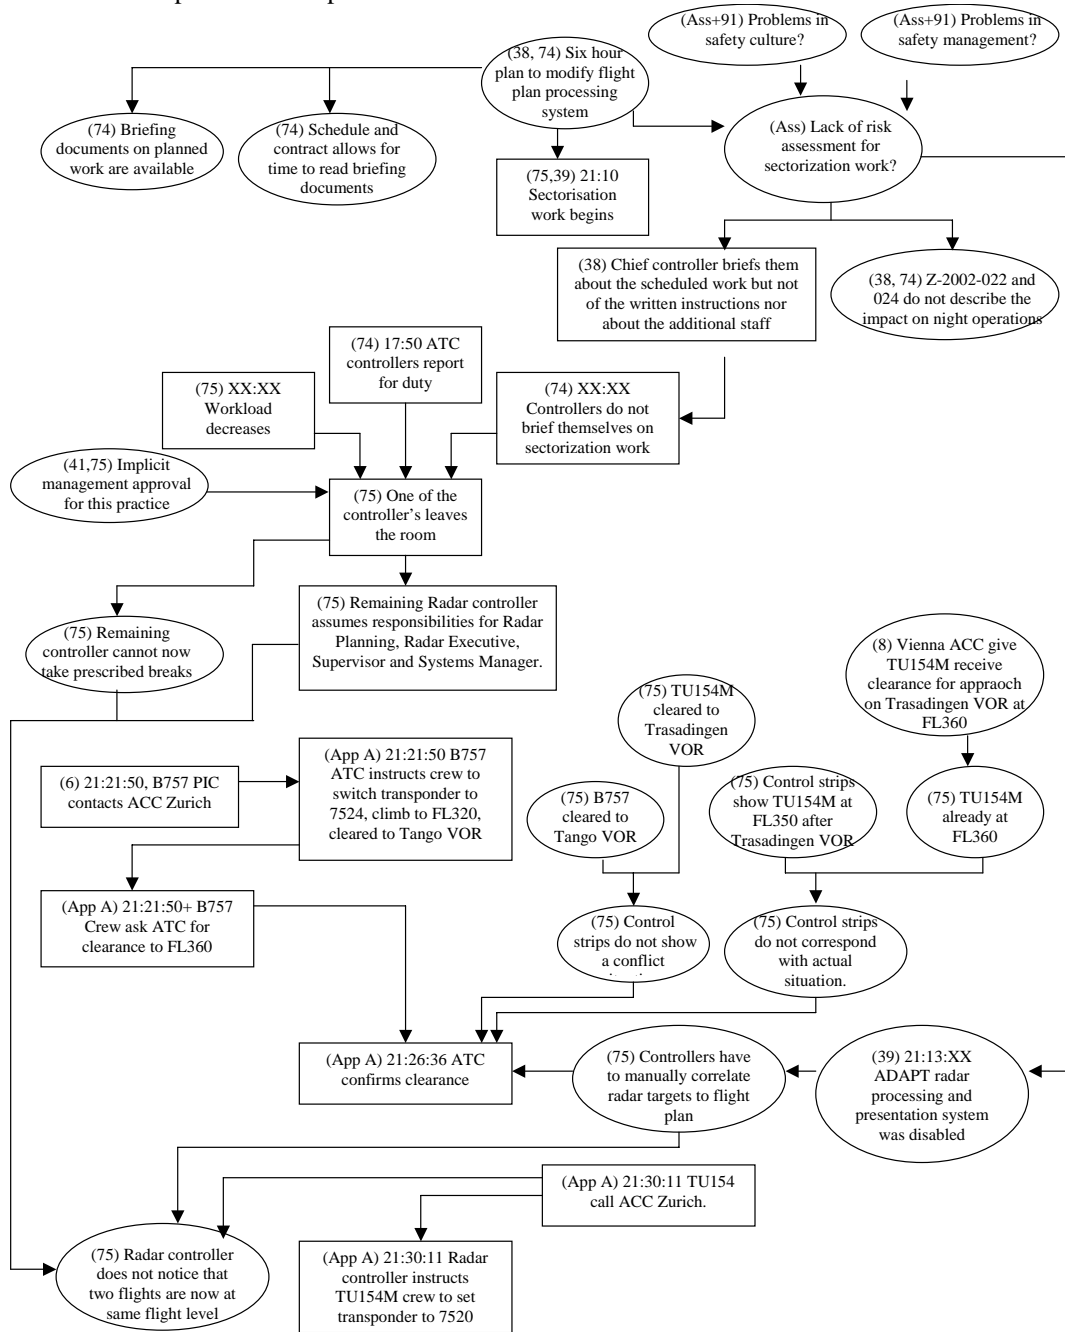
**Figure 4: Clearance for B757 to Join TU154M at FL360**

Figure 4 takes the analysis from the time at which the controllers reported for duty (17:50). However, it also carries forward elements of the earlier analysis of the technical and personnel infrastructure. For instance, it refers to the lack of documentation on the impact of the upgrades. It also links back to the lack of any adequate risk assessment and the impact that this may have had on, for instance, the Chief Controller's briefing about the upgrade work. Similarly, this diagram includes elements of Figure 3 that refer to the remaining controller assuming a considerable number of additional responsibilities at a time when they were left exposed by a lack of systems support.

Figure 4 goes well beyond the previous ECF diagrams because it begins to map out the more immediate chain of events that led to the accident. As can be seen, the B757 contacts Zurich ACC at 21:21:50. The request is made for clearance to FL360 immediately after the initial contact and this is granted at 21:26:36. The conditions that make this event more likely include the fact that the paper control strips for the B757 and TU154M do not show any apparent conflict. They were cleared to different waypoints. The controller's difficulty in anticipating the potential conflict is compounded by the observation on page 75 of the BFU report that the strips no longer began to reflect the true situation as the TU154M was shown at FL350 after Trasadingen VOR. However, the controller would have had to detect this inconsistency manually given that the automatic flight plan and radar

correlation (ADAPT) support had been disabled as part of the SYCO flight plan processing system upgrade. The ECF diagram ends with the call from the TU154M to Zurich ACC as it approaches their airspace.

The key insight from Figure 4 is the role that inadequate risk assessment may have played in exposing the Controller to an error inducing context. This builds on the previous contextual analysis that has already made a similar point because it shows the more detailed causal mechanisms that led from managerial and cultural problems to specific events in

the accident itself. In this case, the lack of risk assessment led to the controllers being poorly informed about the sectorisation work. It is possible to conjecture that if additional information had been available, for instance about the interruption to the SWI-02 communications system with neighboring centers then the second controller might not have departed for the lounge. Similarly, if an adequate risk assessment had been conducted then additional consideration might have been paid to the possible consequences of disabling the ADAPT radar system.

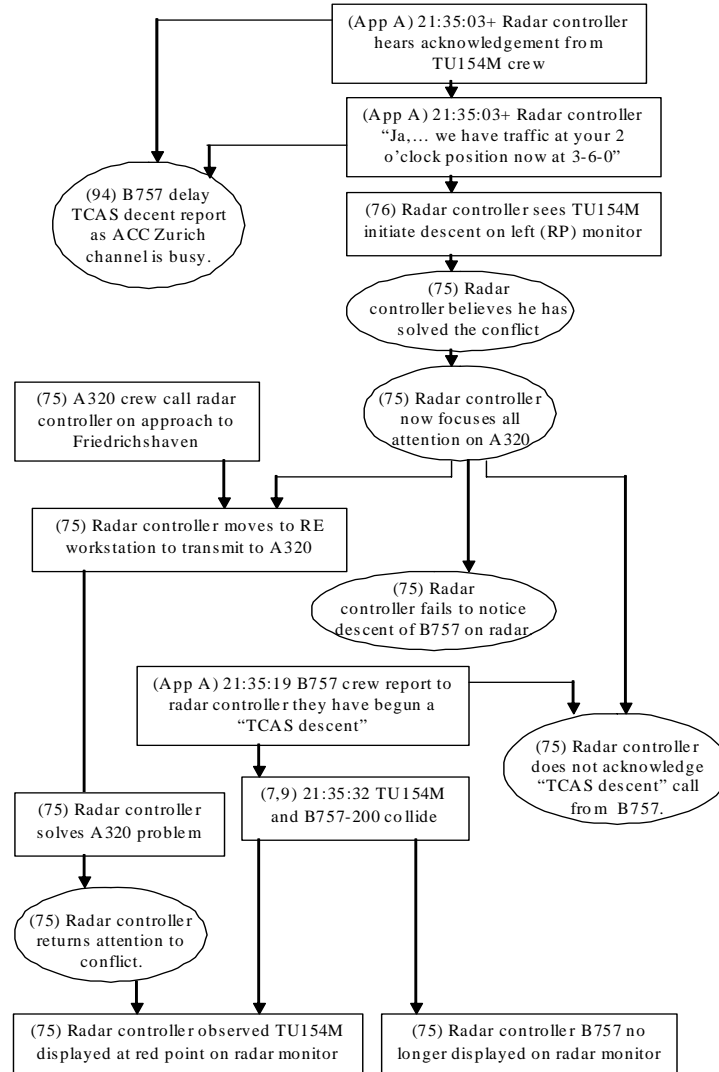
Figure 6: B757 TCAS Descent

Figure 6 illustrates the immediate events before the collision. Again, the controller begins to focus his attention on the A320 on its delayed approach to Friedrichshafen. This allocation of attention is explained in the BFU report by the observation that the Controller now believed they had resolved the conflict once the crew of the TU154M had expedited their descent to FL350. The decision to focus on the A320 had important consequences as the controller again had to move to the Radar Executive workstation to transmit to this aircraft. Any subsequent transmissions to the B757 or the TU154M would then involve a move back to the Radar Planning workstation, although all flights were visible on both displays. The outcome of this 'distraction' or division of attention was that the controller failed to observe the radar trace of the B757's descent in response to the previous TCAS advisory.

The controller's preoccupation with the A320 and the split working positions may also explain his failure to notice the B757 crews' radio signal to warn of a 'TCAS descent'. The BFU report suggests that the timing of this call was particularly unfortunate. The crew of the B757 had been trained to alert ATC as soon as possible after a TCAS advisory. Both the Pilot Flying and the Pilot Not Flying initially tried to contact ACC Zurich. It seems that the Controller's descent instructions to the TU154M and the subsequent conversation about the possible '2 o'clock' position of the other aircraft prevented the B757 crew from conveying the critical information about their decent to ACC Zurich:

When the radio channel eventually became available, the B757 crew transmitted their descent call. However, this in turn overlapped with the call from the A320 crew on their approach to Friedrichshaven. This pathological sequence of events may, therefore, have prevented the controller from hearing the critical information from the B757 crew. Although, it can also be argued that when this information was transmitted there was insufficient time available to

successfully avert the collision. Thirteen seconds provides an extremely narrow window within which to formulate a response, communicate that advice to one of the crews and for them then to act upon that information especially given that both crews had already initiated a decent to resolve the apparent conflict.
