Review of the ANSV Linate Accident Report

(Version 1: 8/2/2005)

Prof. Chris Johnson

Glasgow Accident Analysis Group, Department of Computing Science,
University of Glasgow, Scotland.

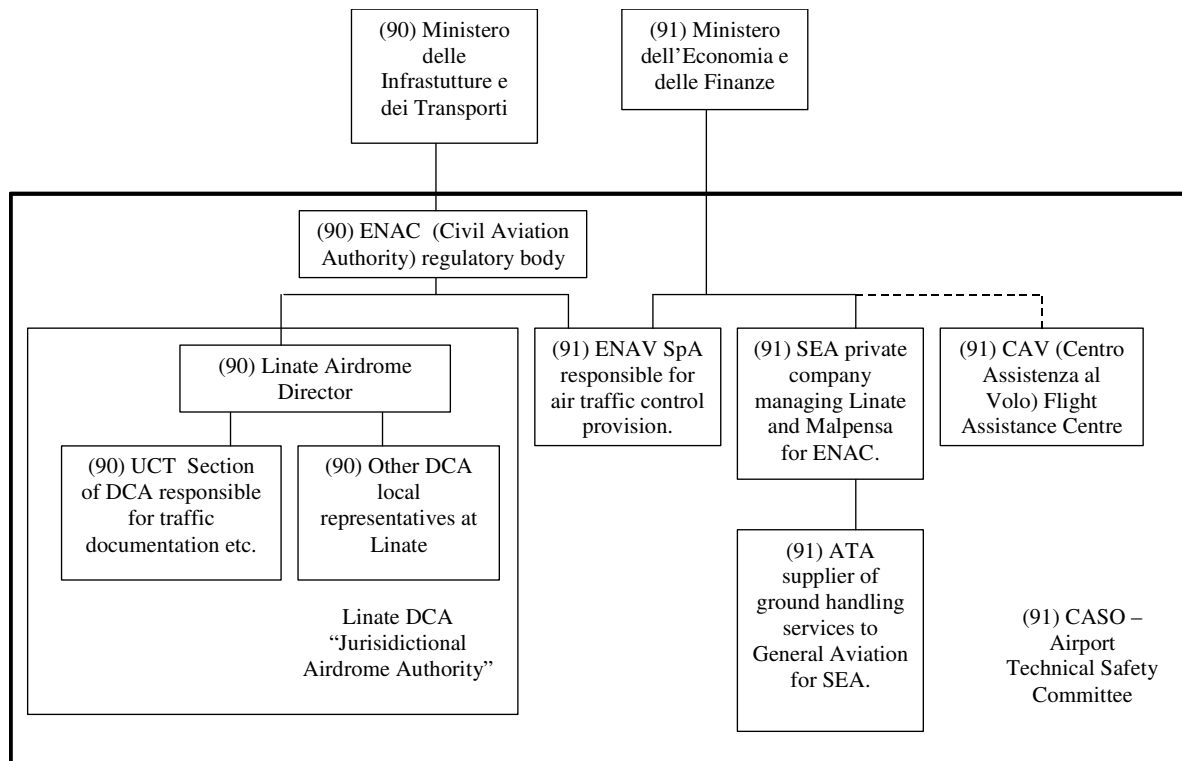
Figure 2: Simplified Organisational Structure Prior to the Linate Accident

As can be seen, this diagram shows some of the organisational relationships that shaped the operation of the aerodrome prior to the collision. As before, the figures in brackets refer to the page numbers in the English language version of the ANSV report. It is important to note that this translation cannot easily be used to derive the organisational structure illustrated in Figure 2. The report uses phrases such as “under the surveillance of” or “with the local CAV is responsible for ATC provision...” These cannot easily be interpreted to produce a clear reporting or management structure. This does not imply that such a structure was not present; it is impossible to tell whether or not the lack of clear organisational guidance was a factor in the accident because it is not made explicit within the ANSV report. One consequence of this is that the depiction of the CAV at the same level as the SEA management company is the result of an assumption based on the current report.

A number of insights can be obtained from the control structures sketched in Figure 2. It seems that the operational staff at Linate were caught between the two pressures of economic competition and safety regulation. These are represented by the Ministero delle Infrastrutture e dei Trasporti and the Ministero dell'Economia e delle Finanze. This is a common tension in modern air traffic management as market forces play an increasing role in former state monopolies. Perceived changes in the priorities associated with economic competitiveness and with safety regulation have also been identified as root causes of accidents in a wide range of industries, as diverse as UK railways and US space missions. Such tensions are hinted at in the ANSV report but are not made explicit.

It is important that future accident reports explicitly consider the management and organizational structures that were in place prior to an accident so that readers can clearly identify the impact that they might have had upon the course of an adverse event. As later sections will show, this is particularly important for the credibility of any recommendations that focus on the role of safety management systems. It is difficult to clearly understand the ways in which these systems might

have been improved if readers cannot identify the reporting structures that held when an accident occurred.

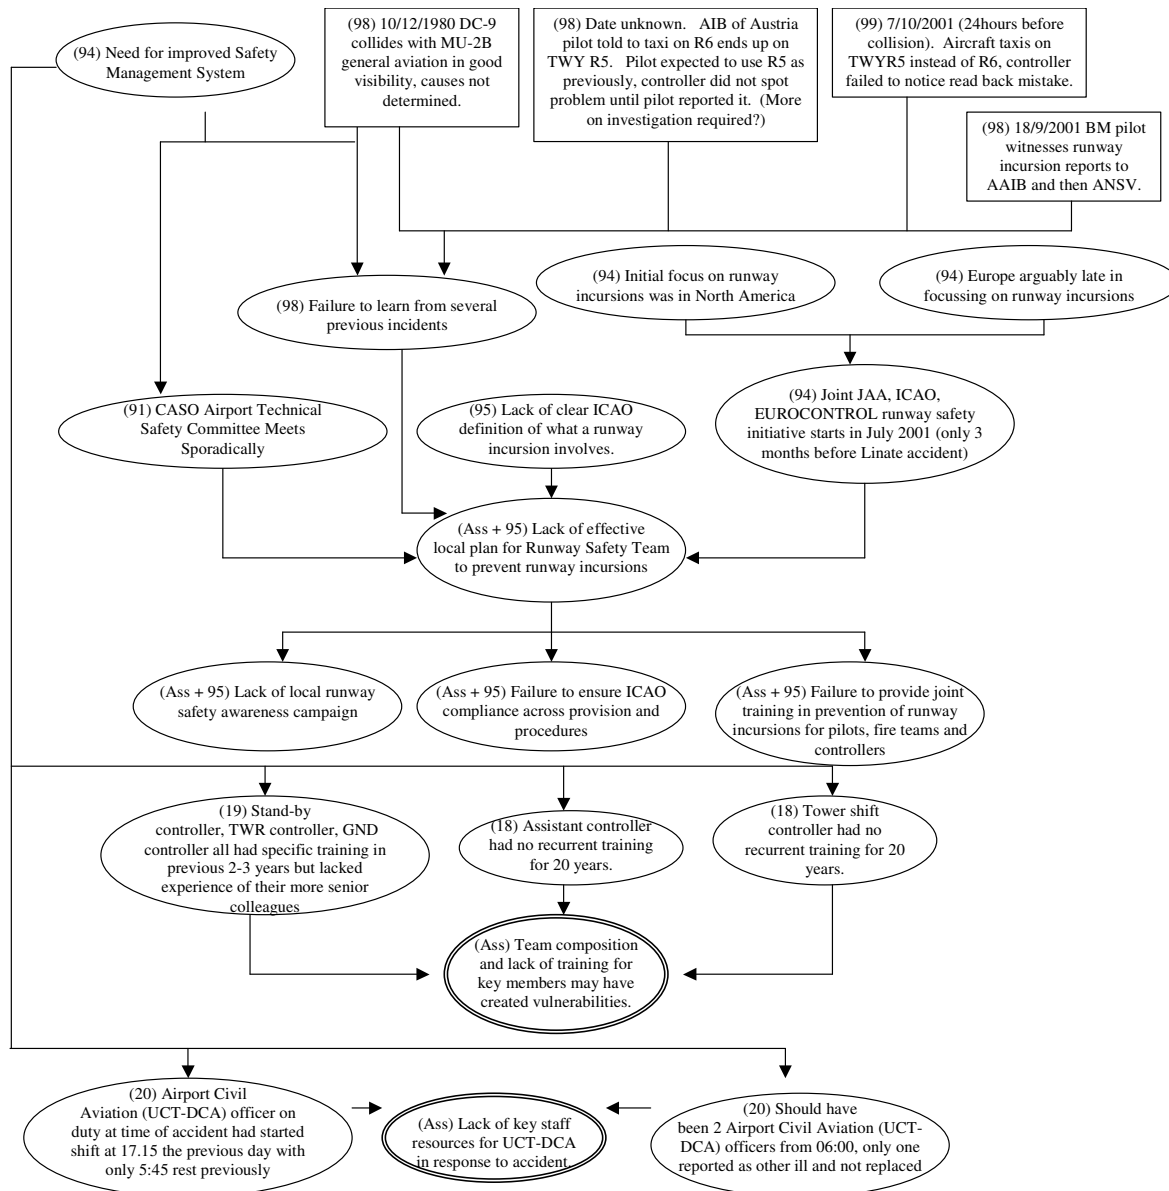
Figure 3: Contextual Factors Stemming from Organisational Issues Prior to the Linate Accident

Figure 3 presents the next stage in our analysis. It represents a simplified form of Events and Causal Factors diagram, initially pioneered by the US Department of Energy. Previous EUROCONTROL projects including the analysis of the Uberlingen mid-air collision have used similar diagrams to model human error and

systems failure in ATM incidents. Ellipses are used to denote contributory factors that combine to make events more likely. Events, as before, are denoted by rectangles. This diagram moves from an initial analysis to look at some of the many ways in which the organizational structure directly affected the context in which the accident occurred. Figure 2 shows how ENAC, the SEA, CAV, DCA etc all contributed to or influenced the CASO, Airport Technical Safety Committee. In contrast, Figure 3 records the observation that this grouping only met sporadically. This is represented by a contributory factor approximately mid-way down the diagram on the left-hand side. One of the factors that led to this was the need to improve the Safety Management Systems in operation at Linate prior to the accident. This apparent shortcoming also partly explains a failure to learn from previous incidents. These are shown as four separate events, including a very similar incident to the collision between the Cessna and the MD-87 which occurred only 24 hours before the accident. In this incident an aircraft taxied along TWY R5 instead of R6; the Controller was only alerted to the incident when the crew realized their potential mistake.

Figure 3 also draws on factors that go beyond the organizations listed in Figure 2. For example, the ANSV argue on page 94 of the report that most of the early concern about runway incursions came from North America rather than Europe. This may partly explain why transatlantic initiatives to address the problem began to make significant progress some three months before the collision leaving insufficient opportunity for many of the subsequent recommendations to be adopted at Linate. These factors combined with the issues that stemmed from the lack of effective Safety Management. Together they contributed to a situation in which there was no effective runway safety plan. The lack of a fully developed runway safety team may also help to explain the absence of runway safety awareness campaigns, of a failure to ensure compliance with ICAO runway requirements and for well integrated plans to deal with runway emergencies. The key point here is that local failures, such as the failure of personnel at Linate to learn from a number of specific previous incidents, combined with higher-level issues, including delays in the development of an international initiative to coordinate efforts to improve runway safety.

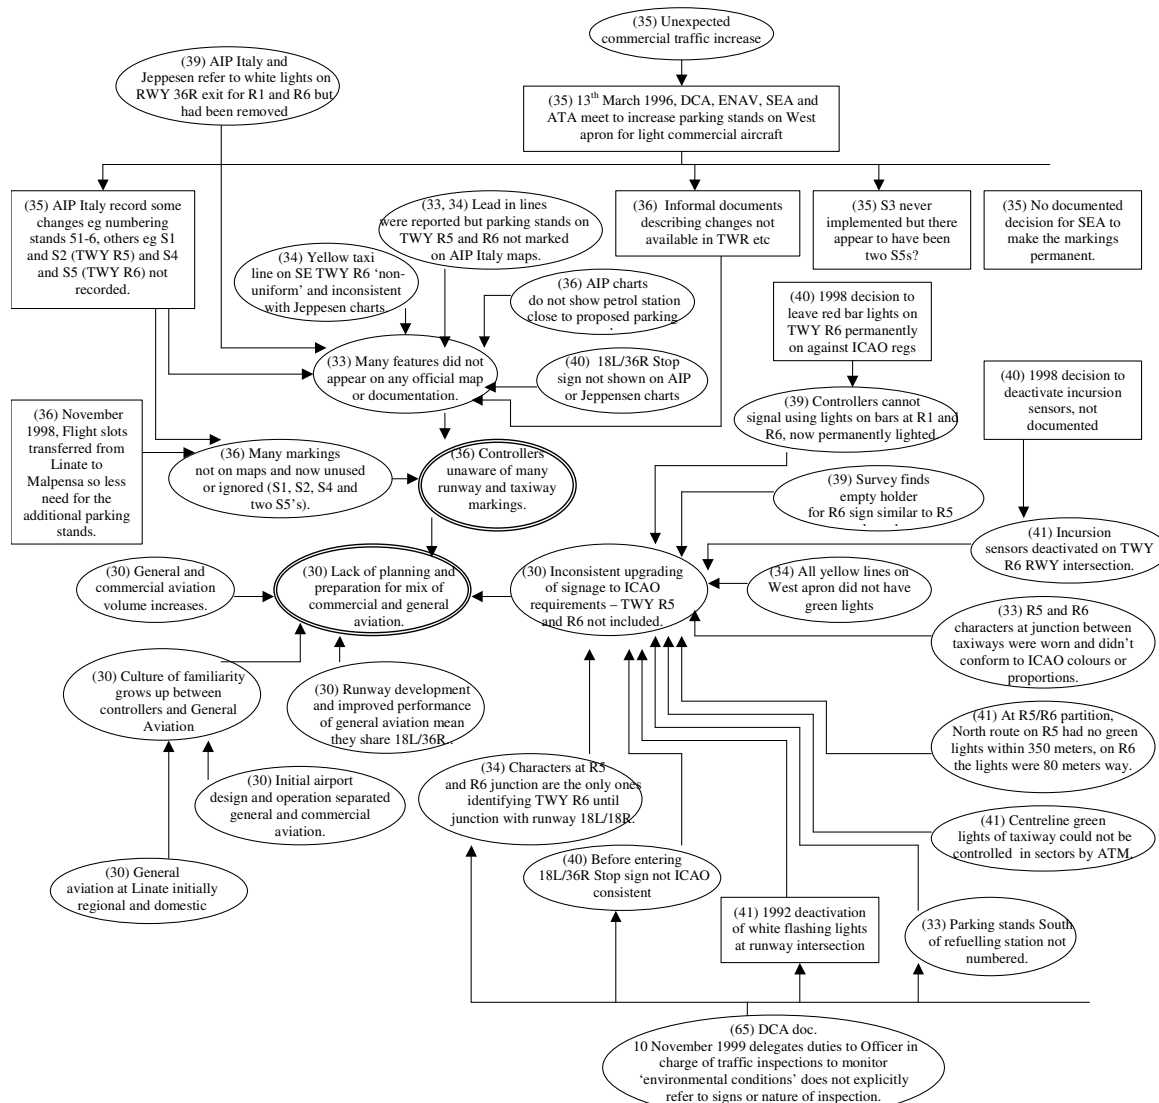
Figure 4: ECF Analysis of the Runway Infrastructure at the Linate Accident

As can be seen, Figure 4 begins with a change in the operating conditions at Linate when there was an unexpected increase in commercial traffic. One consequence of this was that many of the operational groups, identified in Figure 2, met to consider increasing the parking stands on the West Apron to accommodate the increase. The outcomes from this meeting are described on page 36 of the ANSV report. These include the lack of documentation to support the proposed changes in marking that were made as part of this plan. There does not appear to have been a documented decision to make the markings permanent. There were also inconsistencies in the parking stands that were finally developed. For example, the stand S3 never seems to have been implemented and yet there were two S5s. As we shall see, these inconsistent markings created the potential for confusion when controllers were

Figure 4 extends the previous analysis to show that ATM personnel's lack of information about runway and taxiway markings formed part of wider problems that stemmed from inadequate planning for the mix of commercial and general aviation at Linate. Initially, the design and operation of the airport had separated these different forms of traffic. The general aviation had been largely domestic or regional and the ANSV refer to a 'culture of familiarity' between ATM personnel and the aircrews. However, as we have seen, there had been a gradual increase in traffic at Linate. Runway developments and the increasing power of aircraft used by general aviation pilots created a situation in which runway 18L/36R was shared by an increasingly mixed range of traffic. A further consequence of this was that ATM personnel gradually absorbed the additional overheads associated with synchronizing this mixed-use traffic as they moved from the parking areas, to the taxiways and the runways. These additional demands were exacerbated by the problems in signage mentioned above.

As can be seen from the previous diagram in Figure 4, a DCA document dated the 10th November 1999 delegated responsibility to the officer in charge of traffic inspections to also monitor the ‘environmental conditions’ associated with the runways and taxiways. However, there is no explicit mention of the signage or of the types of inspections that might be appropriate to meet this objective. Partly in consequence, there was a range of modifications to the runway and taxiway infrastructure at Linate that did not meet ICAO requirements. These included the stop sign before 18L/36R, the 1992 deactivation of white flashing lights at the runway intersection, the 1998 decision to deactivate incursion detectors etc. It should be noted that this last modification was not properly documented and this reinforced the comments made in additional recommendation 8. The inconsistent signage created problems for the aircrews that had to navigate onto appropriate runways. It may explain the previous runway incursion incidents mentioned in previous paragraphs. Further problems were created by the lack of control over critical sections of runway and taxiway lighting. ATM personnel could no longer alter the configuration of these light sources to provide positional cues to aircrew. Some of the inconsistencies with ICAO regulations and wider safety provisions stemmed from decisions made 7 or 8 years before the accident. The fact that they had not been addressed after previous incidents arguably reinforces the need for improved Safety Management Systems, identified by the ANSV. It also underlines the need to provide better support for the responsible individuals, such as the ‘officer in charge of traffic inspections’, and groups, including the ‘runway safety teams’ anticipated by the working groups on runway incursion. The runway environment at Linate evolved over many years. Hence, it would be useful if regulatory organizations provided specific guidance for responsible individuals and groups on how to identify existing problems when they take up their post. This is a non-trivial problem. It seems clear that many of the deficiencies at Linate had been accepted as ‘normal’ prior to the accident. Management could argue that there had been no serious accidents even with the current marking problems, the lack of lighting control and the deactivated incursion sensors. The key recommendation here is, therefore, to provide guidance on how to expose the potential consequences of these ‘normal operational circumstances’ before an accident takes place.

Consideration should be given to the additional workload imposed on ATM personnel operating mixed-mode runways that service both commercial and general aviation. This workload will differ depending on the proportion and total volume of traffic in each category. It will also vary in relation to environmental conditions. It is surprising that existing regulations governing high, medium and low traffic flows in low visibility conditions seem to ignore the characteristics of that traffic. They are purely defined in terms of numbers of ‘operations’ rather than the mix of traffic and Linate shows that this mix plays a critical role in determining workload when commercial and other forms of traffic must share a runway.

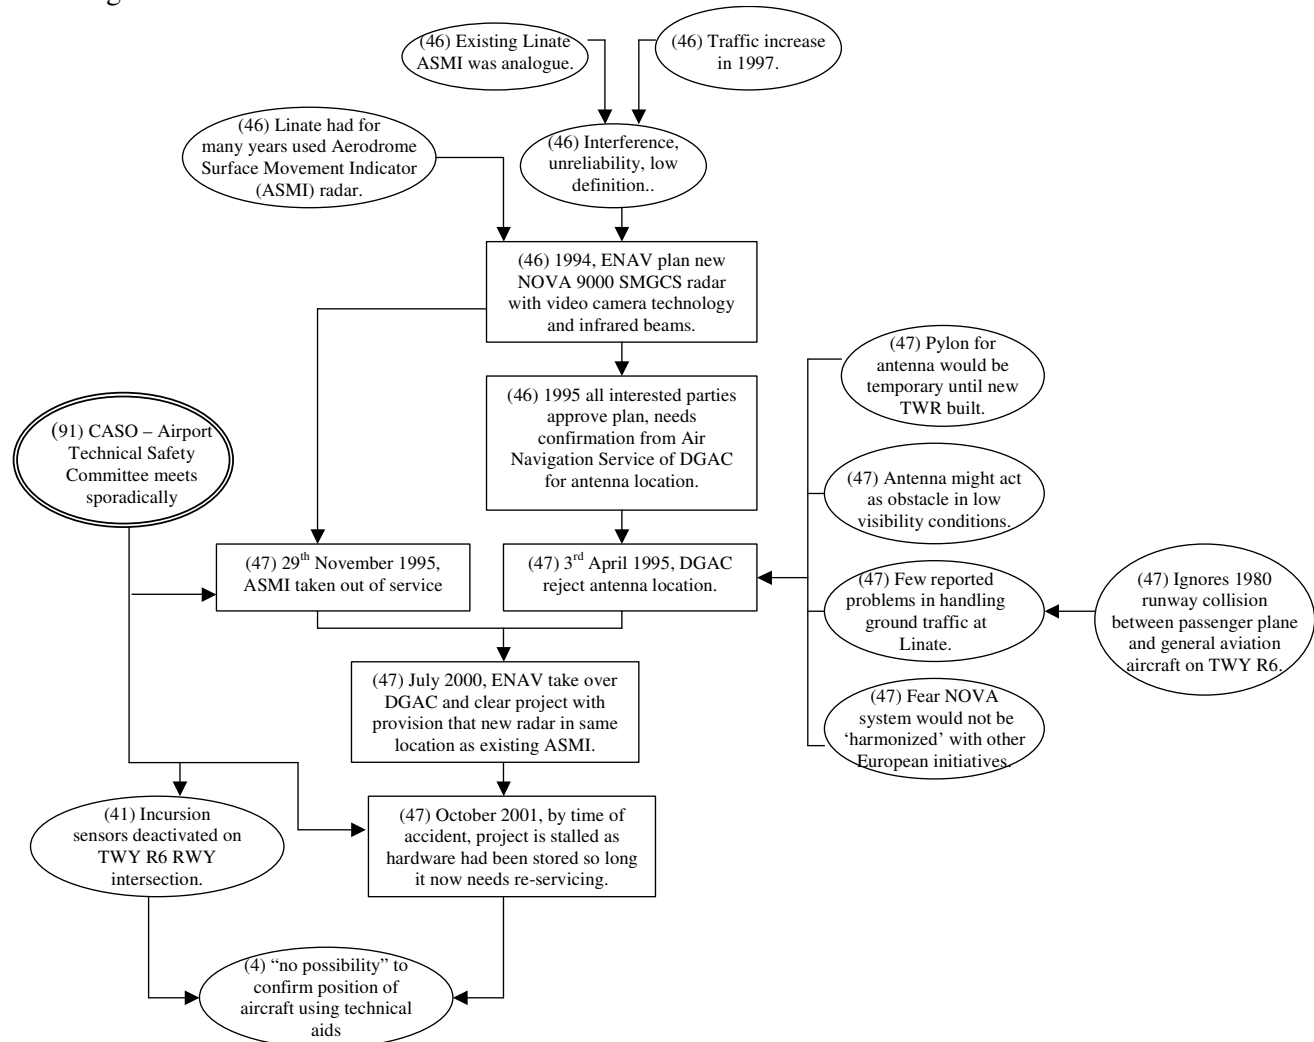
Figure 5: ECF Analysis of Technological Infrastructure at the Linate Accident

Aerodrome Surface Movement Indicator (ASMI) radar at Linate was analogue. The traffic increase mentioned in previous paragraphs exposed the reliability and low definition of this system to a point at which ATM personnel began to look for an alternative. This again emphasizes the points made in Additional Recommendations 8 and 9 about the need to provide explicit support for the management and documentation of structural changes in ATM operations. As we shall see, the technical decisions that were made as a consequence of the increase in traffic were not followed through in a systematic manner. Change management systems and associated documentation support tools, similar to those advocated under ISO9000, might have an important role to play in reducing the likelihood of such problems recurring.

Figure 5 specifically shows how there was a plan to introduce a NOVA 9000 Surface Movement Guidance and Control System (SMGCS) using video camera technology and so the old AMSI system was taken out of service some three years before the accident. The plans to install the new system were jeopardized when the predecessor of ENAC objected to the antenna location. They argued that this would involve additional expense by constructing a temporary structure that would then be moved once a new Tower was built. It was also argued that the proposed structure might hinder visibility and that there were few reported problems in handling ground traffic at Linate. The ANSV do not explicitly consider the relevance or strength of this argument given the previous incidents noted in this report. Equally, the DGAC precursor of ENAC might not have been told about such previous incidents and hence would, from their point of view, have been justified in reaching this conclusion. The ECF diagram in Figure 5

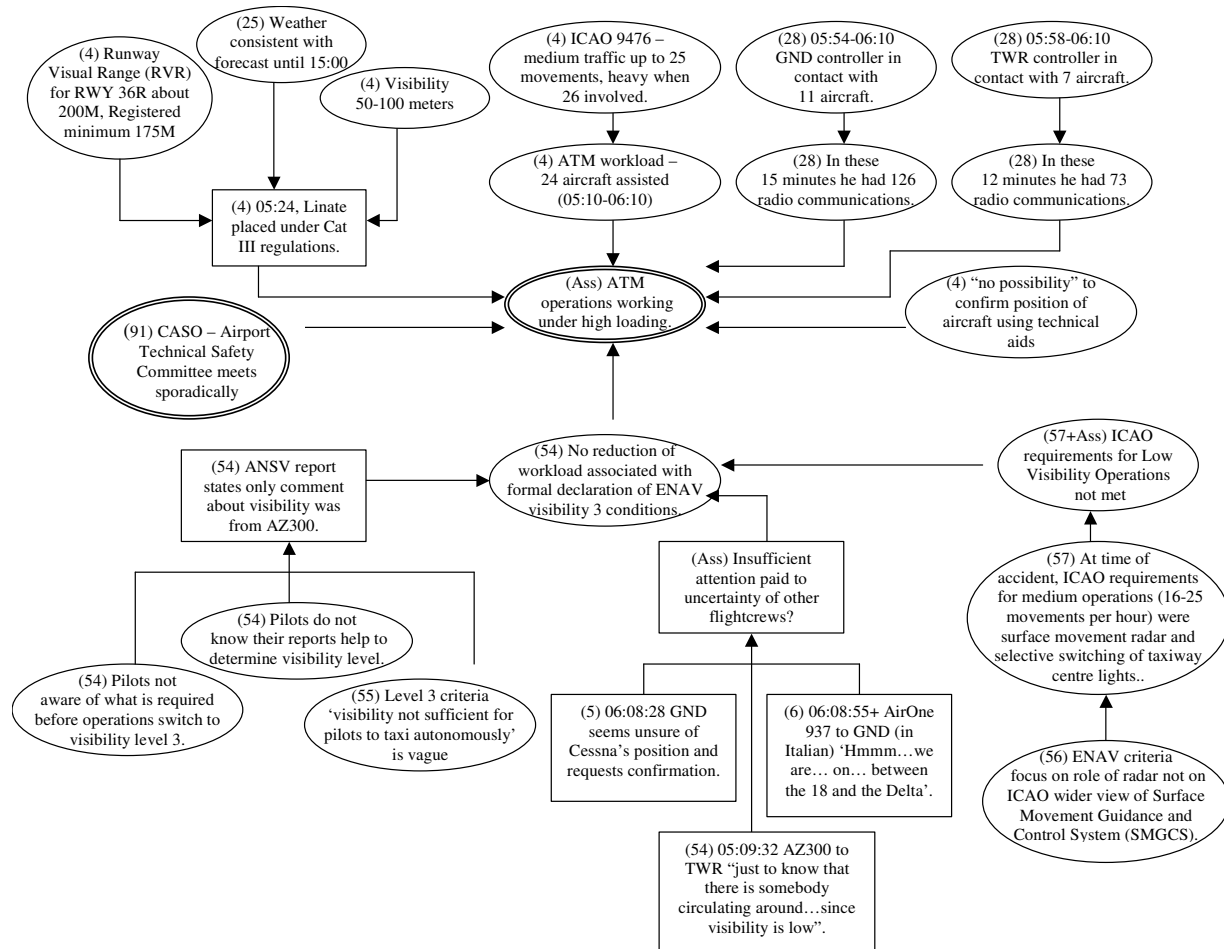
Figure 6: ECF Analysis of the Linate Accident Linking Organisational Issues to Specific Events

Figure 6 illustrates the way in which ECF diagrams can bridge between the previous organisational and contextual issues to focus more narrowly on the events in the timeline that led to the accident. As can be seen, this diagram focuses on those factors that contributed to the loading on ATM personnel. Some of the contributory factors have been analysed before, such as “no possibility to confirm position of aircraft using technical aids”. Analysts can, therefore, use previous diagrams such as Figure 5 to trace back the underlying organisation and technical issues that are summarised by the inclusion of this node in Figure 6. The left-hand side of the previous diagram deals with meteorological conditions that can be seen as the catalyst for the accident. The ANSV report describes the low visibility conditions that held on the morning of the crash. The observed conditions were consistent with the forecast until approximately 15:00 and, as can be seen, the airport was therefore placed under Cat III regulations at 05:24. During the interval from 05:10 to 06:10 when the collision occurred the controllers assisted 24 aircraft. 21 taxied from the North and West apron. 3 more had landed and were moving from the runway areas. During the 15 minutes before the accident, the GND controller was in contact with 11 different aircraft and had

approximately 126 radio communications. Over the last 12 minutes before the accident the TWR controller contacted 7 aircraft and had 73 radio communications. ICAO DOC 9476 defines medium traffic to be up to 25 movements. Anything beyond this is classified as heavy traffic. The analysis of the upper portion of Figure 6 leads to conclusions that are similar to those voiced in recommendation 10. This urged regulatory organisations to consider the workload imposed by mixed mode operations, combining general and commercial aviation, rather than simply defining workload in terms of the total number of movements or aircraft. Our analysis of the previous ECF diagram suggests that a number of other factors should also be considered.

Figure 6 also includes information on the ICAO requirements for low visibility operations. Page 57 of the ANSV report includes the observation that for medium operations (16-25 movements per hour) there is an assumption that surface movement radar would be available and that controllers should be able to perform the selective switching of taxiway centre lights. As we have seen, ATM personnel were not supported by these infrastructure facilities prior to the Linate collision.

The level of traffic should be determined by a combination of the mode balance, commercial or civil, the total number of movements *and* the prevailing meteorological conditions. Current distinctions between low, medium and high traffic movements are relatively meaningless without this additional contextual information. Further research might be conducted to provide controllers and supervisors with simple mnemonics and other aide-memoires that could help them to make decisions about workload when they are faced with changes in their operational environment.

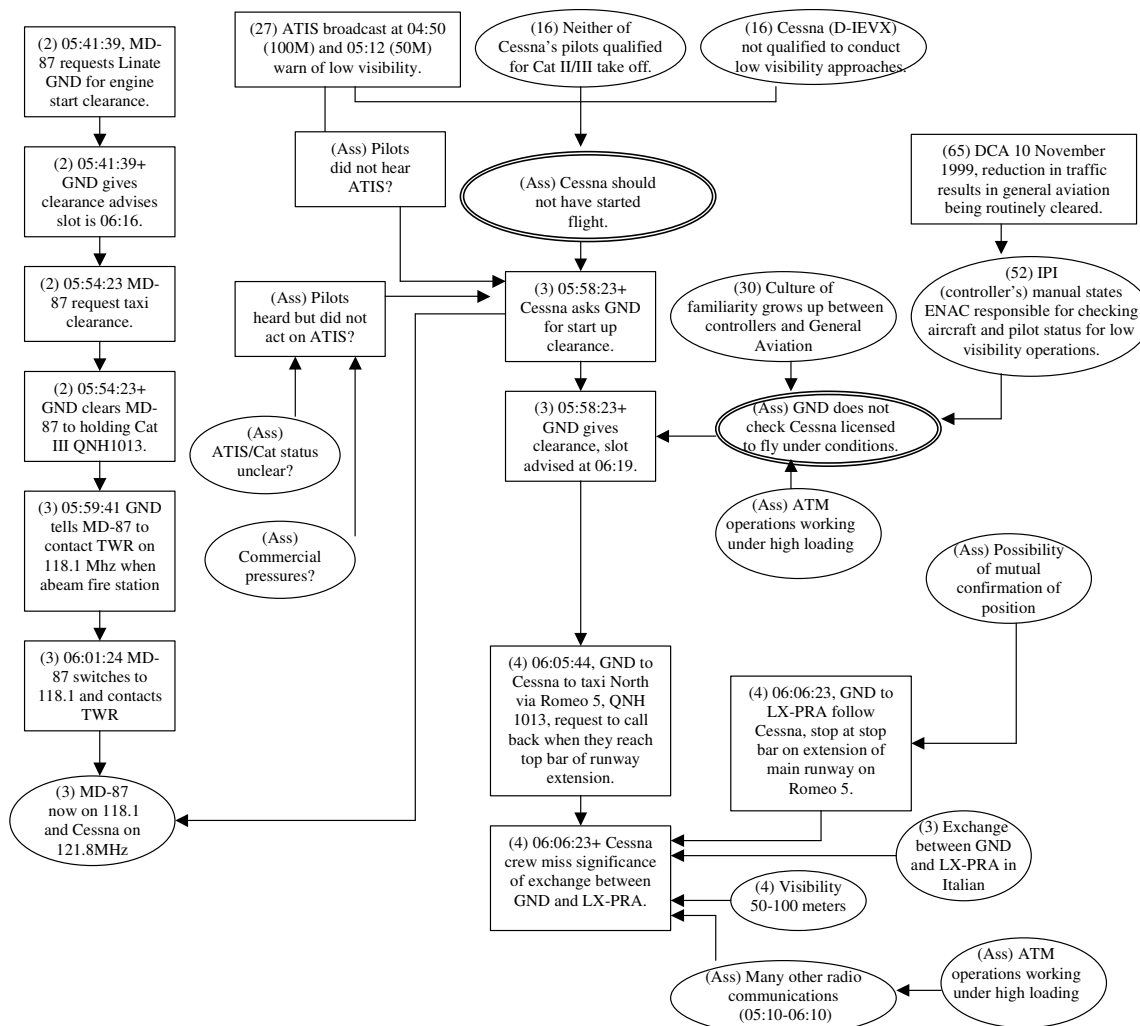
Figure 7: ECF Analysis of the Linate Accident – Initial Events on the Morning of the Accident

Figure 7 moves the ECF analysis from the contextual and background factors to the specific events that occurred on the morning of the accident. It begins with the observation that there was an Automatic Terminal Information System (ATIS) broadcast at 04:50 advising of low visibility. This broadcast was updated at 05:20, 05:24, 05:25, 05:50 and 06:20 (post accident) repeating the warning. Figure 7 also

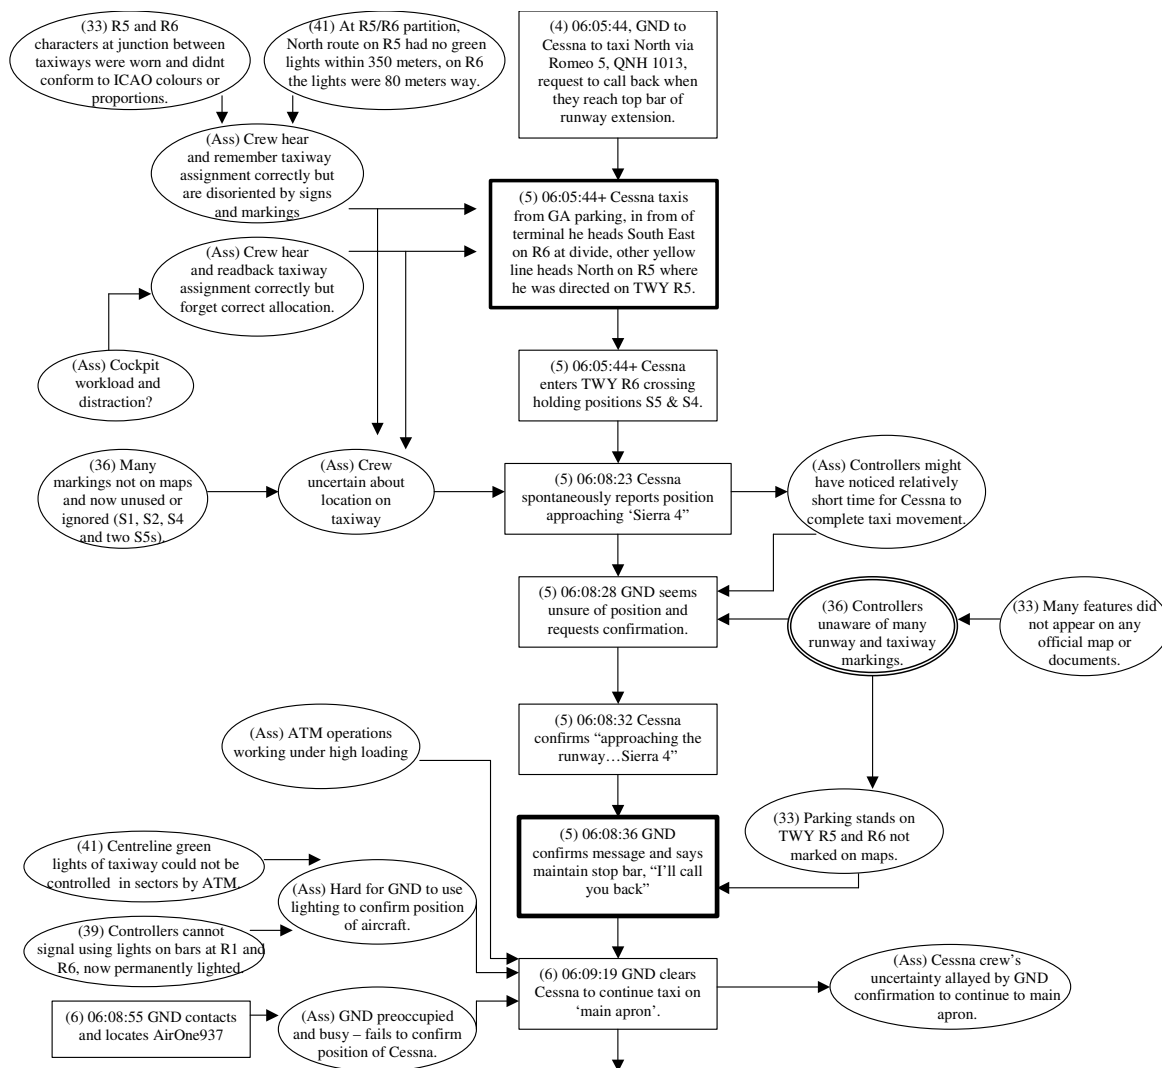
Figure 8: ECF Analysis of the Linate Accident – Problems with the Taxiway Signage and Markings

As mentioned, the crew of the Cessna made an unexpected report of their position near ‘Sierra 4’ at 06:08:23. This provided one of the few opportunities for ATM personnel to detect the potential runway incursion. These are two different lessons to be learned from this opportunity. Firstly, we must understand the potential reasons why the crew made this report so that we can encourage these observations and provide similar opportunities for the detection of incursions in the future. Secondly, we must also understand the reasons why the ATM personnel did not identify the potential problem once the report had been made. Figure 8 builds on the previous analysis of recommendation 19 where it was argued that aircrews need to identify and communicate uncertainty over their location on a taxiway. As can be seen, this uncertainty was based on the lack of sufficient markings and signage and may also arguably have been compounded by uncertainty over the initial allocation to R5. In either case, the lack of markings for S1, S2, S4 and the two S5’s may well have compounded any apparent confusion for the aircrew. The reasons for the lack of documentation and the disuse of these markings were analysed in

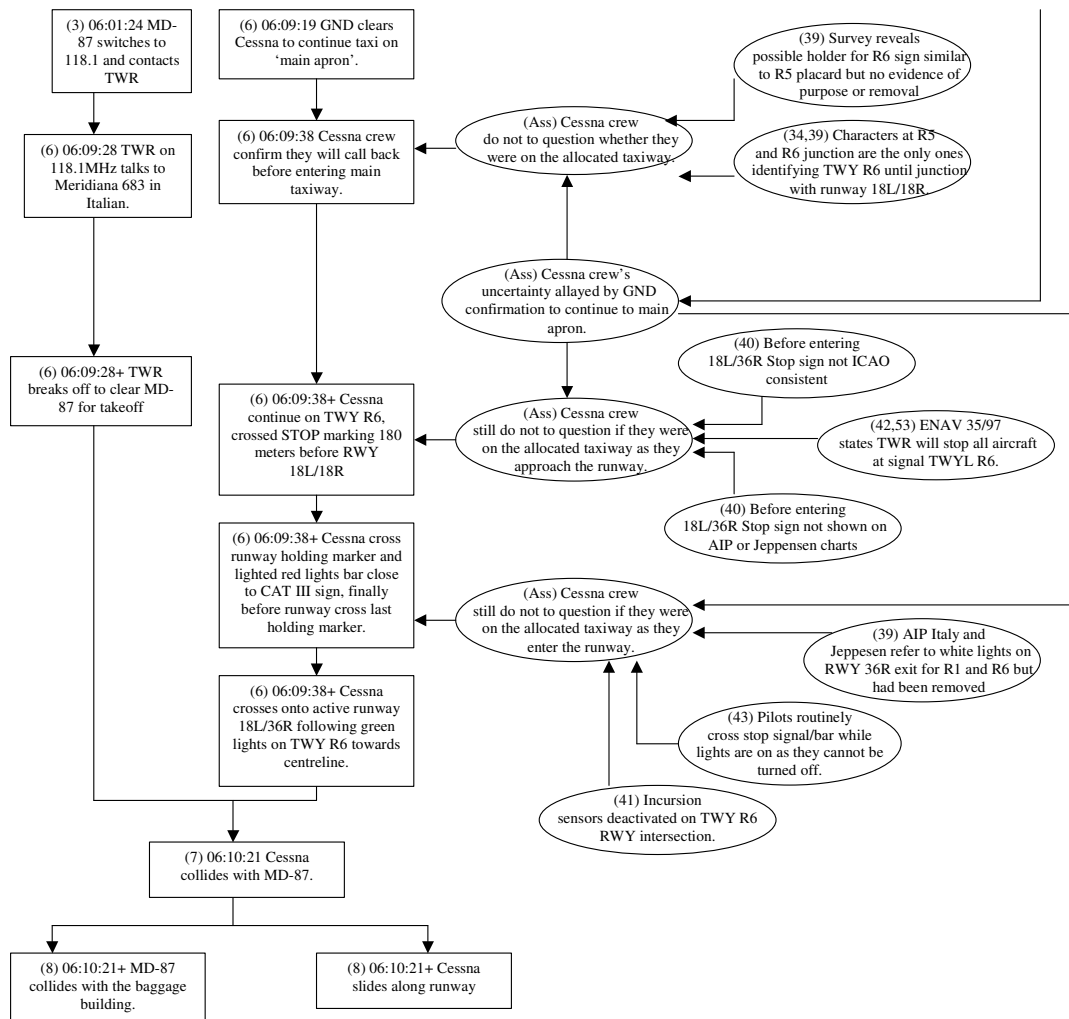
Figure 9: ECF Analysis of the Linate Accident – Events Immediately Prior to the Collision

Figure 9 also illustrates another key moment in the events leading to the accident. In this case, the Cessna's crew crossed the STOP markings 180 meters before RWY 18L/18R onto TWY R6. The ECF diagram reiterates points from Figure 4 that the STOP sign was not ICAO compliant. The sign was not shown on AIP or Jeppesen charts even though ENAV regulations required that the TWR should stop all aircraft at the signal on TWY R6. If it is true that neither the aircrew nor the ATM personnel knew the true location of the Cessna at this point then these last two comments are irrelevant and might arguably be

excluded from the analysis. Neither the aircrew nor the ATM staff would have known to check the maps to check for the signs in their location. The TWR was not expecting the Cessna to be on R6 and so was unlikely to enforce the STOP regulations. Equally, if the GND proceed command had allayed the aircrew's lingering concerns then they too are likely to have missed the inconsistent STOP signs because they were not expecting them to be there.

AT some time shortly after 06:09:38, the Cessna crossed the runway holding marker. They passed an illuminated red light bar close to a Cat III sign. Again it must be assumed that they were disoriented and did not at this stage question their assumed location on the appropriate taxiway short of the runway. The ANSV provide some information about the reasons why this final set of defences might have been breached when they argue that pilots routinely had to pass illuminated stop signals because ATM personnel could not routinely turn them off. Figure 9 also includes further observations on inconsistencies between the signage and official documentation. As before, however, it is uncertain whether these inconsistencies were immediate causes of the accident. There is no evidence that the Cessna crew attempted to use this documentation to trace their position on the taxiway at this relatively late stage in the accident. Their decision to cross onto the active runway may also have been influenced by the path of the green lights on TWY R6 that led onto the centreline of 18L/36R.

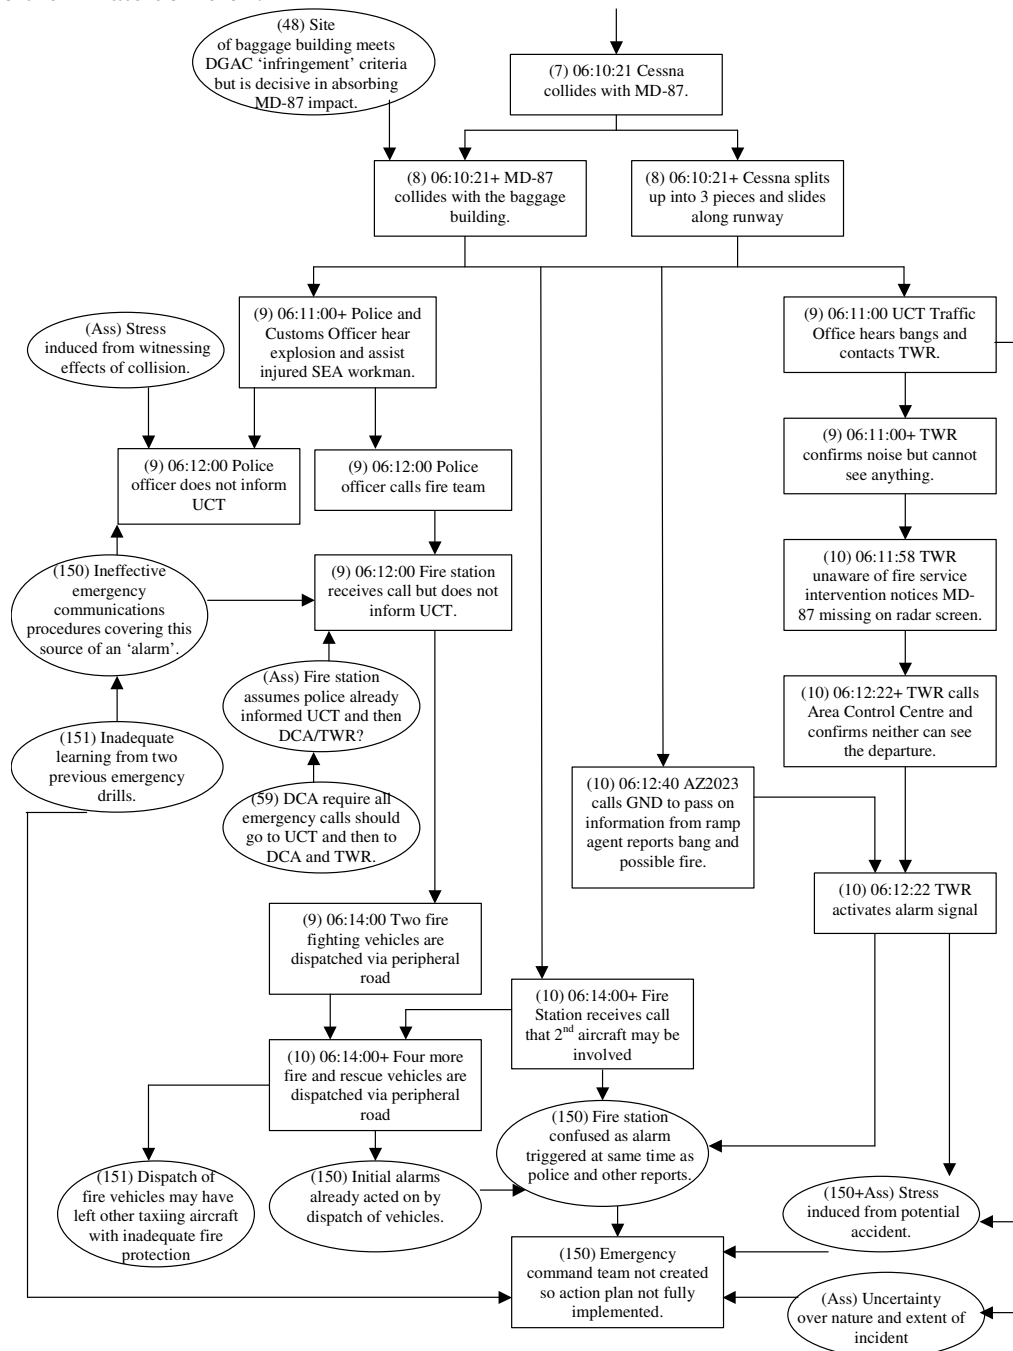
Figure 10: ECF Analysis of the Linate Accident – Events Immediately After the Collision

As can be seen, the MD-87 collided with a baggage building that was situated close to the runway. The location of this structure conformed to the relevant DGAC infringement criteria. Although a previous ENAV survey had shown that it encroached the permitted area by around 1 metre and additional warning lights had subsequently been added to the structure. The ANSV report concluded that the position of the building was 'decisive' in absorbing the violent impact of the aircraft (page 48) and was 'instrumental in the catastrophic sudden and violent stoppage of the aircraft' (page 160). The official report does not speculate whether the consequences of the incident would have been less severe if the baggage handling facility had not been placed so close to the runway. The ANSV report does not list the location of the baggage facility as one of the factors that caused the adverse outcome to this incident once the collision had occurred. None of the existing recommendations mention the location of buildings adjacent to runways.

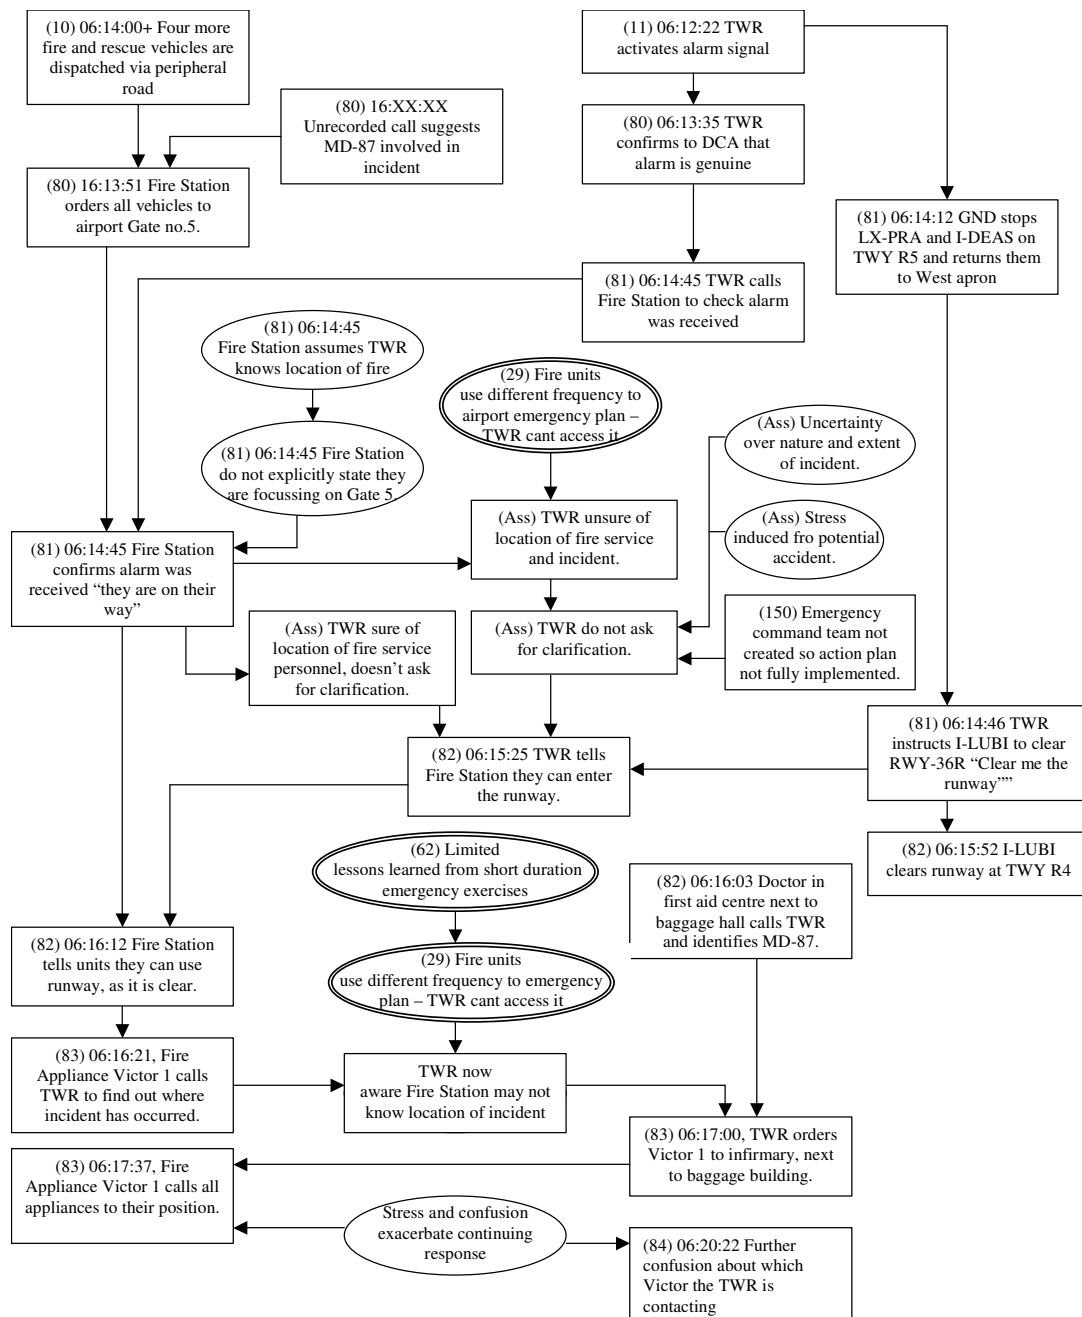
Figure 11: ECF Analysis of the Linate Accident – Events After the Collision

Figure 11 captures the way in which the response evolved after the collision. The activation of the alarm signal prompted the GND controllers to return two taxiing aircraft to the West apron. The ANSV report does not go into detail about the precise steps that were taken to confirm the locations of these and other aircraft. Given the previous discussion in this report, there is a clear concern that the meteorological conditions and other factors that led to the initial runway incursion would not also have created potential uncertainty over the location of other aircraft. Meanwhile, an unrecorded call had alerted Fire Personnel to the possibility that the MD-87 had been involved and that there was wreckage close to Gate number 5. The Fire Service then ordered all vehicles to proceed to this gate even though the initial report had not, as yet, been confirmed.

The TWR confirmed to the DCA that their emergency alarm was genuine. TWR personnel also then called the Fire Station to ensure that they had received the alarm. They confirmed that the alarm had been heard and that ‘they are on their way’. This ambiguous response did not tell ATM personnel the precise destination of the Fire crews as they attempted to locate the site of the incident. Fire officers may have assumed that the TWR knew of the location of the incident because they initiated the alarm. The ambiguous communications between the Fire Station and the TWR creates two possibilities. Either the TWR were sure of the location of the fire crews and the incident and hence they did not need to ask for clarification or they were uncertain about the deployment of emergency personnel in the aftermath of the incident. It seems likely that there was at least some uncertainty over the location of fire personnel and the site of the wreckage. TWR personnel could not directly monitor the crews’ communications because they were on a different frequency to that used for emergency coordination. The fire crews’ frequency was not accessible to the TWR. The ANSV report argues that such channels should have been made available to other parties involved in the emergency response but does not consider the additional workload implications for key personnel, including ATM staff, who would have to filter a mass of communications as they coordinated the response. They do, however, identify a host of distractions that were created by unauthorised communications in the aftermath of the incident.

Figure 11 also identifies a number of reasons why the TWR did not request clarification about the location of fire personnel and the site of the incident. Stress and uncertainty may explain the TWR's failure to confirm these details. Similarly, the lack of an Emergency Command Team or more detailed plan may have removed effective prompts for the TWR to obtain a clearer overview of the immediate response to the accident. The ANSV report analyses the need to coordinate information and to remove ambiguity in communications between emergency services, aircrews and ATM personnel. As mentioned, it also considers the importance of providing access to common communications channels and of minimising unauthorised use of those channels. Arguably, the official report does not consider a range of low-cost technical innovations that might easily be used to address some of the confusion in the aftermath of runway incursions and similar events. Later sections will deal with the use of military grade thermal imaging and image intensification equipment by fire personnel. For now it is sufficient to
