Configuration Management as a Common Factor in Space Related Mishaps

C.W. Johnson, Ph.D.; Department of Computing Science, University of Glasgow, Scotland.
L.L. Fletcher, PhD, US Air Force Advanced Space Operations School, Colorado Springs, CO, USA.
C. Michael Holloway, NASA Langley Research Center, 100 NASA Road, Hampton, VA, USA.
C. Shea, M.Ed., Ph.D., ESR Technology Ltd, Warrington, Cheshire, UK.

Keywords: Configuration Management, Space Mishaps, Accident Analysis.

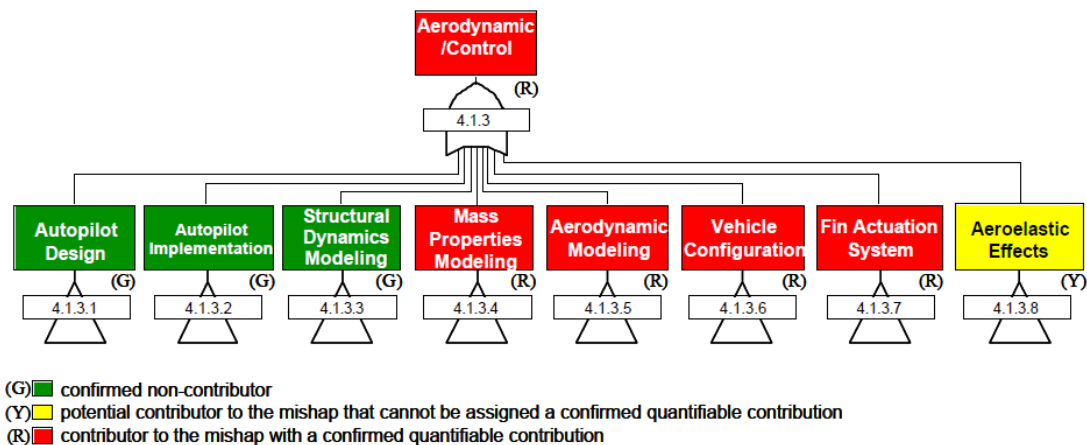
numerous different issues in the configuration management of the different safety-related applications. In other words, the investigations argued that even if the N-Prime and X-43A mishaps **had not failed** in the way that they did then it is possible that other weaknesses may have led to other incidents in the future. For instance, the difficulty in integrating multiple theoretical models and in using data from complex mathematical systems not only revealed itself in the higher level aerodynamic aspects of the HXRV project, it also led to errors in the modelling of dynamic aerodynamics and aeroservoelasticity as well as mass.

Configuration Management and the Interaction with Uncertainty: Previous sections have referred to the complexity of research projects, such as X-43A. This explains the difficulty of ensuring configuration management techniques are exploited in many safety-critical applications. At the same time, complexity also increases the need to exploit appropriate configuration management techniques in order to ensure that critical details are not missed. Even all of the errors in the mathematical models that were produced to guide the configuration and architecture of the X-34A stack cannot on their own explain why this mishap occurred. For instance, the aileron gain margin was reassessed and the revised models showed a reduction from the predicted pre-flight level of 8 dB down to less than 2 dB once the errors in the calculations had been corrected. This was significantly less than the 6 dB ‘safe’ gain margin. The investigation team concluded that although this came close to creating instability, the revised prediction was still stable [4]. Non-linear time history predictions had to be used to account for the behaviour of the X-34A during the incident. In particular, this had to be revised to consider parameter uncertainty. It was argued that “no single contributing factor or potential contributing factor caused this mishap. The flight mishap could only be reproduced when all of the modelling inaccuracies with uncertainty variations were incorporated in the system level linear analysis model and nonlinear simulation model” [4].

Figure 2 — Critical Fault Tree Branch (Ack: X-43A Mishap Investigation Board [4])
