Report on the Loss of the Mars Polar Lander and Deep Space 2 Missions

JPL Special Review Board

22 March 2000

JPL D-18709

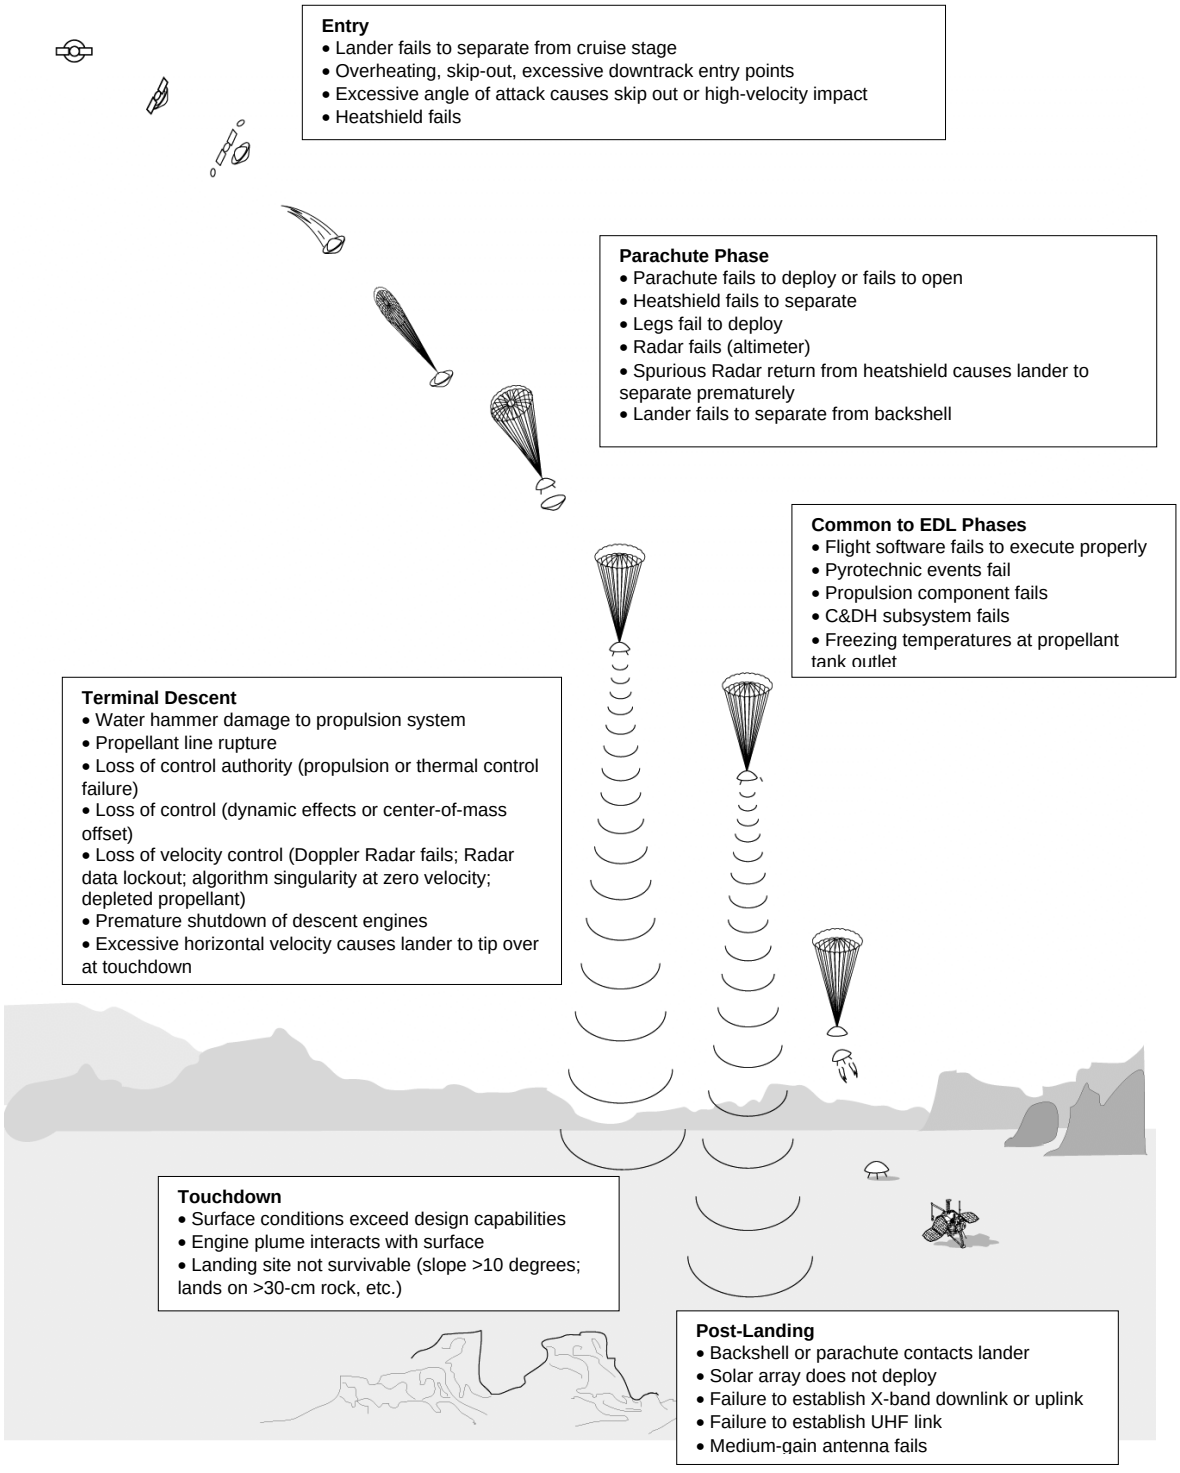
Figure 6-1. MPL Entry, Descent, and Landing (EDL) Sequence with Potential Failure Modes

Figure 6-1 depicts the MPL EDL sequence and shows potential failure modes.

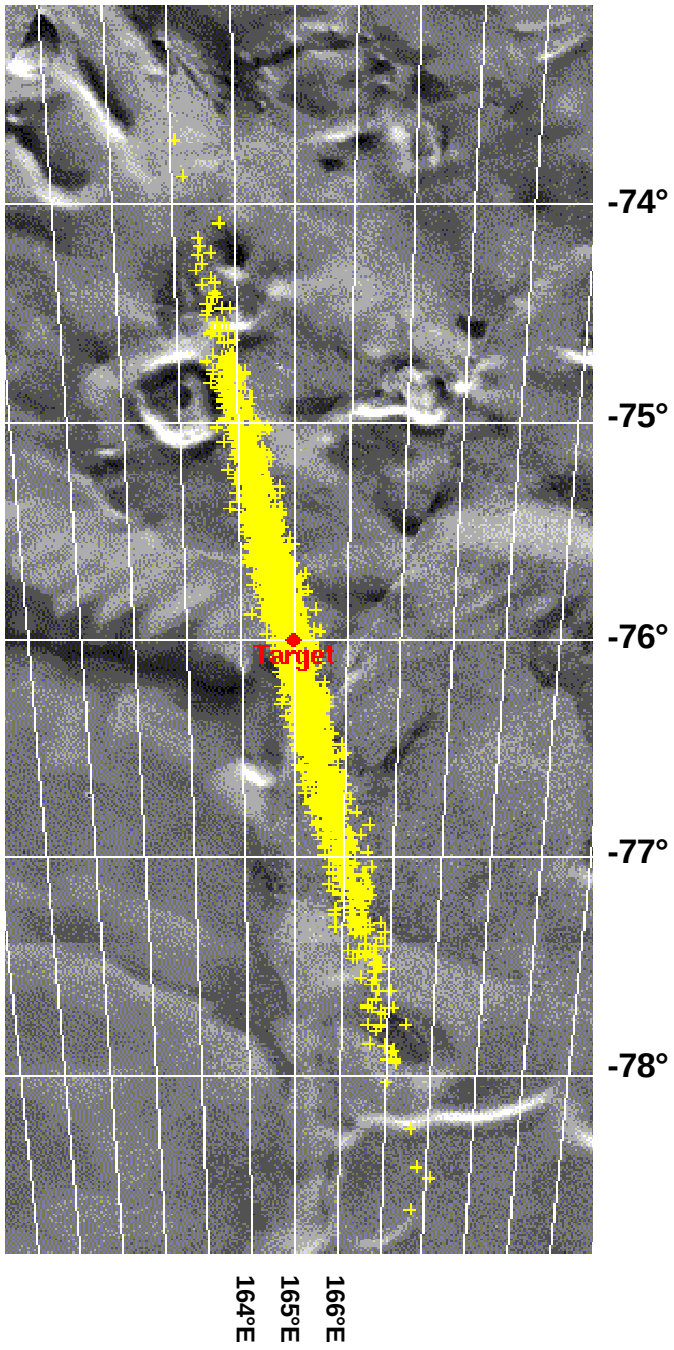
Figure 7-1. Site Selection Ellipse —
Based on LMA Scatter for 75° S, Rotated for 76° S Landing Site

Additionally, in order to achieve the desired landing ellipse on the surface of Mars, the analysis assumed that the spacecraft center of mass could be controlled to within 2.8 millimeters of the centerline of the entry body. The resulting surface ellipse had dimensions of 85 kilometers semi-major axis (along-track) by 5.4 kilometers semi-minor axis (cross-track), both 2 sigma. Figure 7-1 shows the landing ellipse estimate at the time of the site selection several months before EDL, based on earlier 3DOF/4DOF LMA Monte Carlo simulations, adjusted in orientation to the new landing latitude of –76° S. (*Note*: The landing latitude was –75° at launch.)

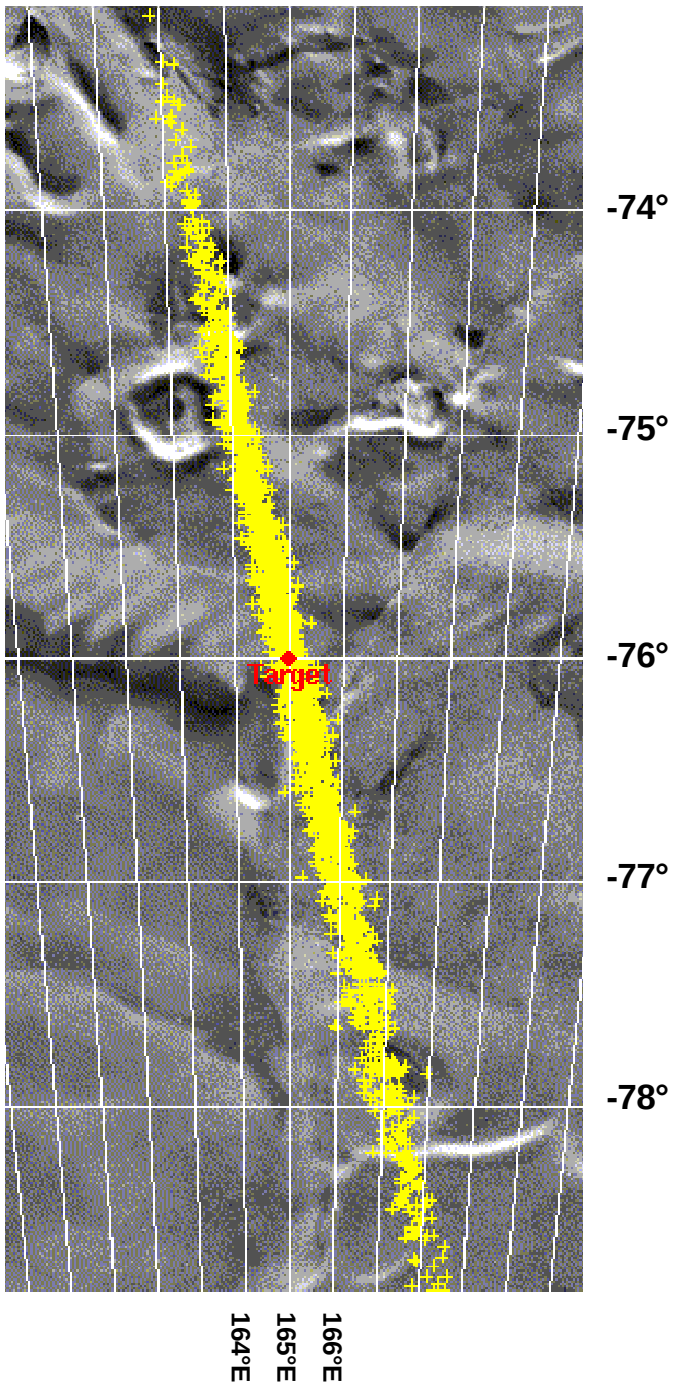
Figure 7-2. TCM-4 Planning Ellipse — LaRC 3DOF Scatter, 11/23/99

Analyses performed after EDL revealed that the effects of maneuver-execution errors were larger than expected. The TCM-4 planning ellipse was based on a maneuver magnitude of 0.35 meter per second, the best estimate available at that time. The final TCM-4 maneuver magnitude was 0.6 meter per second. This maneuver magnitude resulted in considerably larger execution errors than had been previously assumed. For very short burns, execution errors are small because little time is available for pointing errors to develop. For longer burns, errors are also small because the control system will steer back to the desired attitude. The executed burn magnitude fell in between these extremes and, therefore, was subject to a larger set of expected errors. This increased the size of the 3-sigma B-plane error to as high as 20.5 kilometers × 13.8 kilometers, using worst-case requirement estimates of maneuver-execution errors. (Typical or “expected” maneuver-execution errors led to substantially smaller B-plane errors (18.3 kilometers × 6.2 kilometers). This widening effect is illustrated in Figure 7-3, which shows both the narrow TCM-4 planning ellipse, based on the assumed maneuver magnitudes and associated error statistics, and the wider ellipse, based on the actual maneuver magnitude and associated error statistics. This graphic represents the difference between the delivery accuracy that the project assumed was achievable at the time of TCM-4 versus what is now believed to be the best estimate, after the fact. Also shown is the center of the final navigation solution based on tracking data after TCM-5 through the loss of signal.

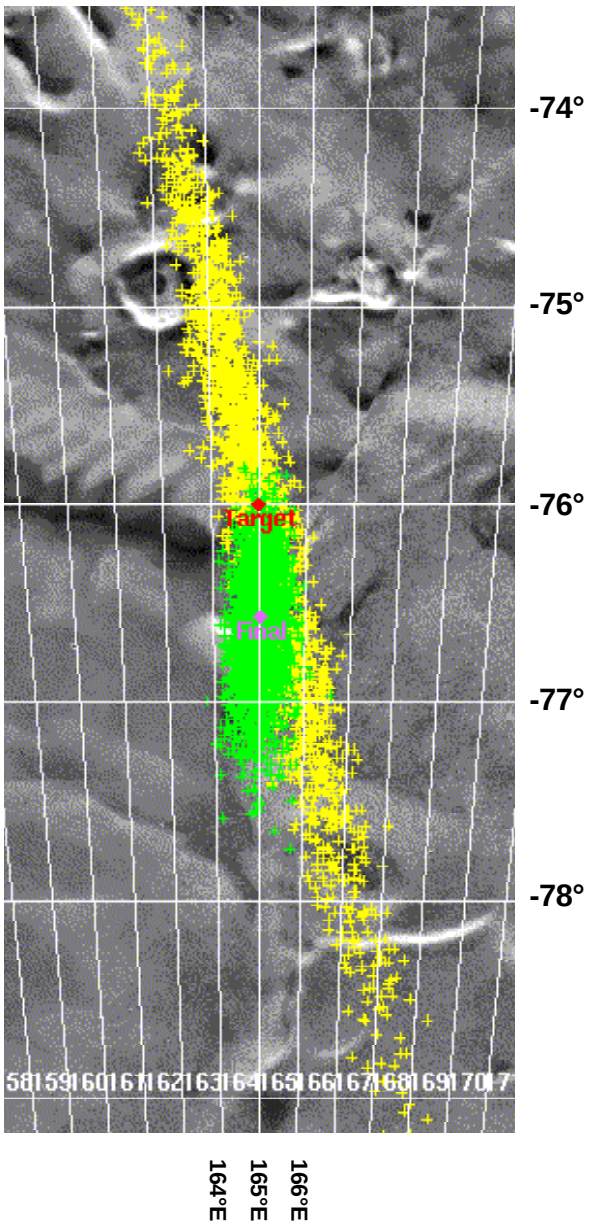
Figure 7-4. Required Maneuver-Execution Errors, LaRC 6DOF 3/3/00 (Yellow [Light]) and Final Estimated Ellipse, LARC 6DOF 3/3/00 (Green [Dark])

On the basis of the final pre-entry tracking, the desired in-plane entry conditions appear to have been met. The entry flight-path angle was reconstructed at –13.10 degrees against the target zone of –13.25 ± 0.94 degrees (revised from the original –13.25 ± 0.54 degrees). The cross-track error in the B-plane was within 7.2 kilometers of the planned target, which corresponds to a motion of approximately 8 kilometers at the surface. This distance is marginally consistent (within approximately 2 sigma) with the eventual understanding of the uncertainty surrounding the spacecraft small-forces environment and TCM-4 execution errors, which are discussed above. In Figure 7-4, the yellow (light) data once again reflect the best estimate of the delivery accuracy after TCM-4; these data are based on analysis after the fact. Also in Figure 7-4, the green (dark) data represents the best estimate of where the lander actually did go, eliminating effectively all navigation errors by using the final tracking data arc through loss of signal, but continuing to represent scatter around that final solution due to atmospheric and aerodynamic uncertainties.

Some concern has been expressed regarding how close the ultimate landing site was to a questionable terrain feature immediately to the west of the reconstructed landing site. Features equally hazardous appear further north on the western edge of the planned landing ellipse and on the eastern edge of the landing ellipse. These risks were known and accepted when the landing site was selected and did not represent risks that were higher than any alternative landing site during the early fall of 1999 at the time when a burn could have been executed to move the landing site. During the days prior to EDL, the cross-range drift (subsequently attributed to TCM-4 execution errors) was observed; however, as previously discussed, the project maneuver strategy did not allow for cross-track corrections at TCM-5.

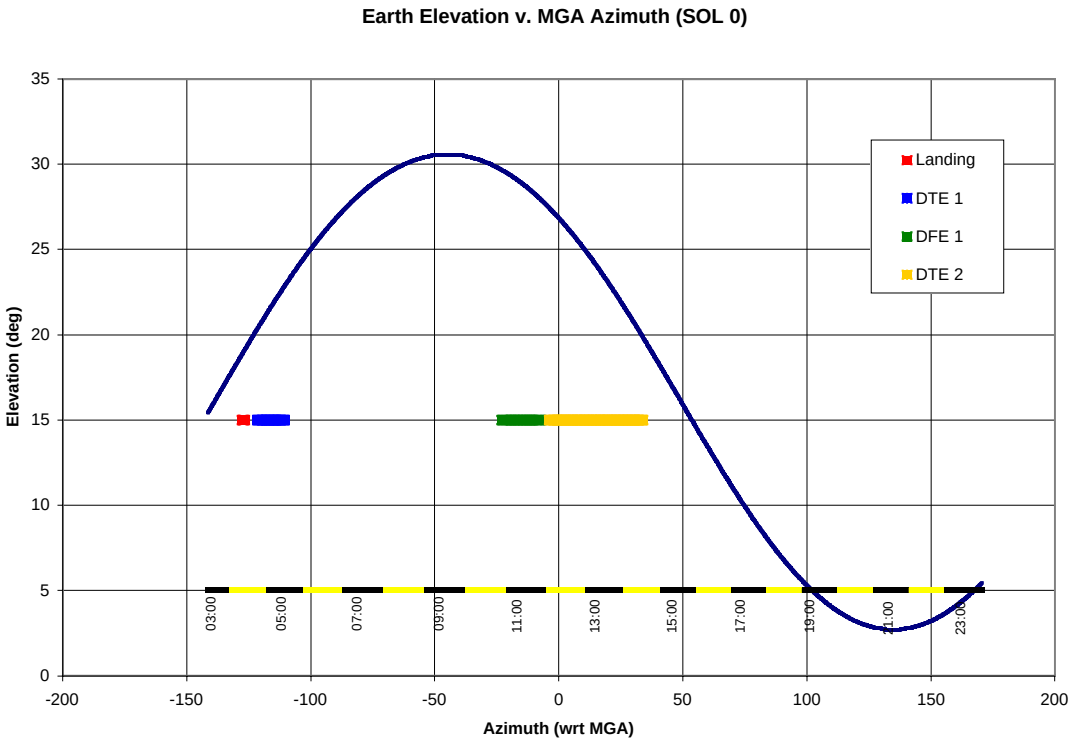
Figure 7-5. Earth Geometry for the Nominal Landing Orientation and Site on Sol 0

On sol 0, Earth was above 10 degrees elevation for azimuth angles of –150 degrees to +75 degrees (in the nominal landing attitude). Earth elevation peaked at ~32 degrees above the horizon. The azimuth and elevation "soft stop" ranges are: –138 degrees < AZ < 51.5 degrees, 2 degrees < EL < 57 degrees. The sol 0 Earth geometry is shown in Figure 7-5.

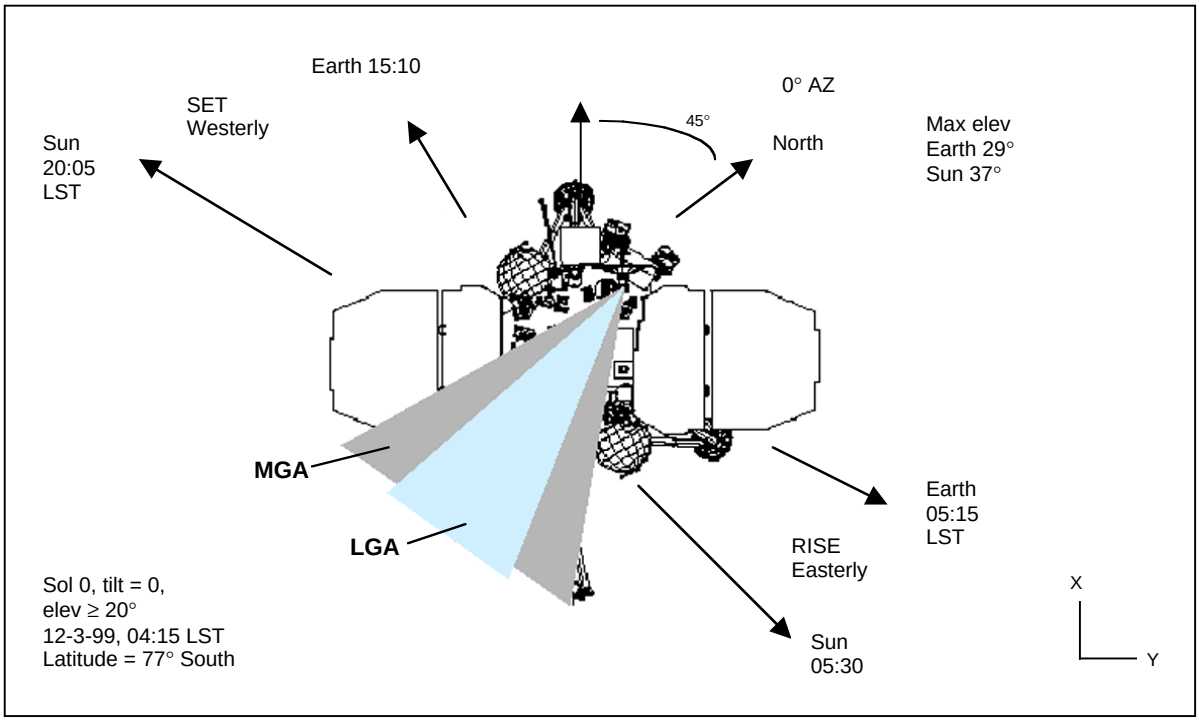
Figure 7-6. Command-Blind Zones in Azimuth for MGA (125 bps) and LGA (7.8125 bps)

For downlink, the "blind" zone is similar if no "touchdown power-on reset (POR)" scenario occurs that would kick off the autonomous Find the Earth (FTE) sequence (see Figure 7-6). Otherwise, the Telecom Subsystem would have been configured for carrier-only downlink for the duration of the sequence, which increases the field of view around the MGA to approximately 30 degrees. In carrier-only mode, a downlink signal would almost certainly have been observed from Earth during the FTE sequence, if the landing azimuth error had been less than 36 degrees (6 degrees FTE minimum "pad" plus 30 degrees field of view).

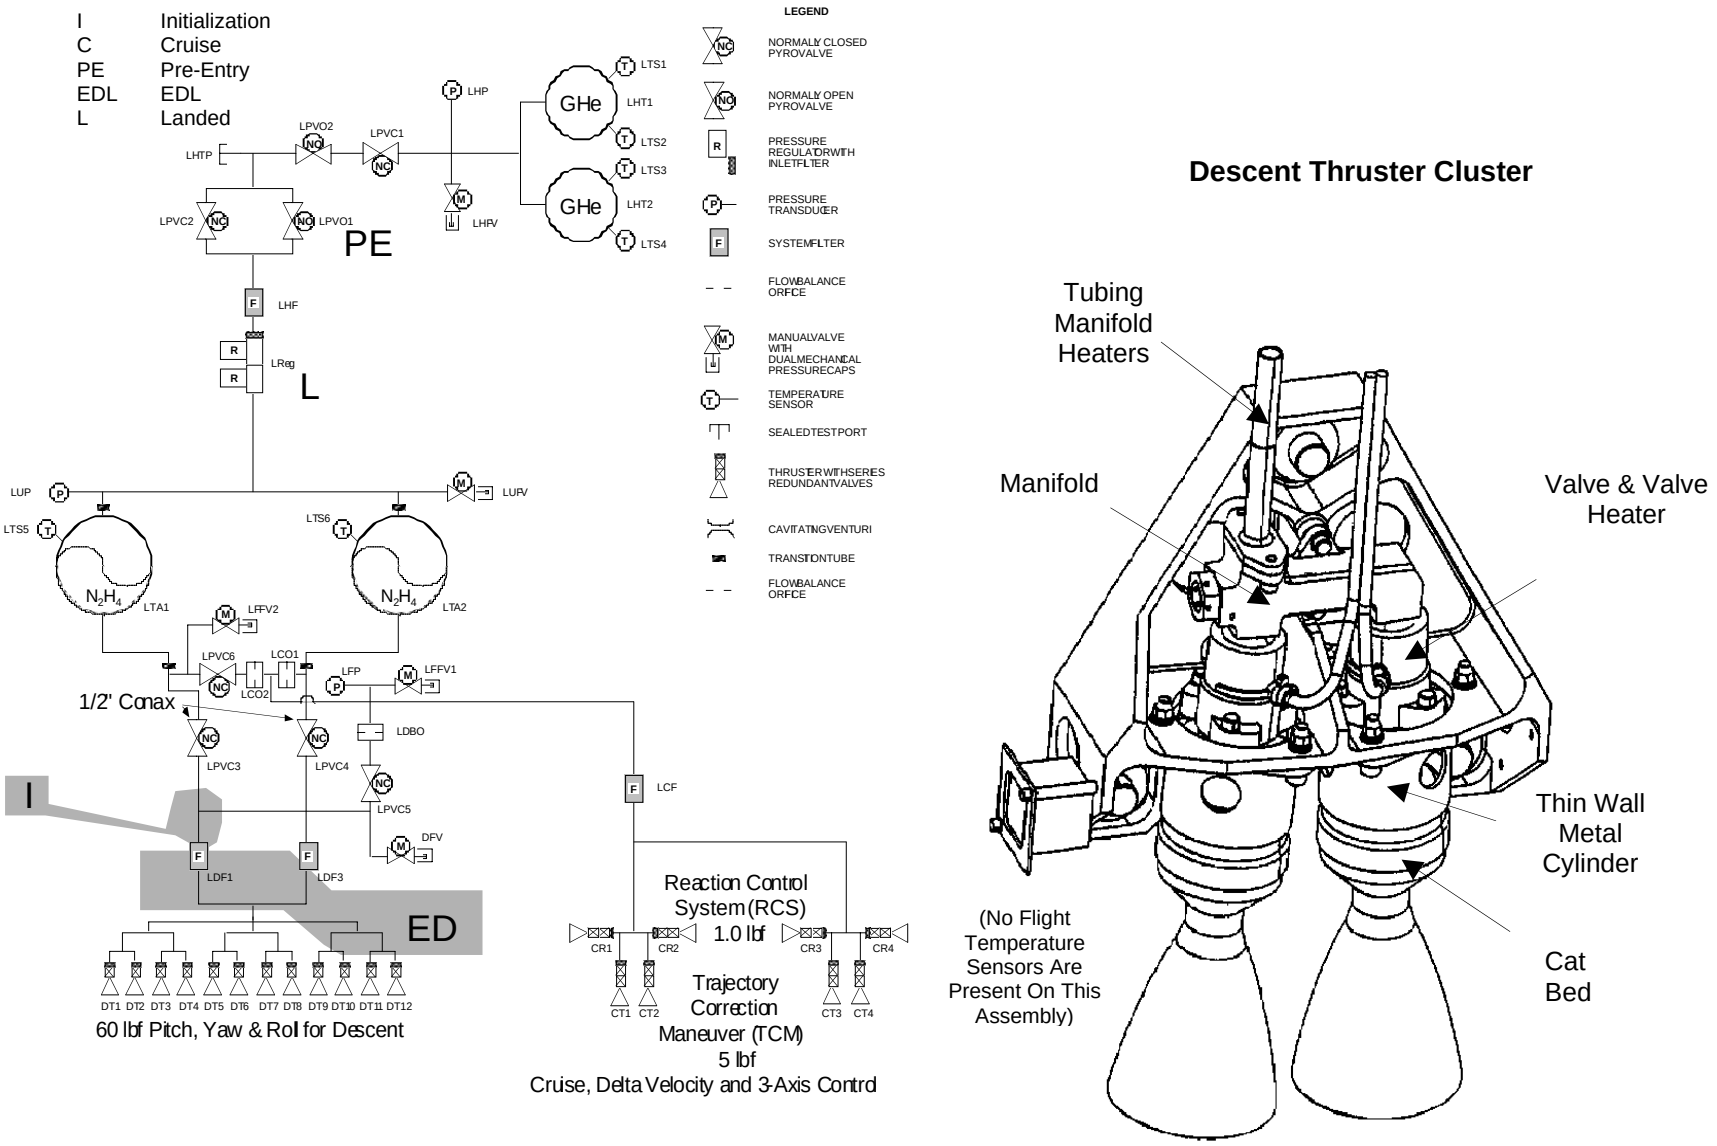
Figure 7-7. MPL Propulsion Subsystem Schematic

There are propellant center-of-mass management requirements for each of the mission phases. The objective was to prevent unacceptable offsets in spacecraft center of mass that affect the angle of attack of the aeroshell during hypersonic entry, and loss of control during powered descent. This was made more difficult because the propellant is simultaneously fed from two parallel tanks. The tanks contain diaphragms to separate the pressurant gas from the hydrazine. Each tank was filled to

approximately 85 percent (which is the maximum before the diaphragms are stretched). The propellant center of mass can shift from nominal because of the following:

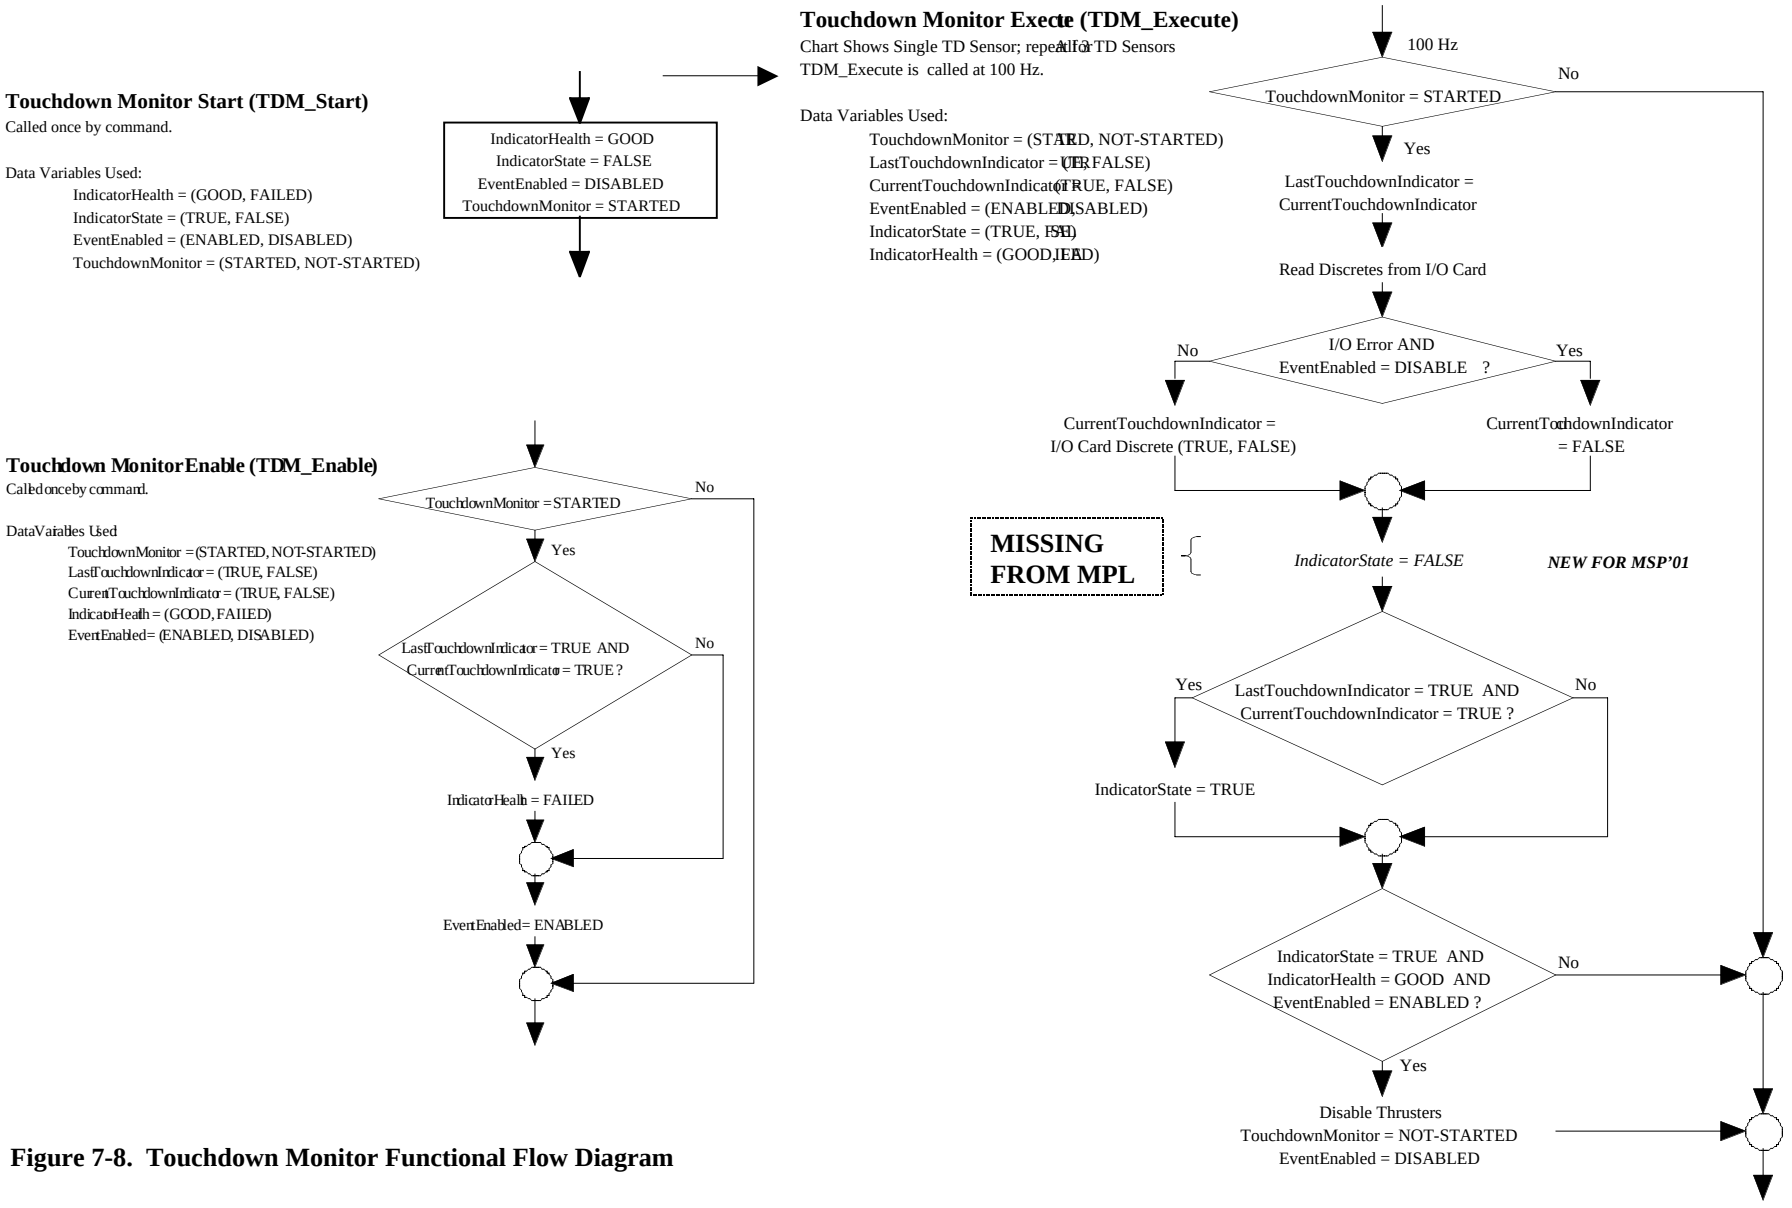
Figure 7-8. Touchdown Monitor Functional Flow Diagram

The design logic to implement the requirements is shown in the flow diagram in Figure 7-8.

The software designers did test the sensors prior to their use at the 40-meter altitude with a routine that checked the sensors right after the Radar sensed the altitude. That routine labeled any sensor that was on for two consecutive samples to be labeled as a “bad” sensor and not used. The transient would not be present at that time in the EDL sequence, so the sensor that had the transient (and showed an indication of touchdown during the transient) would now pass the test as a healthy sensor. The sensor touchdown state that was set as True during the transient would still be in the True state, and since the enable was then present, all the conditions for descent engine thrust termination would be present. Because the software designers and systems engineers were not aware of the transient behavior from the Hall Effect sensors, the people participating in the walkthrough process did not catch the software problem.

The requirements for the touchdown sensing logic were not changed after the landing leg deployment tests established the likelihood of transient response of the Hall Effect sensors to the leg dynamic effects. This may have been the result of the mechanical design personnel not informing the systems and software personnel of the results in a timely manner. Perhaps, if the Systems Engineer was told, he or she may have thought that the problem was solved by the requirement not to use the touchdown sensor data until the 40-meter altitude had been reached. By that time, the transient would no longer be present. The combination of that requirement and the requirement to initiate the sampling process prior to entry to keep the processor demand constant put everything in place for the flight software to be vulnerable to a transient, triggering a premature engine shutdown. The systems and software personnel may not have informed the mechanical design personnel of the software design that was used to detect touchdown and to disable sensors that indicate a premature touchdown signal. If that is true, the mechanical design personnel would not have been sensitive to the problems that a transient would cause.

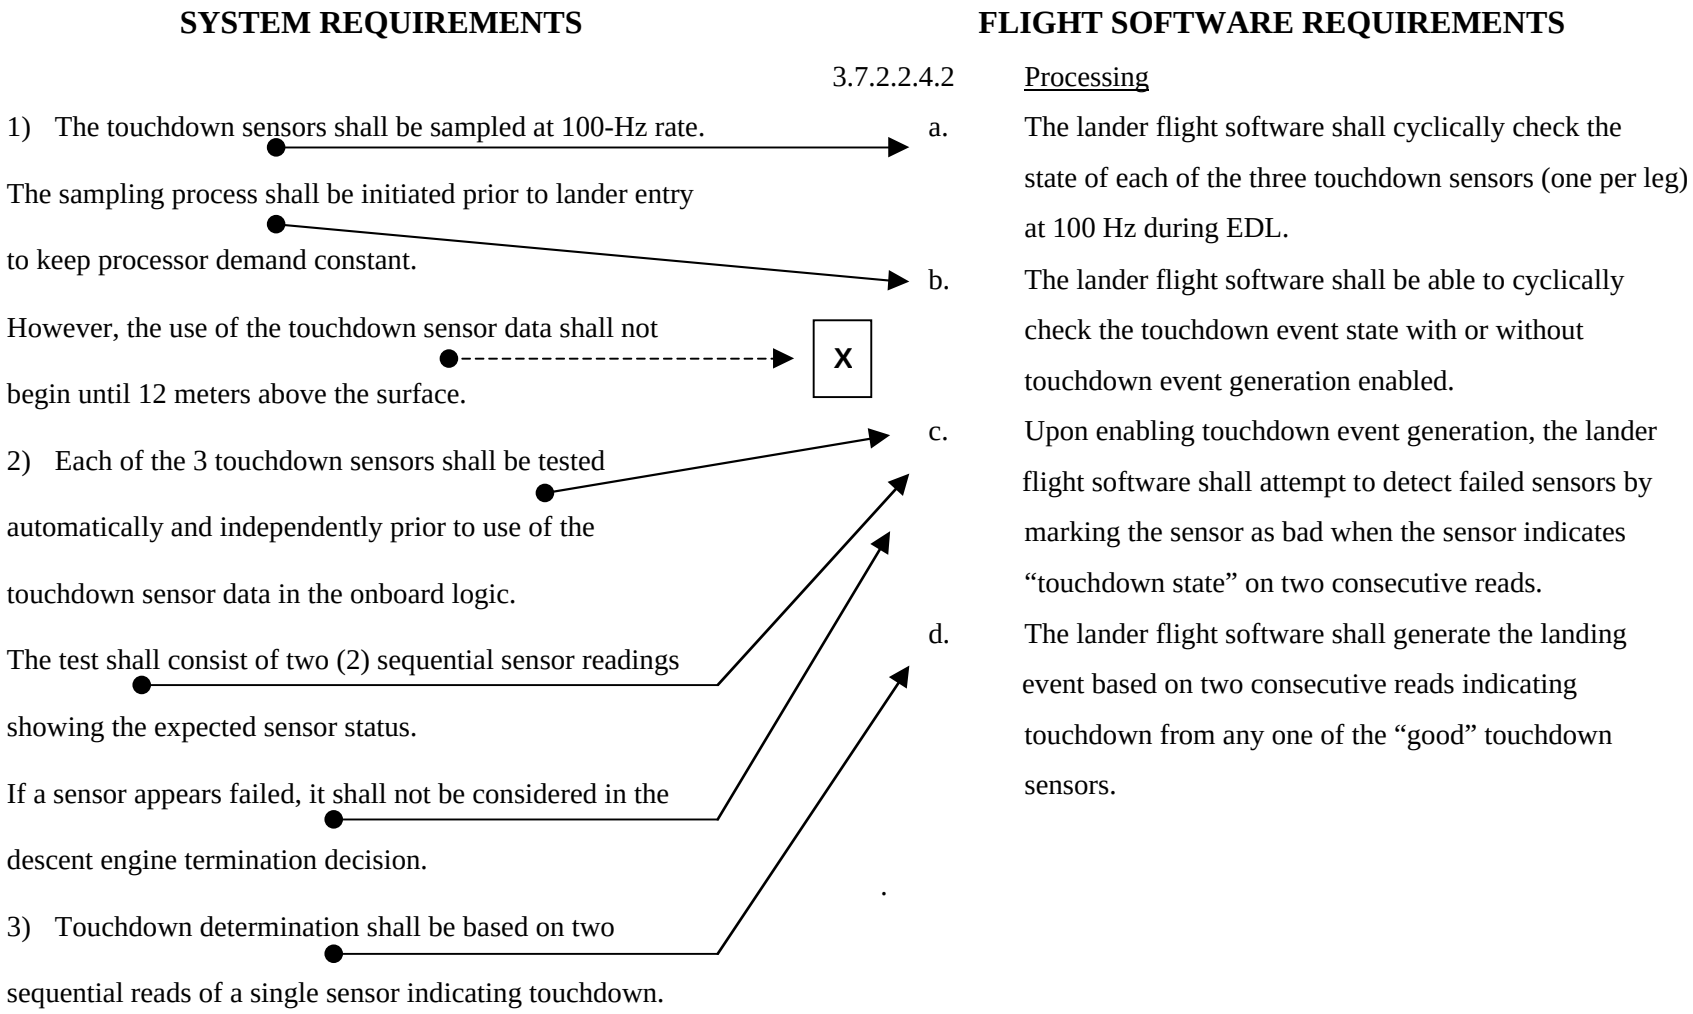
Figure 7-9. MPL System Requirements Mapping to Flight Software Requirements

Even though the software walkthrough process is well defined and the walkthroughs are well attended, the existence of the Hall Effect sensor transient response during leg deployment was not known. (It should be noted that the Hall Effect sensor Product Integrity Engineer was not present at the walkthroughs.) Thus, it was not discussed during the walkthroughs, nor were suitable test cases defined to test the software with conditions representing the transient response of the system.

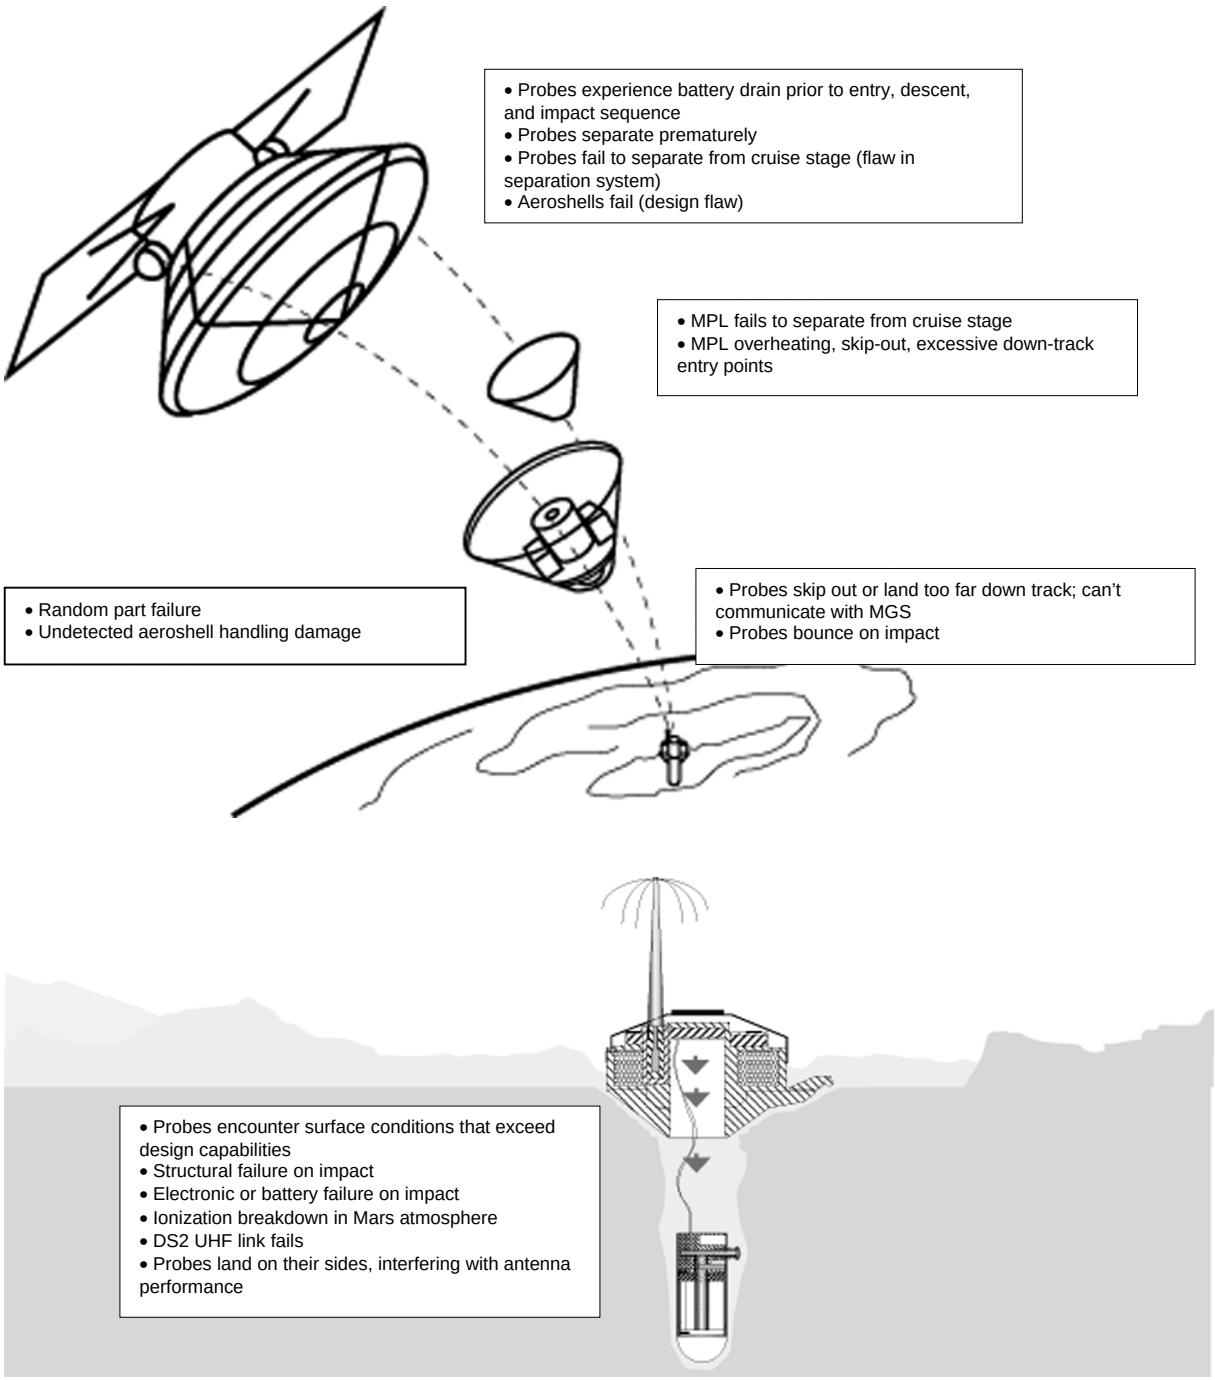
Figure 8-1. DS2 Entry, Descent, and Impact Sequence with Potential Failure Modes

The four DS2 potential failure modes identified by the Board as plausible are highlighted as *FLAG 1*, *FLAG 2*, *FLAG 3*, and *FLAG 4*.

Figure 8-1 illustrates the DS2 entry, descent, and impact (EDI) sequence and shows potential failure modes.
