Case Study 1: STAMP Analysis

Chris Johnson,
Dept. of Computing Science, University of Glasgow, Scotland.
<http://www.dcs.gla.ac.uk/~johnson>

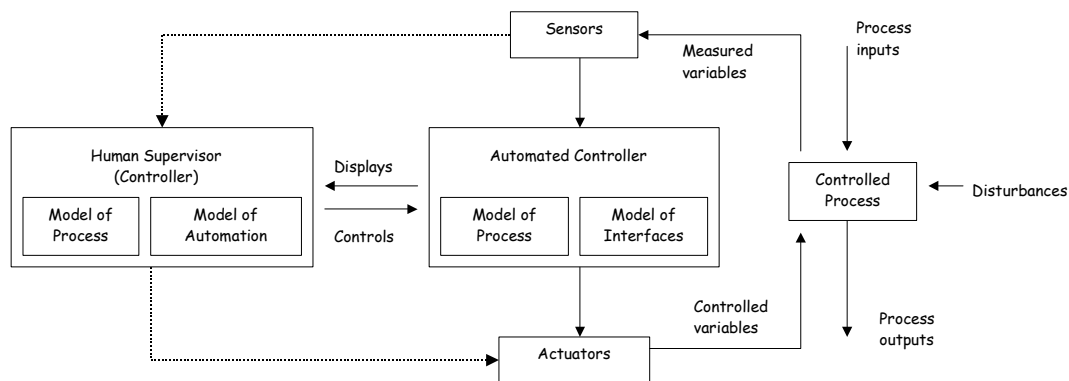
Figure 1: High-Level Model of Control

Your task is to work in groups of three or four to conduct a STAMP analysis of the incident described above. The first step is to construct a high-level control model. Figure 1 illustrates the initial template that is given in the STAMP papers. In practice, however, things are seldom this 'clean'. There will be multiple control relationships between operators and management.

In this incident we know very little about the role of the State and Federal regulators. We are also told relatively little about the company management structure. If your group would like to include them in the analysis then they should be incorporated into the control model with a suitable annotation to indicate that further analysis is required. An important role of many causal analysis techniques is to help identify areas for further analysis and the elicitation of additional information.
